Casting Defects Analysis in Foundry and Their Remedial Measures with Industrial Case Studies

Avinash Juriani¹

¹(M.tech Scholar, Department of Mechanical Engineering, Indian School of Mines, Dhanbad, Jharkhand, India)

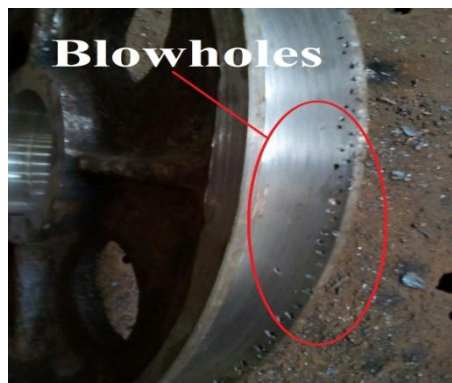
Fig.2. Blowhole

Sheave of Grade 270-540 IS1030 undertaken for study showed blowholes on groove edges.

- High moisture on chills.
- Low permeability of sand.
- Improper sand mixing.
- Inadequate vents.
- Use of undried coatings.
- High turbulence during filling.
- High bentonite content.
- Excessive Gas Entrapment.
- Liquid metal not properly degassed.
- High binder content.

- Avoid over ramming of sand.
- Use dry chills only.
- Optimum pouring temperature at 1585 degree centigrade for mild steel.
- Avoid using fine sand grains.
- Provision of adequate venting.
- Use dried and properly dressed cores.
- Reduce binder and additives.
- Control of Aluminum level.
- Increase runner height for increased static pressure.
- Adjust carbon equivalent value.
- Use water based zircon coatings.

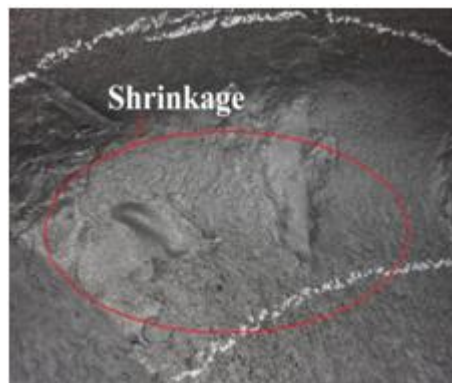
Fig.4. Shrinkage

Bottom bearing housing of Grade EN-9 alloy undertaken for study showed internal shrinkage defect towards the centerline.

- Unevenly dried sand with low compressive strength.
- Mould wall shift due to high metal pressure.
- Chills not placed properly.
- Sudden change in thickness of sections.
- Too many sharp internal corners causing hot-spots isolation.
- Excessive Ferro Silicate use during metal charging.

- Dry mould using CO₂ gas for at least 60 seconds for high rigidity.
- Use of chills at correct position to for directional solidification.
- Feeding of sharp corners to avoid hot spots.
- Riser to be properly located.
- Use of inoculants.

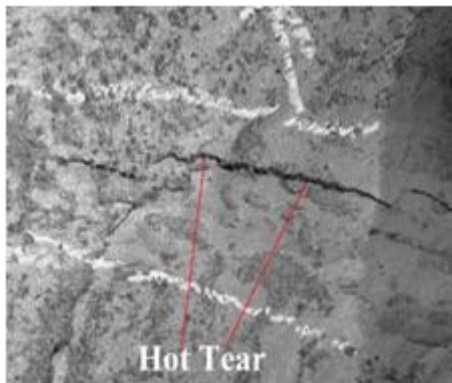
Fig.6. Hot Tears

Bottom Chock of Grade EN-9 alloy undertaken for study showed hot tear near thick sections.

- Use of coarse size sand grains.
- Mould disturbance before complete solidification.
- Imperfect riser location.
- Abrupt changes to be avoided which increase internal stress
- High binder and ramming density
- Hydrogen content too high
- Low amount of eutectic cells at grain boundary
- Excess amount of sulphur/phosphorus present

- Sufficient cooling of mould to be done.
- Avoid sharp turns/corners.
- Provision of draft during removal.
- Deoxidize to kill sulphur/phosphorus present.
- Use inoculants mixture of Mn/Si/Mg to reduce sulphur/phosphorus content.
- Use of fine sand grains.
- Add coal dust to increase eutectic cells during solidification.

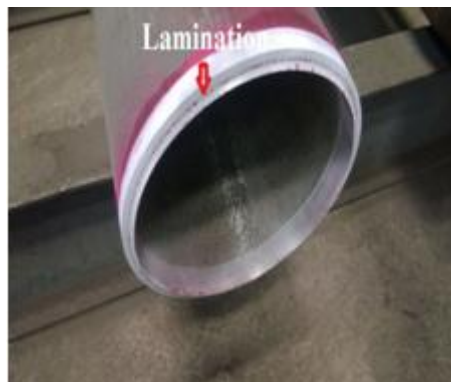
Fig.8. Lamination

Centrifugally Casted Pipe of Grade SS HK40 undertaken for study showed lamination defect protruding from pipe periphery.

- Use of low quality charge metal and scrap.
- Low rpm or extremely high rpm during pipe solidification.
- Friction between pipe die and material is low.

- Pipe to be rotated at optimum speed of 500rpm.
- Use of best quality materials for charging.
- Locking of pipe die by correct flange size.
- Asbestos sheet for packing should be of good quality and properly aligned in pipe die.

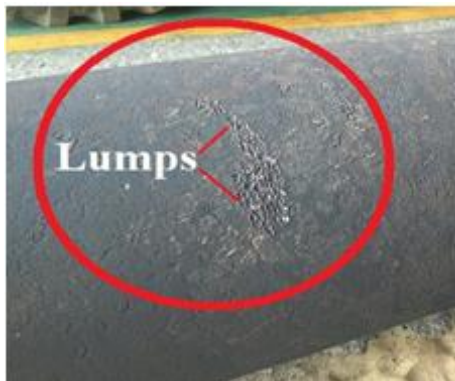
Fig.10. Lumps

Centrifugally Casted Pipe of Grade SS HK40 undertaken for study showed lumps defect on pipe surface

- Present of air voids in pipe die& metal interface.
- Low adhesion between metal and pipe during rotation.

- Increase rotation speedup to 475 to 500 rpm.
- Proper preheat of pipe die.
- Pouring ladle and die to be free from any foreign particles.
- Increase number of mould coatings inside pipe die.

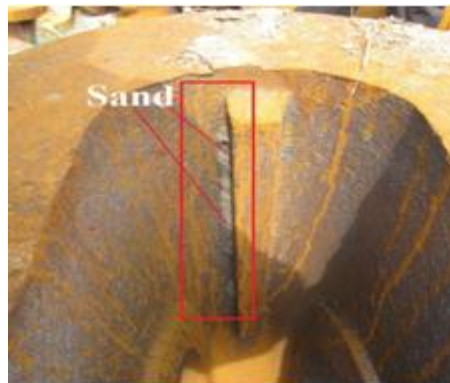
Fig.12. Sand Inclusion

Ball Valve of Grade ASTM A300 WCB undertaken for study showed sand inclusion near parting walls.

- Tilting of metal stream directly to cores causing erosion.
- Use of unevenly compacted moulds.
- Mould breakage during assembly.
- Uneven sand mixing.
- Improper pouring practices leading to mould disturbances.

- Use of high bentonite content.
- Proper ramming of sand for uniform compaction.
- Frequent cleaning of mould boxes.
- Use of properly dressed cores.
- Proper mixing ratio of reclaimed sand and binder.
- Proper pouring time.
- Optimum pouring height.

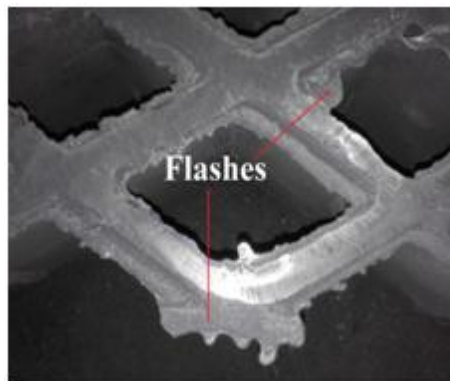
Fig.14. Flashes

Grid plate of Grade SG500/7IS1865 undertaken for study showed flashes defect.

- Excessive Clearance between top and bottom parts of mould box.
- High pouring pressure.
- Use of mould with poor pattern designs.
- Patterns having cavities at the end.
- Improper clamping of top and bottom parts.

- Sealing of mould box near parting line.
- Ensure end cavities to be filled to avoid metal leakage.
- Dimensions to be controlled.
- Carefully setting mould assembly.
- Proper core setting.

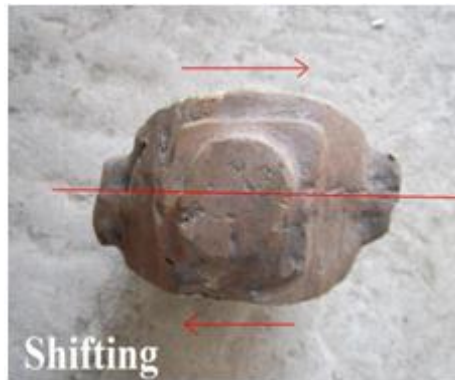
Fig.16. Mismatch

Valve of Grade ASTM A216 WCB undertaken for study showed mismatch.

- Clamping cope and drag using worn out dowels.

- Faulty pattern designs of top and bottom parts.
- Inadequate amount of weight kept on cope part.

- Use of proper gating system.
- Heavy weight to be kept on top of casting, ensuring no dislocation of cope part.
- Ensure top and bottom parts are aligned properly.
- Replace worn out dowel pins with new ones.
- Use locators to match top & bottom parts.
- Use C-Clamps to clamp the mould box.

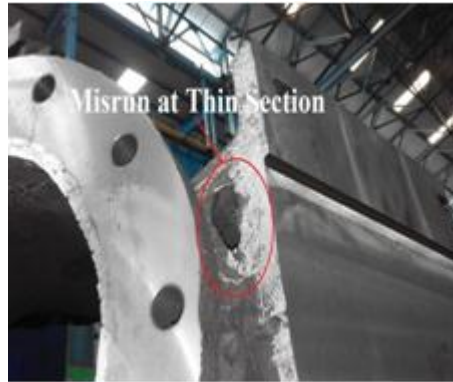
Fig.18. Misrun

Wind Box of Grade SG500/7IS1865 undertaken for study showed misrun defect at thin section.

- Lower pouring temperature.
- Intermittent Pouring.
- Pouring Delayed.
- Back Pressure during Pouring.
- Inadequate venting.

- Sufficient pouring temperature to ensure fluidity.
- Design proper gating system.
- Cleaning of mould box before pouring.

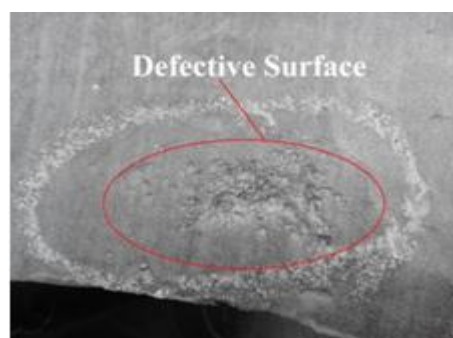
Fig.20. Defective Surface

Valve of Grade ASTM A216WCB undertaken for study showed defective surface at flange face.

- Formation of oxide films.
- Foreign impurities flowing on casting surface.
- Low temperature of mould.
- High slag content.

- Preheat the mould before pouring
- Check for slag formation during charge
- Pouring temperature to be lowered
