Analysis for Failure Mechanism of Temporary Shoring Structure

H.N. Ramesh¹, K.N. Jayaprakash²

H.N. Ramesh. "Analysis for Failure Mechanism of Temporary Shoring Structure." IOSR Journal of Mechanical and Civil Engineering (IOSR-JMCE) , vol. 15, no. 2, 2018, pp. 31-37

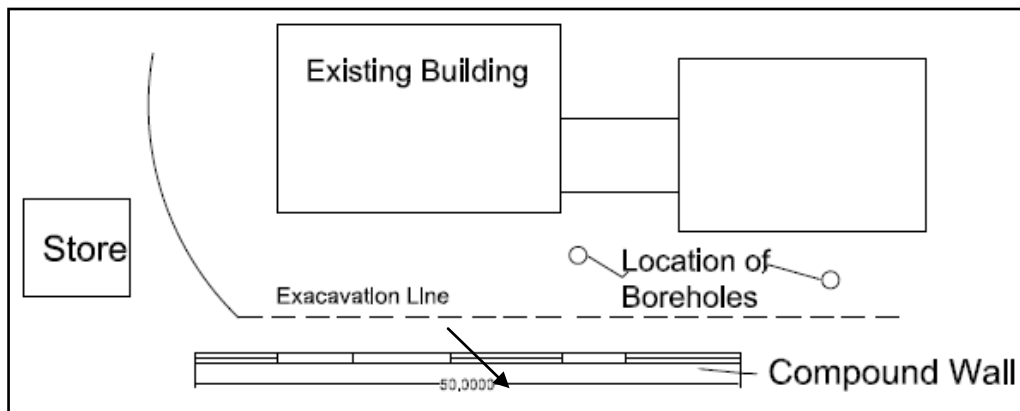
Fig 1. The ground plan and location of geotechnical investigation

This accident occurred at the building construction site which had an excavation done up to a depth of 12.0 M and length of excavation was 45.0M. The ground plan and location of geotechnical investigation, bore log of construction site are shown in Fig. 1 and Fig. 2 respectively.

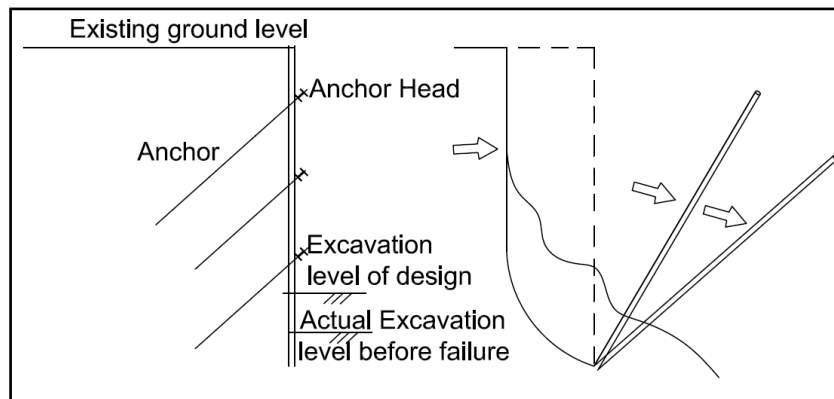
Fig.3 Estimation Mechanism of Collapse

However, at around 3.30 p.m., the east side 12.0 M of the temporary earth support structure collapsed gradually with the ground behind the support. The ground sliced into the excavation area along with the compound wall for a thickness of approximately 4.0m. The sudden collapse of the entire temporary earth system occurred and the mechanism of collapse is due to excessive excavation without adhering to the design as shown in Fig 3.0.

The sequence of collapse is shown schematically in Fig. 3, the mechanism of collapse is summarized as follows;

a. Initially clients had decided to excavate up to 9.0 M depth, later as per revised structural design excavation was done up to 10.0m depth. Due to change in structural design consideration, critical slip circle moves away from the excavation line hence due to increase in critical slip circle, provided embedment length of grouted nail as per design becomes inadequate. This in turn, the embedment length provided of the anchor bar was insufficient. Fig 9 shows the variation in critical slip according to the depth of excavation. When the excavation was done up to 9.0m depth critical slip lies away from the vertical cut. When the excavation was continued up to 10.0m depth, critical slip circle further moves away around 840mm from the vertical cut.

c. It was noticed that there was existing building 6.0m away from the site boundary. The surcharge pressure initially considered for no water table conditions, but due to seepage of drain water and reduced shear resistance, excess surcharge pressure acting over the micro piles along with less embedment depth of micro piles caused over turning of the micro piles.

d. Finally, the unstable earth support structure led to a huge-volume soil collapse.

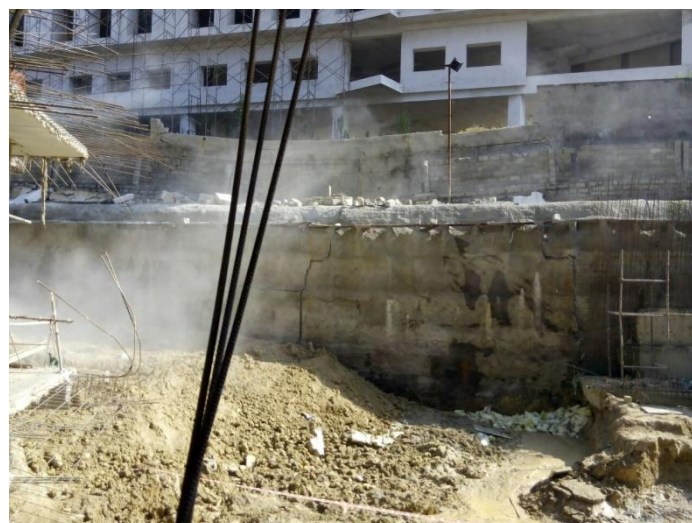
Fig 4. The position of shoring system just before the incident (East corner side)

Fig. 4 shows the progression of the shoring collapse just before the accident. During the excavation process, the penetration depth of the micro pile wall decreased step by step. Failure occurred when the penetration depth of the micro pile reached about 3.0 M and failure continues with a small displacement emerged with excavation step. Fig. 5 shows the total collapse of the micro pile. The failure occurred suddenly when the embedment depth of the micro pile reached about 2.5 M.

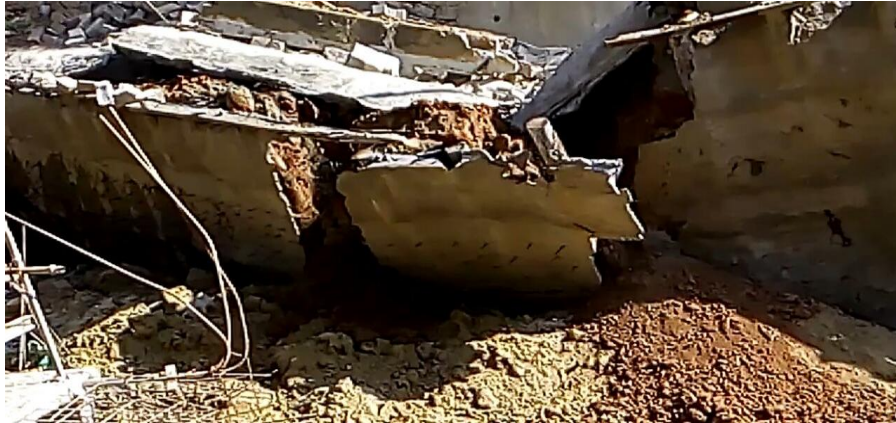
Fig 5. The scene of the collapsed accident (East corner side)

Due to this collapse, thirty-eight MS piles were toppled. All machines and accessories were buried. As a result, this accident made a huge damage to property.

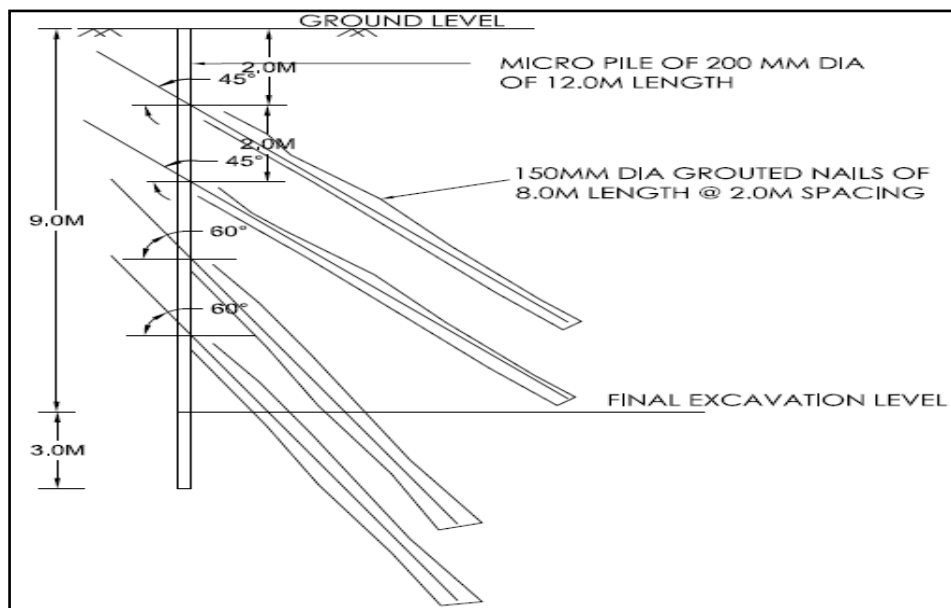
Fig 6. Model according to the design consideration

Fig 6 shows construction of temporary shoring structure as per design considerations. The Design was made for actual site condition. Considering the depth of excavation and existing ground soil parameter, Micro pile was provided with embedded length of 2.0 Mand grouted nail wall designed for 8.0 M length providing the inclination of 45° for top layer and 60° for bottom two layers. While designing shoring for this particular site, there was no consideration of water table for design.

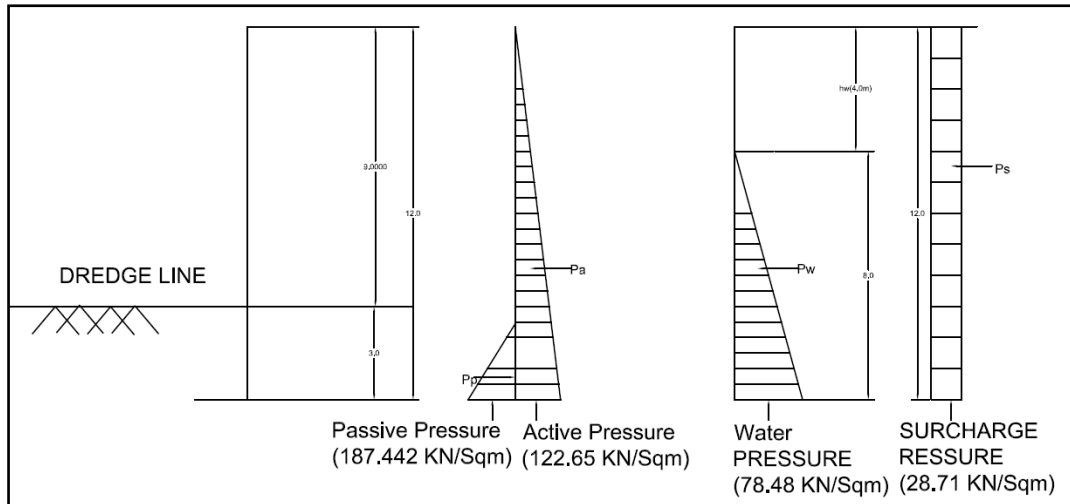
Fig7. Pressure diagram for the load acting on micro piles

Instrumentation is usually required to monitor the performance of a micro pile structure during construction. Measurement of moment and pressure furnish valuable information for use in verifying design assumptions. The pressure distribution diagram is shown in Fig. 7.0. Most importantly, the data may predict the potentially dangerous situation that could affect the stability of the structure. In this construction site, however, only visual inspection was used, such as checking for unusual surface signs. The maximum bending moment was found to be 20.4 kN/M to 20.11kN/M up to 3.0 M depth as shown in Fig. 8.0.

The earth pressure on the micro pile together with depth during excavation process is shown in Fig 7. The active earth pressure increases and passive earth pressure decreases as the excavation depth increases beyond 9.0 M. that is from final excavation level or founding level.

The Figures7 and8 show the pressure diagram and bending moment diagram for micro pile. It is shown that the active earth pressure increased during the excavation and increase in the depth of excavation makes critical slip lies further away from its actual position in terms makes insufficient length of grouted nails to bear the forces. Hence caused the anchor failed to support pile due to large tensile force, as a result temporary structure is collapsed.

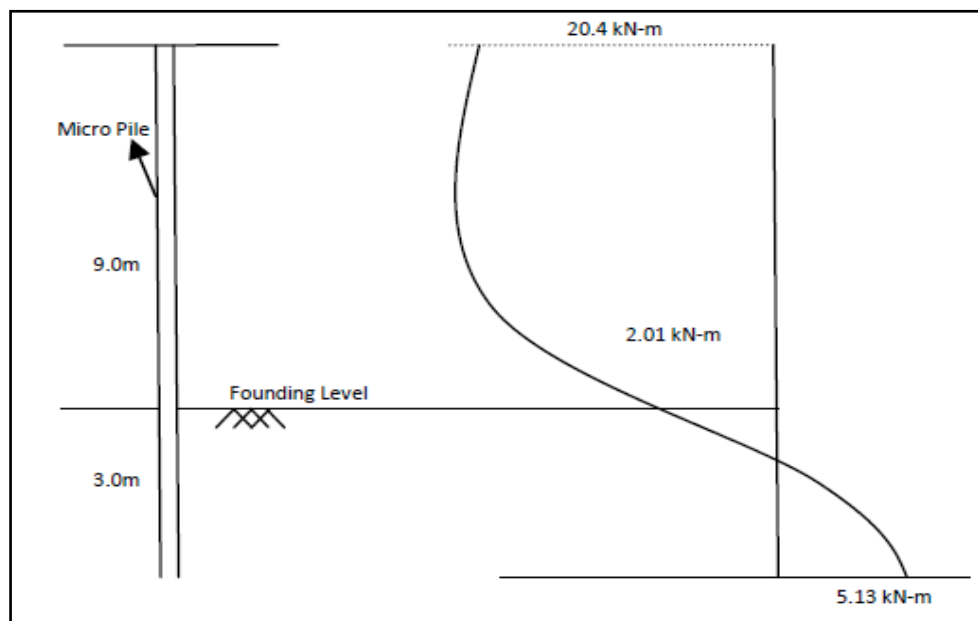
Fig. 8.Bending moment diagram from the load acting on micro piles

The variation of bending moment with the depth of wall is shown in Fig 8. The bending moment increases as the earth pressure increases on the other hand, during excavation, the moment at the middle of the pile rapidly increases while the moment of the pile at the excavation surface decreases as the excavation increased. Therefore, the pile was bent significantly as the upper part of the pile struck out while the pile at the excavation surface did not move much. This suggested that the anchor head suffered severe tensile force due to the bending of pile.

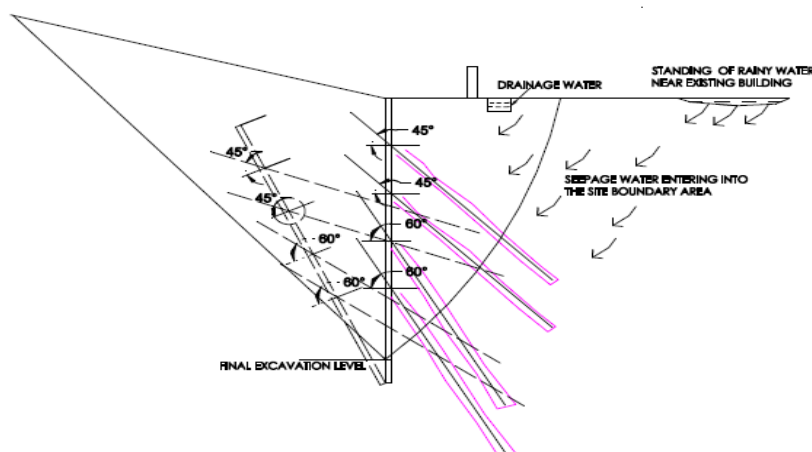
Fig10. Failure of supporting system due to entering of seepage water

b. Fig 10 shows the slip circle before the occurrence of failure. Due to absence of water table during the investigation stage, no water table effect was taken in to account during the design stage. After the construction of shoring system, due to heavy rainfall, water flow choked in the adjacent drain due to improper drainage facility caused the seepage of water into shoring area. As a result, increase in the pore water pressure increases in earth pressure to the existing temporary shoring system and there was decrease in the shearing resistance of soil thereby making tie back anchor bars ineffective. Hence the temporary shore structure starts losing its capacity to stabilize the vertical cut.

- The water table condition plays an important role in the design of temporary shoring system. The presence of adjacent structures, drains are to be considered during the design.
- As the factor of safety for temporary shoring design is less than 1.5, careful planning of excavation and future excavation planning to be considered during the design period so that such accidents can be prevented.
- Proper ground movement monitoring system should be placed after installation of the shoring system so that any adverse conditions can be foreseen and can prevent any probable accidents.
- Good lined drainage facility should be mandatory around the shoring system so that seepage of water can be prevented and provide adequate weep hole in the shoring system as a preventive measure.
