Evaluation of Irrigation Network Performance in Irrigation Areas Jegong Suren Village, Ledokombo District Jember Regency with E-PAKSI

Nanang Saiful Rizal^{1*}, Amri Gunasti² and LukmanEko Prasetyo³

^{1,2}Department of Civil Engineering, University Of MuhammadiyahJember, Indonesia

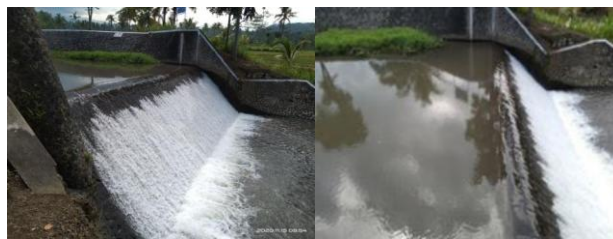
- a. **Weir Crest** :The construction of civil buildings on the Jegong Dam lighthouse is still intact and in good condition. As for the existing condition, no significant damage was found to the civil building of the crest, only less than 20% of the surface of the dam crest was peeling off. The pillar on the drain door has a crack of less than 20%.

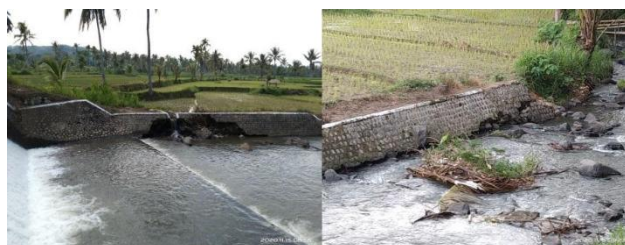
- b. **Weir Wings** : The construction of civil buildings on the wing of the Jegong Dam on the right side at the time of the assessment looked good and in good condition. It is only necessary to clean the rising sedimentation so as to reduce the wet cross-sectional dimensions of the Dampar River. Meanwhile, the construction of the wing of the Jegong Dam on the left side at the time of the assessment appeared to be badly damaged. The damage began to be discovered in the performance assessment in 2019 which began to erode the lower part of the Jegong Dam wing construction building.

And in the 2020 performance assessment, the damage to the construction of the Jegong Dam wing is getting worse due to flooding during the rainy season. So the overall performance assessment for building construction on the wing of the Jegong Dam is in the medium criteria. At the Jegongweir there is no bridge over the lighthouse, operation board, and weir safety fence.

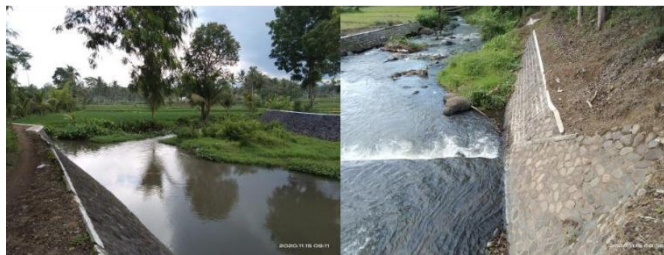
- d. **Weir Embankment** :Overall the condition of the upstream and downstream dam capping embankments is good. It is only necessary to repair the left flank of the downstream side of the weir so that it does not affect the collapse of the left embankment and flood the agricultural area.

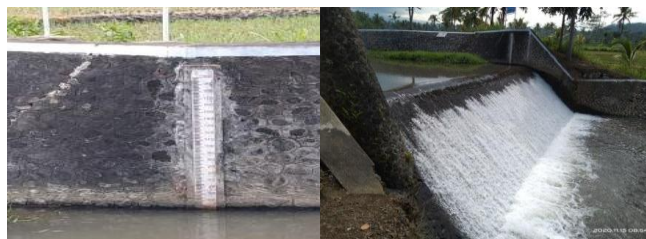
- e. **Weir Bridge** :At Jegong Weir there is no bridge over the weir lighthouse, so the weir operational officers find it difficult to carry out maintenance activities on the part of the weir on the opposite side.
- f. **Operation Board and Weir Ruler** :The Jegong Dam is not attached to an operation board. The operation board needs to be installed to make it easier to record the water debit both at the intake and at the drain door. In general the condition of the ruler is still in good condition and the numbers can be read quite clearly. The position of the ruler installation is also appropriate.

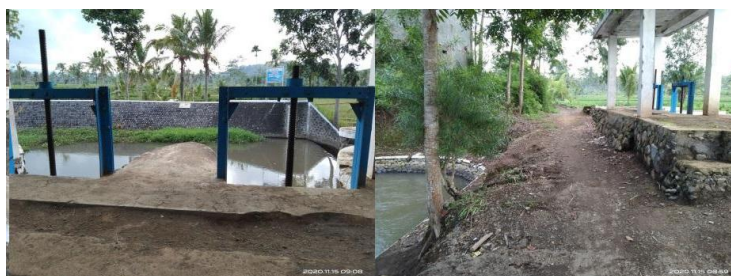
- g. **Safety Fences on Weirs and Weir Doors** :At the Jegong weir there is no safety fence, in the future it will need to be installed as a security sign for state land boundaries. All doors can operate properly and smoothly. The condition of the door leaf, the door handlebar is installed in good condition, no damage or leakage was found. Lifting equipment (morheis) sill, steel sporing is in good condition and can be operated. The door guard house is in moderate condition, and needs to be treated so that it doesn't get damaged

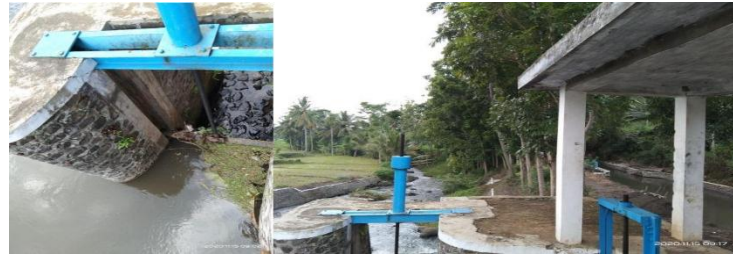
- a. **Weir Drain Door :** The drain door can operate properly and smoothly. The condition of the door leaf has a slight leak from the wooden beam, the door handlebar is installed in good condition, no damage was found. Lifting equipment (morheis) sill, steel spooring is in good condition and can be operated.
