Concrete Face Rockfill Dam Failure Process

Bharat Raj Pandey¹, Dr. Ram Krishna Regmi², Dr. Ram Chandra Tiwari³

1 Author: Tribhuvan University (TU), Institute of Engineering (IoE), Pulchowk Campus

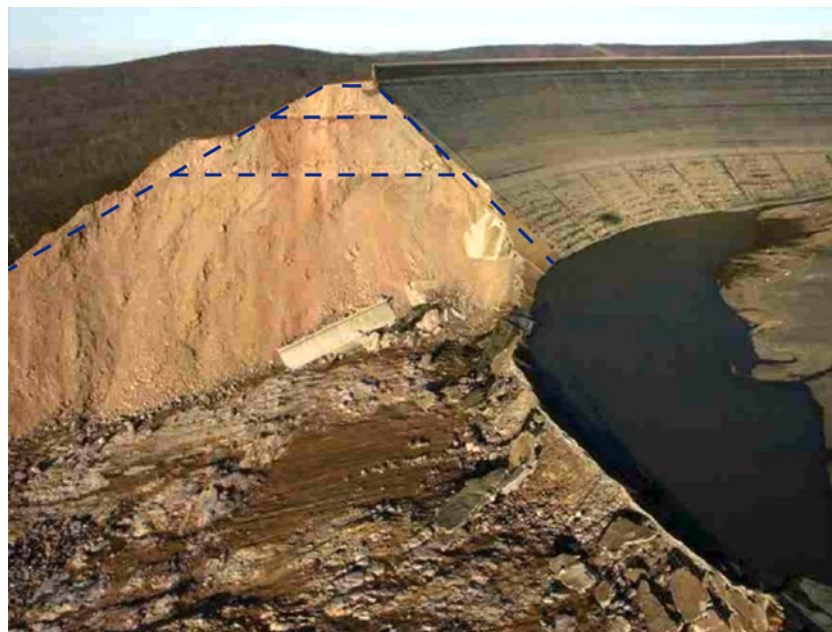
Based on the dam failure analysis report conducted by the Federal Energy Regulatory Commission of the United States, FERC (Federal Energy Regulatory Commission), 2006, most of the rockfill materials for the Upper Taum Sauk dam were built by simple end dumping. The dam fillings were let to tumble down the side of the dam, lying near their natural repose angle. The boundaries between the different filling layers were visible in the final breach side slope of the dam (Fig2).

Figure 3 Photo of dam materials in the breach side slope, W. M. Wu.

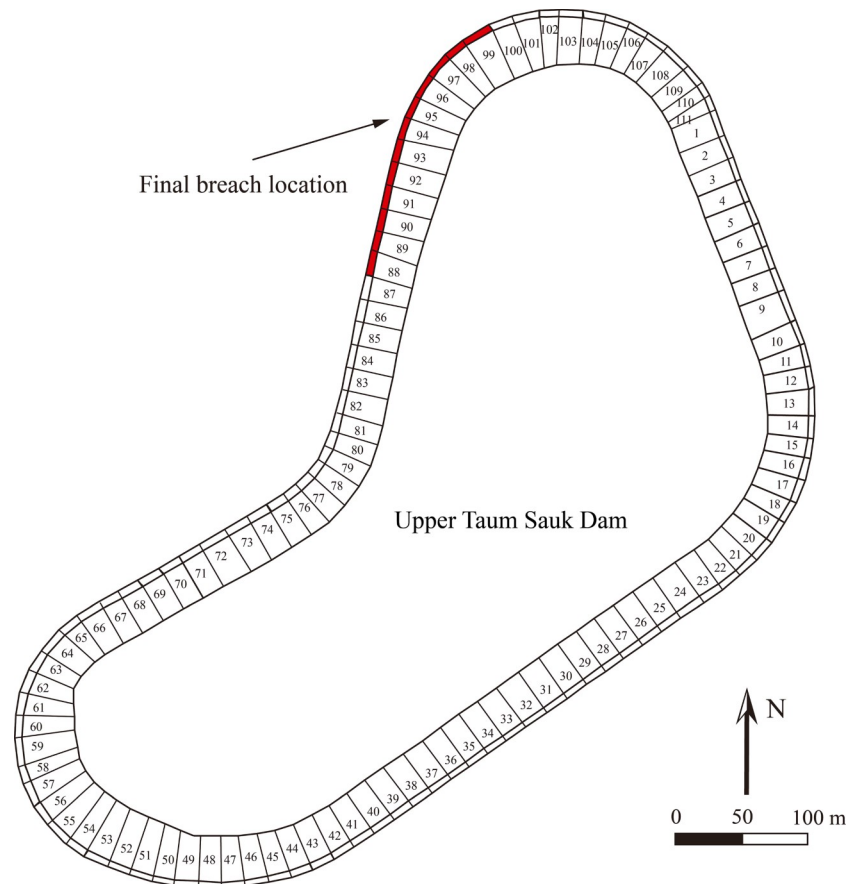
Figure 2 The schematic diagram of the distribution of the concrete face slabs and the location of the final breach.

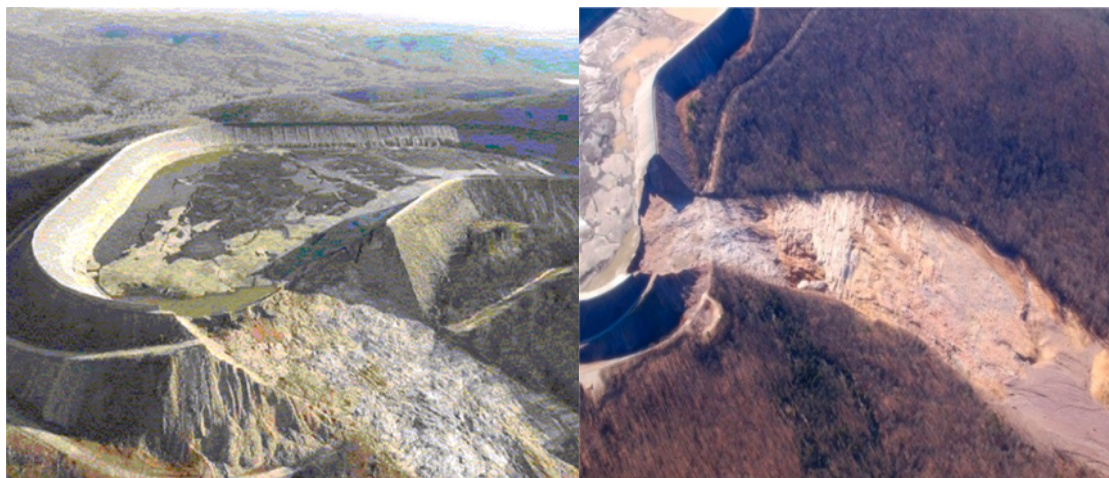
proposed circumstances could have led to wall failure. By observing the overflow section after the dam breaching, it can be seen that the overflow resembles a broad crest weir, with a broad “V-shaped” in the beginning of the breach in later stages the breach shape followed the trapezoidal shape of nearly 274 m. This condition would result in greater discharge towards the center of the settled section. Moreover, the steep face of the rockfill dam (1:1.3, Vertical/Horizontal) can exacerbate this situation, allowing a deeper plunge pool to develop, as depicted in Fig.4.

Figure 5 Breaching Photos

overtopping of the Upper Taum Sauk dam was initiated, water overflowed from the concrete parapet wall, causing erosion and scouring at the dam's downstream crest. This process began to undermine the foundation of the parapet wall. The rockfill materials on the downstream slope were washed away as undermining and scouring progressed. Once enough rockfill materials were lost, the stability of the concrete parapet wall and the rockfill's shear capacity were severely compromised to the point of wall or shear failure. As a result of the collapse of the parapet wall, more water and consequently more flow was released in the area of the initial breach. The additional flow accelerated the erosion process down to the toe of the dam, yielding catastrophic failure. Fig.5 displays photos of the final breach morphology of the Upper Taum Sauk dam from various angles.

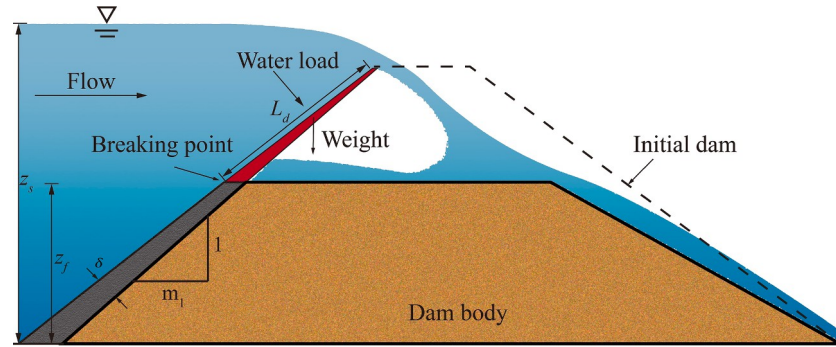
In general, vertical and peripheral joints are embedded in the concrete face slabs of CFRD and are connected to the adjacent slab and toe slab through the waterproof structures. However, the waterproof structures cannot withstand the bending moment when the rockfill materials beneath the concrete face slab are washed away. Based on the failure mechanism of CFRD revealed by the model tests, S.S Chen, Y.L. Lee, Z. Chen 2021, when the suspended length of a single concrete face slab increases, it breaks due to the combined impact of upstream water load and the self-weight of the suspended part (Fig. 6below).

It is considered that a single face slab is a cantilever panel, and the following conditions must be satisfied for its failure: the bending moment caused by upstream water load and self-weight is greater than the slab's ultimate bending moment. When the first slab breaks, the breach flow through the concrete face slab increases abruptly, and then the analytical process is applied to the next slab. It is worth noting that each slab may be failed several times as the erosion process progresses.

Figure 3 Schematic diagram of the failure of the concrete face slab.
