## **Comparative Evaluation of Co-Relation of Visual Deformation and Tendency to Fracture; And Apical Cleaning Ability of Mtwo and Protaper With Stainless Steel Hand Files: An In-Vitro Study**

Dr Shweta Verma, Dr. Munish Goel, Dr Neeraj Sharma, Dr Mahender Singh

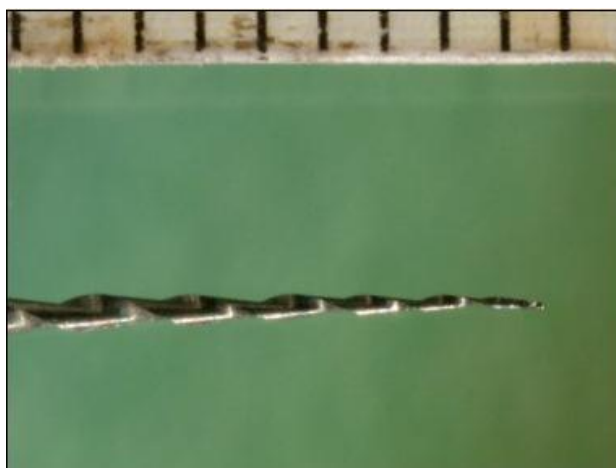
Figure 1: deformation of Mtwo files seen under stereomicroscope.

Only one Mtwo no.20 (.06 taper) instrument separated in apical one third of the canal. The fractured instrument did not show signs of deformation prior to the fracture. The fractured Mtwo file when viewed under stereomicroscope at higher magnifications showed fatigue of apical part of the file following which it fractured (figure 1).

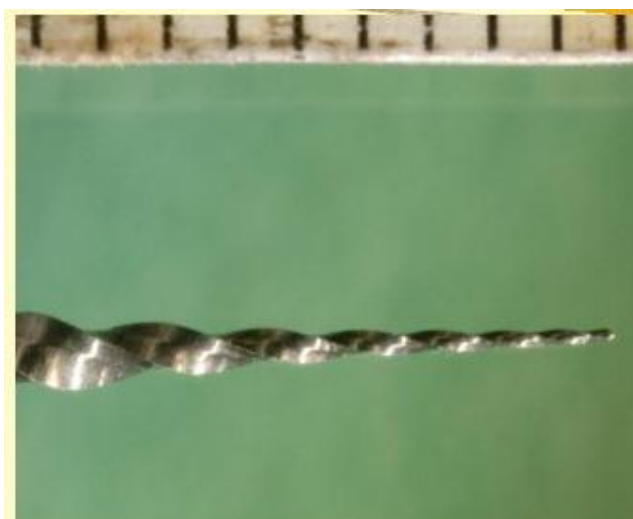
Figure 2: Deformation Of Protaper Files Seen Under Stereomicroscope.

In **group B**, a total of 3 Protaper instruments separated. All of them fractured without any visual sign of deformation except for loss of luster. The surface of used Protaper file when seen under stereomicroscope, did not show any signs of deformation before it fractured. (figure 2).

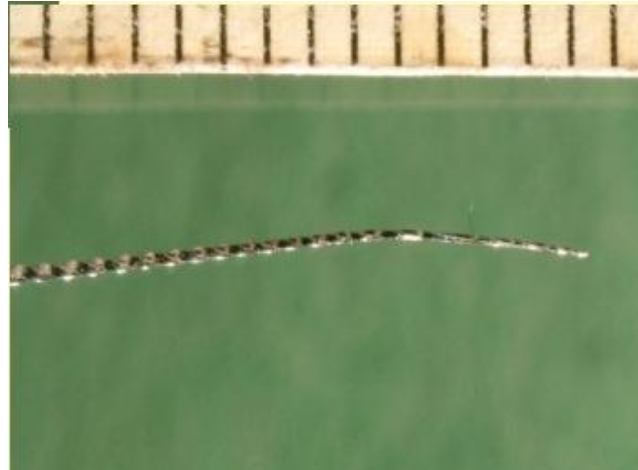
Figure 3: deformation of SS files seen under stereomicroscope.

In **group C**, most of the SS files showed early signs of deformation manifested as unwinding of flutes, so they could be discarded easily without inviting fractures. None of the SS file fractured. The unfluting of the stainless steel files could be clearly seen under stereomicroscope (figure -3).

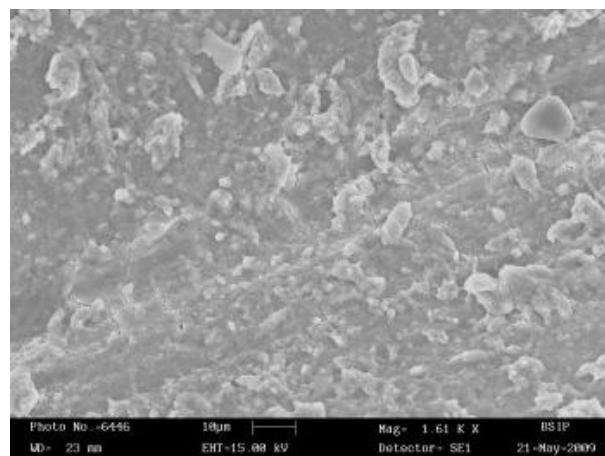
Figure 4: SEM picture of apical 3rd prepared with Mtwo rotary system showing nearly clean canal with small agglomerations of debris [Score 2] and small amount of smear layer with several open tubules [Score 2].

**Apical Cleanliness;** In second part of the study it was found that apical third of the canal is never clean with any of the system used. Mtwo instrumented teeth (Group A) showed nearly clean canals in apical third with small agglomerations of debris particles (**score 2**) and small amount of smear layer with several open dentinal tubules [**score 2** (figure - 4)].

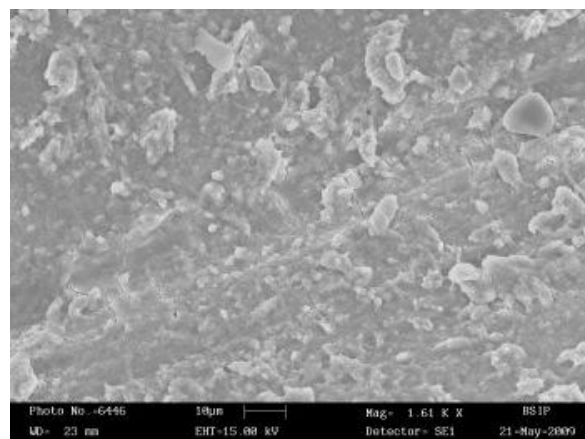
Figure 5: SEM picture of apical 3rd prepared with protaper system showing poorly clean canals with debris covering >50% [Score 4 or 5] and thick homogenous smear with few open tubules [score 4 or 5].

Protaper (Group B) showed poorly clean canals with debris covering more than 50% or entire canal surface (**score-4 or 5**) and thick homogenous smear layer with few or more dentinal tubules [**score-4 or 5** (figure - 5)]

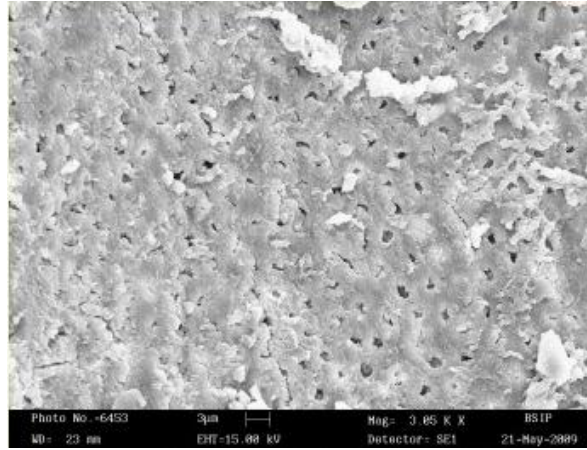
Figure 6: SEM picture of apical 3rd prepared with stainless steel hand files with small amount of debris score [2 or 3] and small amount of smear layer with several open dentinal tubules [score 2]

Stainless steel files (Group C) showed nearly clean canal with small agglomerations of debris particles or covering  $> 50\%$  (**score – 2 or 3**) and small amount of smear layer with several, open dentinal tubules [(**score -2**) (figure - 6)].
