## Management Of Abutment Failure Of Mandibular Implant Supported Over Denture: A Case Report

**Keywords:** Implant Supported Overdenture, Ball Abutment, Abutment Fracture, Screw Retrieval.

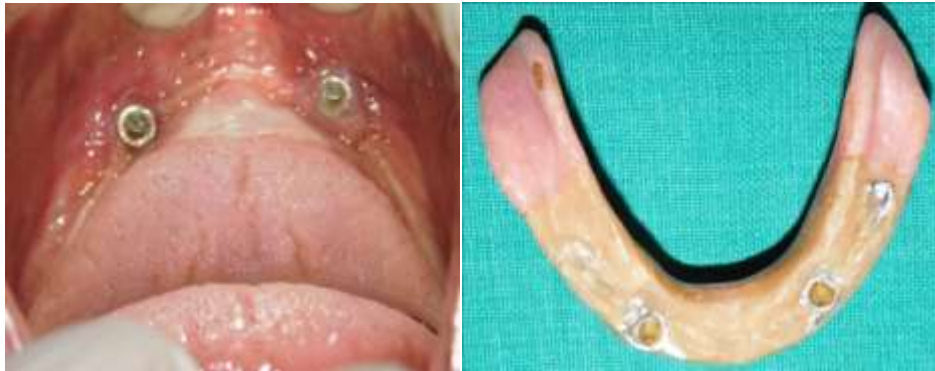
A 65-year-old male patient with an existing mandibular Implant Supported Overdenture (IOD) presented to the Department of Prosthodontics at Government Dental College, Kozhikode. His chief complaint was the lack of retention of the mandibular IOD. Clinical examination of the patient revealed an implant supported overdenture prosthesis retained with a ball abutment and O- ring attachment system since 8 years with 2 implants in the mandibular canine region (fig:1 and 2). The maxilla had been restored with a complete denture. Clinical and radiographic examination of the implant region showed that the overdenture ball abutment of both the implants were fractured at the neck region (fig:4). The screw part of the abutment remained threaded into the implant. Both implants were osseointegrated and showed no signs of peri-implantitis. Treatment options considered were : 1. attempting to retrieve the fractured abutment , 2. removing the implant and replacing it with a new implant , 3. Abandon the implant and fabricate a conventional complete denture. Patients mandibular ridge was highly resorbed which would affect the retention and stability of the denture and the patient was not interested for second or third option. So a decision was made to attempt unscrewing of the fractured abutment.

Fig. 1 and 2: Intraoral view of fractured overdenture ball abutments and Existing implant supported overdenture

The fractured ball abutment was retrieved by putting grooves using tungsten carbide (171L) bur. The instrument was copiously cooled with water spray from the air-turbine. The abutment was unscrewed using an explorer taking care not to damage the implant. New correctly sized overdenture ball abutment ( Uniti, Equinox medical Technologies, Holland) were temporarily connected to each implant and attachment's denture base component was snapped onto the abutment ( Fig:5a and b). Preliminary impression was made with impression compound (aslate, Asian Acrylates, Mumbai) and primary cast made in plaster. Edentulous custom tray was fabricated by incorporating space for the overdenture attachment. Custom tray border molded in conventional manner with green stick ( DPI Pinnacle, Mumbai) and Secondary impression was made with addition silicone light body impression material (Zhermeck, Italy) (Fig:6). Impression material was carefully syringed around each attachment to diminish the likelihood of voids. After the impression was removed the attachment components remaining in the impression were removed and impression was beaded and boxed and poured with

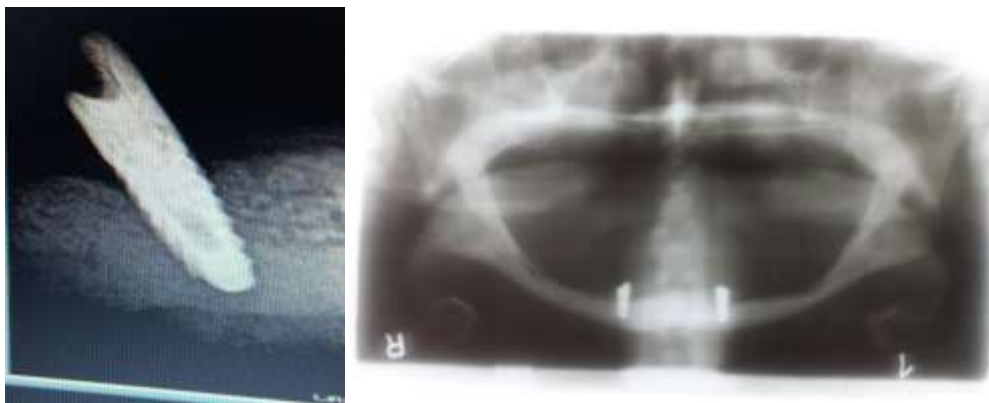
Fig.4 : IOPA and OPG showing fractured implant overdenture abutment

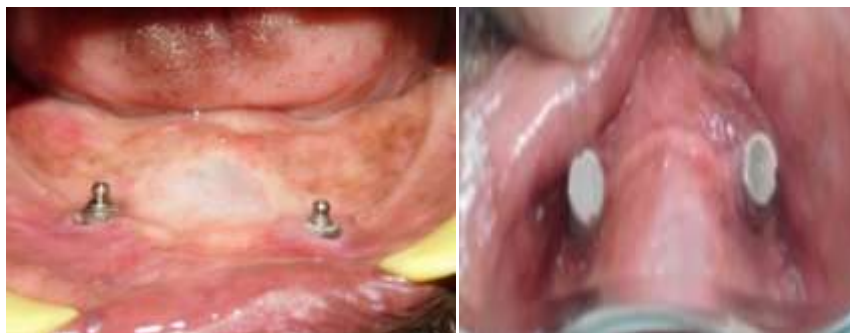
Fig. 5a and b: a. New overdenture ball abutment attached and b. with metal encapsulator

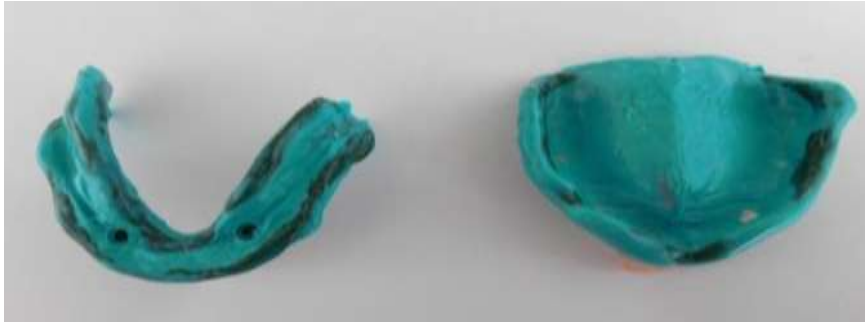
**Fig. 6:** Final impression of maxillary and mandibular arch.

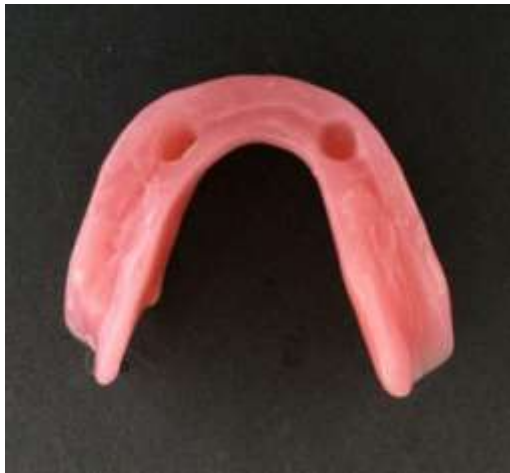
**Fig.7:** Mandibular permanent denture base

improved stone. As the attachment mechanism was incorporated in the master cast, the space allocation necessary for the attachments was accurately detailed from the beginning itself ( Fig:7 ).

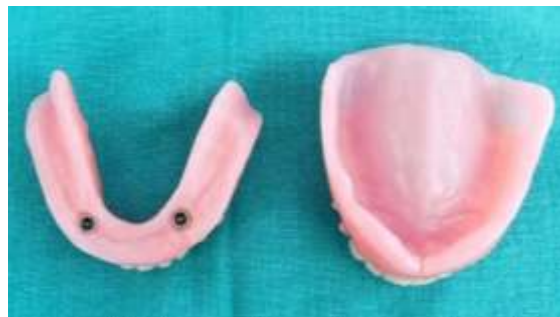
**Fig.10:** completed prosthesis with metal encapsulator incorporated into mandibular implant supported overdenture

Edentulous impression for the maxillary complete denture was made using conventional techniques. Record bases were made for both the cast with heat cured acrylic resin. Jaw relations were completed using standard techniques and transferred onto the semi-adjustable articulator with the help of face-bow( Fig:8). Teeth selection was done and arranged on the record base for trial denture set up. Trial denture was evaluated in patients mouth (Fig:9).After denture processing,(fig:10) the tissue surface of the mandibular denture base included the relieved areas where the attachment mechanisms were accurately transferred from the master cast. Attachment abutments were connected to their respective implants and were luted into the denture base using autopolymerising denture base material (DPI-RR cold Cure, Mumbai). Powder and liquid were mixed with a brush and placed into the attachment wells in the denture base filling them half way and firmly seated on to the mucosa. Resin was allowed to polymerize and patient was asked to bite to avoid increase in the vertical dimension. A thin layer of wax was placed over the implant surface to avoid attachment of acrylic resin over metal part (Fig:11). The attachments were fit passively without any rocking movement. Post insertion instructions and care of implants were discussed with the patient. The patient was recalled after 1 week and 1 month for examination and no peri-implant mucositis, or esthetic failures were observed, and the denture retention was satisfactory.
