A Clinical Evaluation to Assess the Amount of Residual Excess Cement when Using Prefabricated and Custom Fabricated Implant Abutment and a Modified Final Restoration.

*1Vinni TK. "A Clinical Evaluation to Assess the Amount of Residual Excess Cement when Using Prefabricated and Custom Fabricated Implant Abutment and a Modified Final Restoration." *IOSR Journal of Dental and Medical Sciences (IOSR-JDMS)* 16.7 (2017): 86-91.

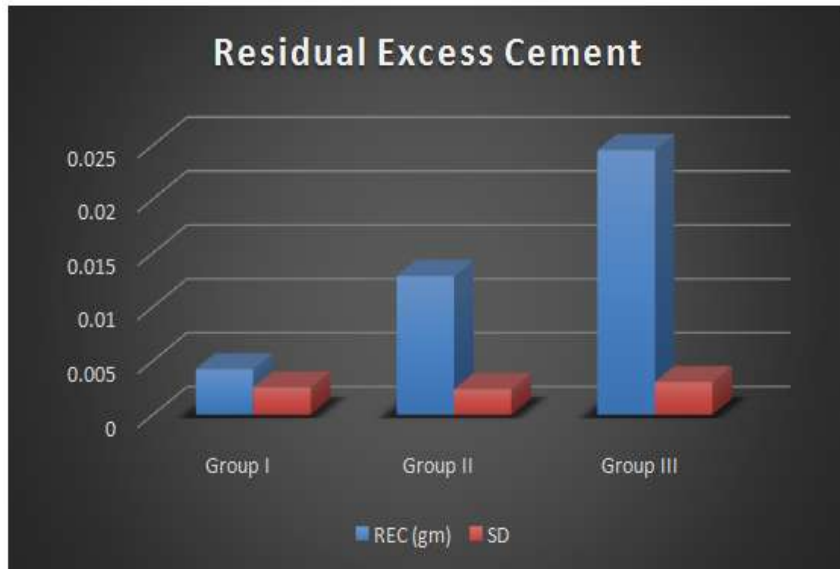
Graph 1: showing the comparison of mean values of residual excess cement formed IN GROUP I, II, and III

Result of the study shows there is a statistically significant difference between the groups I, II, and III. The amount of residual excess cement formed is significantly lower in case of custom fabricated abutment, followed by modified final restoration. (Table 1, Graph 1)

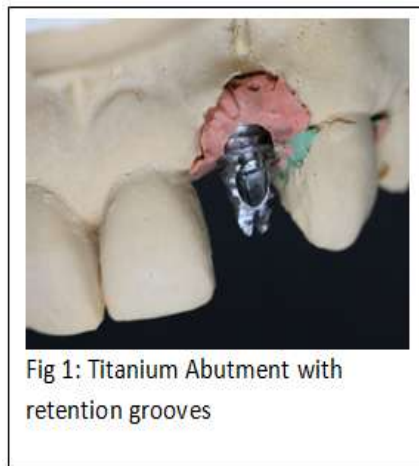
Preparation of custom abutment: After preparation of retention grooves with a diamond disc on the titanium abutment surface (Fig 1), wax-up was done with dental casting wax (Fig 2), invested in phosphate bonded investment (Brevest, Bredent GmbH &Co.KG, Senden, Germany).After dewaxing at 630°C, the mould was cooled down to 400°C. Pressing of PEEK was done at 400°C with a pressing machine (For 2 Press, Bredent GmbH &Co.KG, Senden, Germany). After deinvesting, custom abutment is retrieved and necessary adjustments were done with a Tungsten carbide bur. Gingival collar is polished to high gloss with PEEK polishing kit(Fig 3). Final restoration: Final restoration with an occlusal hole for easy access to abutment screw was fabricated in porcelain fused to metal by using conventional casting and ceramic layering. The access opening was sealed with composite resin so that it does not interfere with crown seating and will prevent venting of luting agent during cementation.

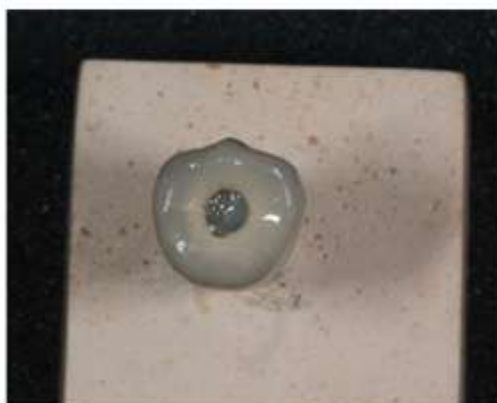
Fig 4: Final restoration with vent holes

Group III: - The same crown used in the group II is used after sealing the access opening with composite resin without interfering with crown seating to prevent venting of luting agent during cementation(Fig 4).

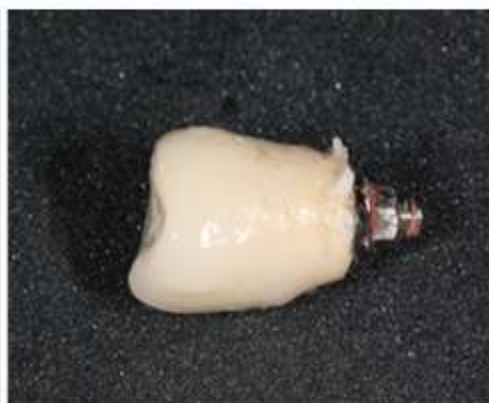
Fig 6 Crown shows residual excess cement
