Management of Perforated Schneiderian Membrane During Sinus Augmentation Surgery Followed By Immediate Implant Placement: A Case Report

Abstract: Augmentation of the maxillary sinus floor is well accepted surgical procedure for the placement of dental implants in the posterior atrophic maxilla. When the procedure is complicated by perforation of the sinus membrane, the proper management of the perforation is important as it can threaten the coverage of the graft materials. In this case report, we describe a technique for repairing a perforation of the sinus membrane by suturing the membrane and placing the GTR membrane over it followed by immediate placement of the implants. We observed 100% success rate of the immediate implants placed with sinus bone grafting in the patient whose membrane was perforated. Suturing the perforated area of the membrane and securing the bone graft with collagen membrane was an effective alternative for repair of a perforation of the sinus membrane.

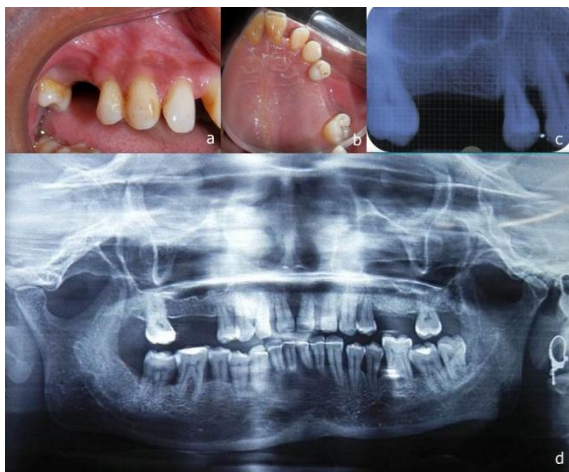
Figure 2 :- a,b – per-operative lateral and occlusal view showing missing 15, 16. c,d - Digital orthopantomogram (OPG) and IOPA revealed a residual bone height of 5 mm in relation to 16 with a pneumatized sinus.

A 44-year-old female patient reported to the Department of Periodontology in 2016, with a chief complaint of missing teeth in the right and left back region of the upper jaw since 1 year. On examination, teeth no #15, 16 and #25, 26 were missing (Fig. 2 - a,b) Detailed case history of the patient revealed that both the teeth were extracted due to extensive caries and persistent pain. The patient had no relevant extraoral or intraoral abnormalities. Blood investigations were done and were within normal limits. The patient was systemically healthy. The Panoramic radiograph revealed insufficient bone height in 15, 16 region for placement of the implant and the maxillary antrum was pneumatized (Fig. 2 - d). Intra Oral Periapical Radiograph (IOPA) done using a grid of 1 mm, showed only 5 mm bone was present below the sinus in #16 region (Fig. 2 - c).

Pre-surgical diagnostic models were prepared. In the cast, the inter-occlusal distance was measured as 9 mm with respect to #15 and #16. Phase 1 therapy was completed.

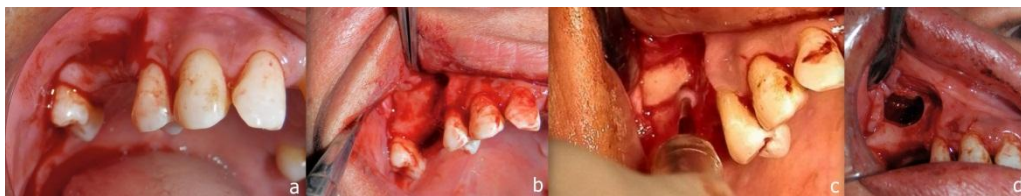
Figure 3 :- a - Placement of para – crestal and vertical releasing incisions. b - Flap elevated exposing the lateral bony wall. c - Preparation of bony window. d - Infracture of bony window perforation of sinus membrane encountered during membrane elevation.

Prior to the surgical procedure, preparation of the patient following aseptic condition was done. The patient was instructed for pre-procedural rinsing with 0.2% chlorhexidine gluconate. The maxillary posterior segment was anaesthetized with posterior superior alveolar, infraorbital nerve block and palatal infiltration using local anaesthesia of 2% lignocaine with 1:80,000 adrenaline. Midcrestal incision was made using a no.15 surgical blade extending from the distal surface of #14 up to the mesial surface of #17. A vertical incision was extended until the end of the buccal vestibule (Fig. 3 - a). A full thickness mucoperiosteal flap was raised until the zygomatic buttress (Fig. 3 - b).

A bony window was then traced in the #15, 16 region at a slow speed rotating instrument (Nsk Ex-6 Dental straight Handpiece) and a round carbide bur under constant irrigation with normal saline. It began with the most coronal horizontal preparation, with a length of approximately 14 mm positioned approximately 3 mm apical to the residual crestal bone. A round bony window was made in the area of the second premolar–first molar (Fig. 3 - c). This produced a bony window in which the frame is represented by the Schneiderian membrane (sometimes red in colour, sometimes blue). At this point, during the osteotomy since due to slight excess pressure the bur slipped inside the membrane perforating it (Fig. 3 - d).

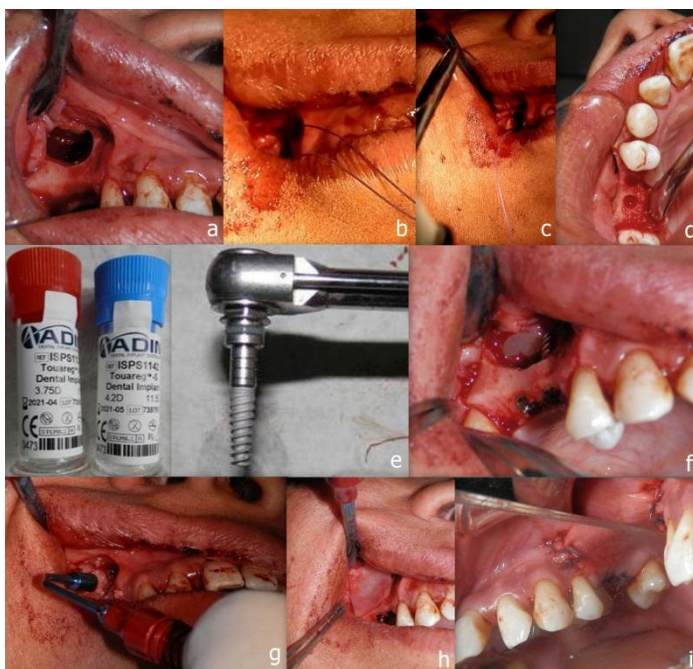
Figure 4 :- a - the membrane surrounding the perforation was delicately dissected. b,c - The Perforation was sutured with 5-0 vicryl suture. d - Implant osteotomy sites prepared in 15, 16. e,f - ADIN 4.2 x 11.5 mm and 3.75 x 11.5 mm, Implant placed in prepared osteotomy sites. g - Bone graft placement in the defect. h - GTR membrane placement. i – suture.

When a membrane perforation was discovered, immediate cessation of all reflection and isolation and visualization of the perforation was done. Sterile gauze was packed as needed superior to the site to aid in maintaining a clear field for examination of the area. On careful examination a membrane perforation of 8mm was detected, the membrane surrounding the perforation was delicately dissected with a blunt instrument, along with the bony window in an attempt to relieve the pressure, at the perforated area. (Fig. 4 - a). According to Valassis and Fugazzotto,⁴ class 4 perforation was located in the central two-thirds of the inferior border of the osteotomy site. Depending on the extent of the perforation, which was approximately 8mm, direct suturing of the membrane with 6/0 Vicryl (Ethicon, Norderstedt, Germany) and patching with a collagen membrane (Fig. 4 -b,c).

Once the resulting space had been examined and injury to the membrane was repaired, the implants sites were prepared (Fig. 4 - d). Carefully the osteotomy fixture sites were prepared according to the standard clinical procedures for the implant system (ADIN dental implant system, Israel.). A sinus elevator was inserted into the prepared cavity to protect the elevated membrane during the insertion of the implants (11.5 x 3.75 mm and 11.5 x 4.2 mm) (Fig. 4 - e,f). All implants placed at the sinus lift procedures were considered to be clinically stable. Both implants protruded a minimum of 5 mm into the sinus cavity. After insertion of the implants, the bone graft was placed (Fig. 4 - g). The posterior part of the cavity was grafted first, followed by the anterior portion and finally the central area. Filling material consisted of Demineralized bone graft matrix (OSSEOGRAFT™ - Advanced Biotech, India) mixed with the patient's blood. Care was taken not to obstruct the middle nasal meatus to allow free sinus drainage. After graft placement and packing, a collagen membrane (HEALIGUIDE® - Advanced Biotech) was trimmed such that 2-3 mm of surrounding adjacent was covered and the membrane was at the level of the window covering all its borders (Fig. 4 - h). The membrane was stabilized in place using firm pressure with moist gauze for 2–3 minutes. The mucoperiosteal flap was repositioned and sutured with monofilament sutures (Fig. 4 - i).

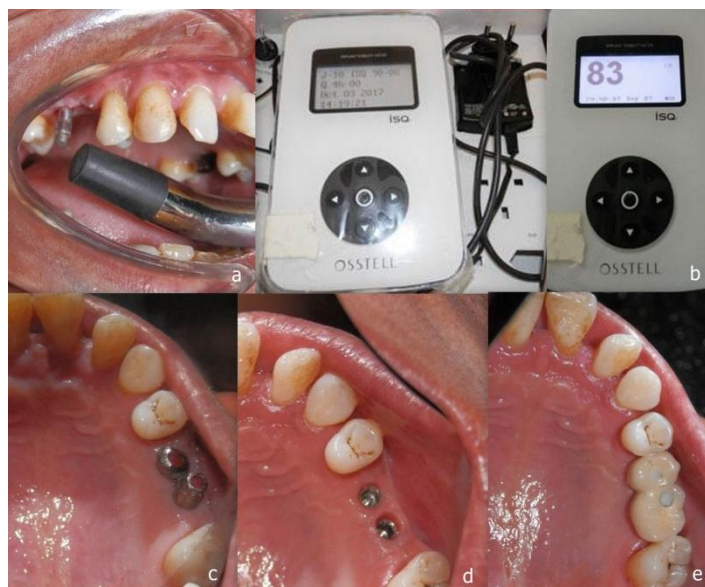
Figure 5 :- a - Measurement of implant stability. b,c - the aid of resonance frequency analysis (Osstell" instrument, Integration Diagnostics AB, Gothenburg, Sweden, Pre-loading implant stability measurement. d - Placement of healing abutment. e - Formation of gingival collar. f – crown prosthesis.

Blowing the nose and sneezing with open mouth was contraindicated for 1 week after surgery. Antibiotics (Amoxicillin 500mg three times/day) and analgesic (Diclofenac Sodium 50mg three times/day) were prescribed for 7 days. Sutures were removed after 10 days following surgery. After 6 months, the healing abutments were replaced and within 3 weeks implants were loaded with screw-retained PFM crowns (Fig. 5 – c,d). The access holes were closed with composite fillings (Fig. 5 – e).

Implant stability measurements were made during stage 2 surgery i.e after 6 months and after 12 months of healing, with the aid of resonance frequency analysis (Osstell" instrument, Integration Diagnostics AB, Gothenburg, Sweden). On these occasions, a transducer was attached to each implant, and measurements were recorded in implant stability quotient (ISQ) units.

Class IV perforation of the sinus membrane was observed during the surgical procedure and was treated using suture directly with a resorbable material (Vicryl 6/0) and a resorbable collagen membrane. Postoperative recovery was uneventful and slight swelling was noted. The patient followed- up daily for the first 10days until the sutures were removed. During this period there was no sign of wound dehiscence, sinus infection, exposure of the graft, local inflammation, or pain. After the sutures had been removed, the patient was monitored two-weekly for the first two months, and no complications were reported. Therefore, according to the site of the perforation in the sinus membrane (classified according to the scale described by Vlassis and Fugazzotto 4), there was a Class IV perforation. In residual ridge of 3 mm, Radiographic examinations showed an increase in the thickness of bone in the floor of the maxillary sinus. Implant length was 11.5 mm, and their diameters were 3.75 and 4.2 mm. The radiographic follow-up showed osseointegration of the implants and after six months, the patient received fixed prostheses (Fig. 6 – a,b) The success rate of the implants 2 years after implantation in the augmented sinus was 100%. At the 12-months postloading follow-up resonance frequency analysis (RFA) were 83 ISQ in 6 months and 94 ISQ post loading (Fig. 5 – a,b,c).

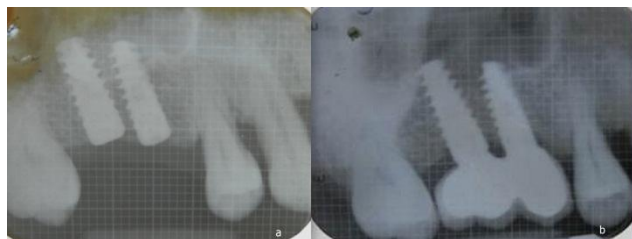
Figure 6 :- Post-operative IOPA. a – six months. b – 1 year.

The clinical variables maxillary sinusitis, pain and success of the implants were recorded. Radiographic assessment including panoramic radiography and intra-oral periapical radiograph 6 months postoperatively. Immediately before and one week after placement of the implant panoramic or periapical radiographs were taken, which were used to assess for any displacement of the bone graft and bone and the implant contact.

Various bone grafting materials have improved the results of sinus augmentation techniques and made them more predictable. In this case, the allogeneous bone graft was used to graft the sinus. Overall implants placed in the area provided a high level of success. On crestal bone loss was noticed before loading and after loading and the level stayed stable throughout 2 years of follow-up.
