# Management Of Communicating Internal-External Inflammatory Root Resorption Conditioned By Orthodontic Treatment

## II. Case Report:

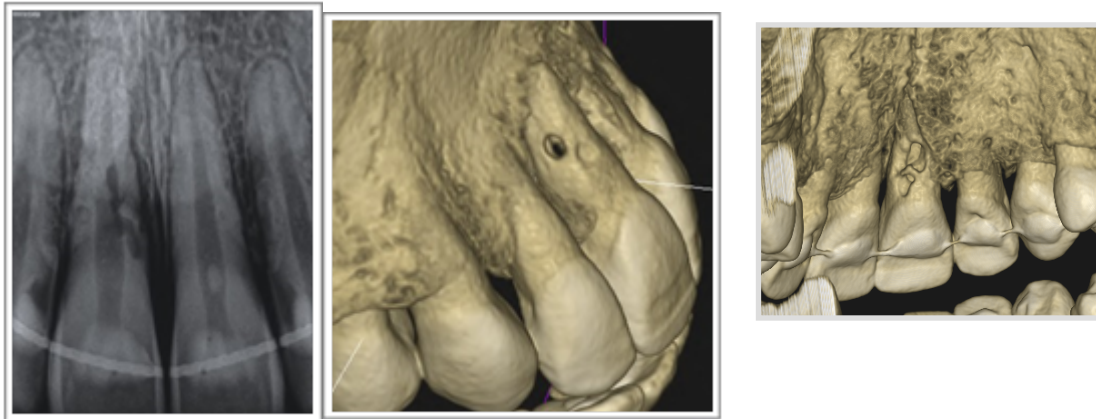
**FIG-1,2,3**

Intra oral periapical radiographic examination showed a widened periodontal ligament space and apical radiolucency, with radiolucency extending along the coronal and middle third of the root. Radiographically it could not be confirmed whether it is an internal resorption or external as with different shifts the lesion was shifting but an overlapping of radiolucency was noticed hence CBCT was advised . CBCT imaging confirmed resorption in the middle third of the root on the distal side, as well as in the cervical region on the palatal side, with lacunae on the buccal surface of the root. Based on the clinical and CBCT examination, the confirmatory diagnosis was communicating internal-external inflammatory root resorption. Procedure was explained to the patient and patient concern was obtained, after proper isolation, access opening was performed on tooth #11. The working length was determined, and the root canal was instrumented up to a size 45 K-file. The canal was copiously irrigated with saline, followed by a final irrigation with chlorhexidine. The root canal was then dried, and calcium hydroxide was placed as an intracanal medicament.

Fig-1 Preoperative Radiograph ; Fig-2 Buccal View On Cbct ; Fig-3 Palatal View On Cbct ; Fig-4 Working Length Radiograph ; Fig-5 C Shaped Resorptive Defect ; Fig-6 Curretarge Of Resorptive Lesion ; Fig-7 Resorptive Defect On Distal Side Of Root ; Fig-8 Resorptive Defect On Palatal Aspect ; Fig-9 & Fig-10 Biodentine Placement ; Fig-11 & Fig-12 Placement Of Gtr Membrane ; Fig-13 Radiograph After Biodentine And Gtr Membrane Placement ; Fig-14 & Fig-15 Flape Reposition And Suturing ; Fig-16 & Fig-17 Before And After Removal Of Stutures After A Week ; Fig-18 Radiograph After Obturation And Post-Op Restoration .

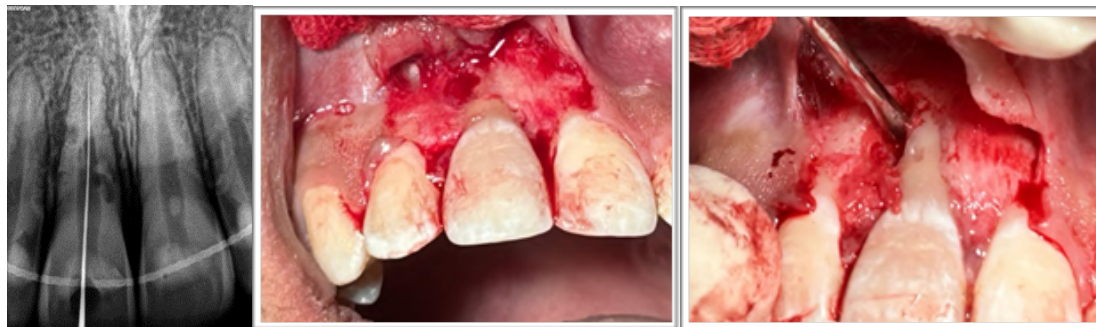
**FIG-,4,5,6**

After a week, surgery was performed. Upon elevation of the buccal flap, a large C-shaped bony defect was found associated with tooth #11, with the buccal plate completely denuded. On elevation of the palatal flap, a bone defect was observed on the mesial side, extending parallel to the root up to the middle third. After thorough curettage of the granulation tissue from the resorptive defect, a thick mix of Biodentine was placed on the external resorptive defect. A guided tissue regeneration (GTR) membrane was placed over both the buccal and palatal defects. The flaps were then sutured. One week later, the sutures were removed, and the canal was obturated using the single cone technique with bioceramic sealer. The tooth was subsequently restored with composite. Follow up after a week and month shows no symptoms

In this case report combined surgical and non surgical treatment was planned , after access opening biomechanical preparation was completed and calcium hydroxide dressing was placed to halt the resorption , but continuous seepage through the canal was noticed. So surgically buccal and palatal flap was raised to curettage the resorptive area ,choosing the right restorative material highly effect the healing of the resorptive area ,henceforth Biodentine (Septodont, Pomerode, Brazil) was used, due to its great biocompatibility, resistance, and the possibility of it being used as a restorative material in place of dentin<sup>6</sup>. Biodentine can help pause the invasion of resorption<sup>5</sup>. Biodentine has bioactive properties that promote the formation of reparative dentin and enhance the healing process. Other materials, such as mineral trioxide aggregate (MTA) and calcium hydroxide, are also used for their regenerative properties and ability to create a favorable environment for tissue repair<sup>4</sup>. Along with biodentine , GTR membrane was used. Recent studies have shown that this material has suitable mechanical properties and excellent dimensional stability after swelling and is proven to be safe and efficient for use as resorbable membranes for bone regeneration<sup>6</sup>. Flap was repositioned , sutures were placed and the flap was closed. A week after the removal of sutures the canal was obturated with bioceramic sealer .
