# Aerodynamic Effect on Axial Vibration of High-Speed Induction Motor

## II. Initial Inspection

## III. Causes of Axial Vibration

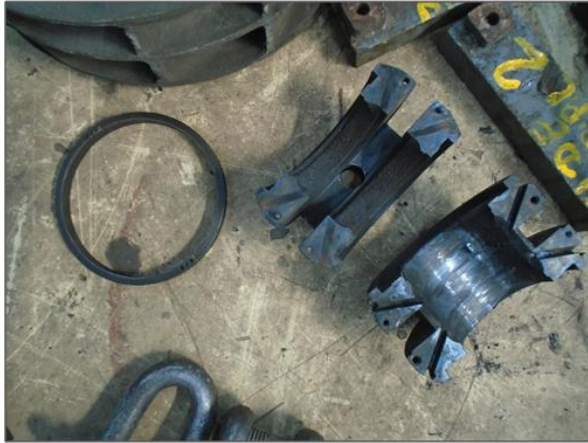
1. Non-Drive End (NDE) side bearing housing was in seized condition
2. Thermal bow was observed in rotor
3. Run out was observed at NDE side.

Fig. 1: Bearing Condition Before Repairs

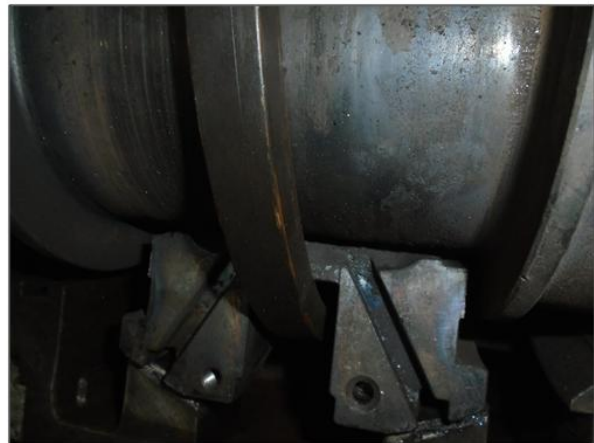
Looking towards the images it can be analyzed that shaft has experienced severe thrust and which resulted into damage. The axial vibration caused shaft deteriorate and therefore it was recommended to replace shaft. But the problem still needs solution to decrease axial vibrations. So, several probabilities were addressed and from that relevant solution was achieved. When motor was received at workshop site it was observed that the direction of fan was found to be reversed than its original rotational direction.

Fig.2 : Shaft Condition Before Repairs

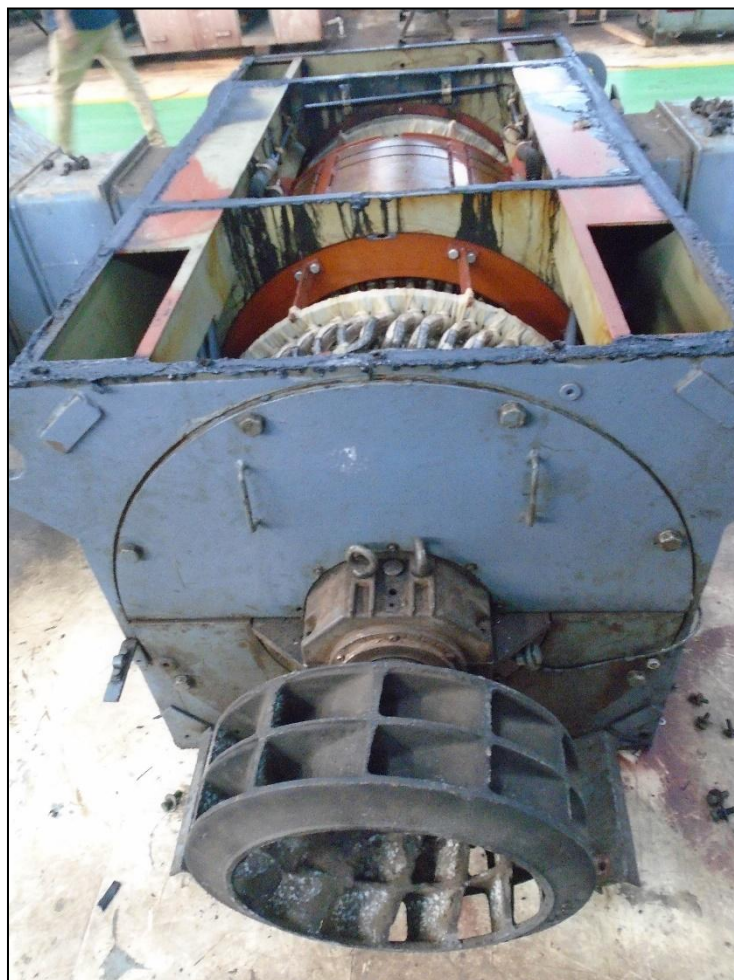
This reverse position of fan creates unbalance aerodynamic force. Aerodynamic force is strong in two pole machines. When the aerodynamic forces resulting from opposing fans are not equal, the stronger fan pull the rotor off magnetic center. Even sometimes blocked openings can upset the balance of air flow. As the rotor is displaced in the axial direction, the force required to restore the magnetic center increases. The rate at which the required force increases, decreases with distance from magnetic center. Steep fan blade pitch increase air flow and axial aerodynamic force [5].

Fig.3: Initial Fan Rotation Position

The root cause was identified and it was found the direction of external fan was not proper and it was required to be modified. The direction of fan blades was changed and again analysis was done in no load condition. Results obtained are briefed in the research article. Along with vibration air flow was also improved.

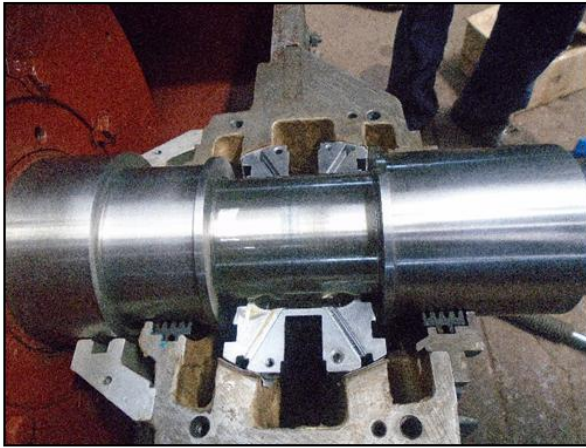
Fig.4: New Shaft

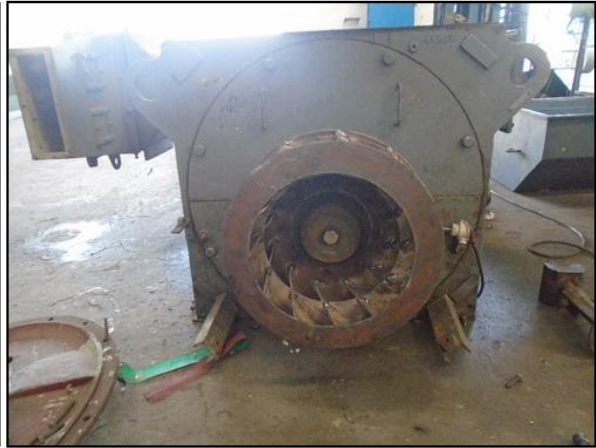
Fig. 5: Modified Fan Rotation

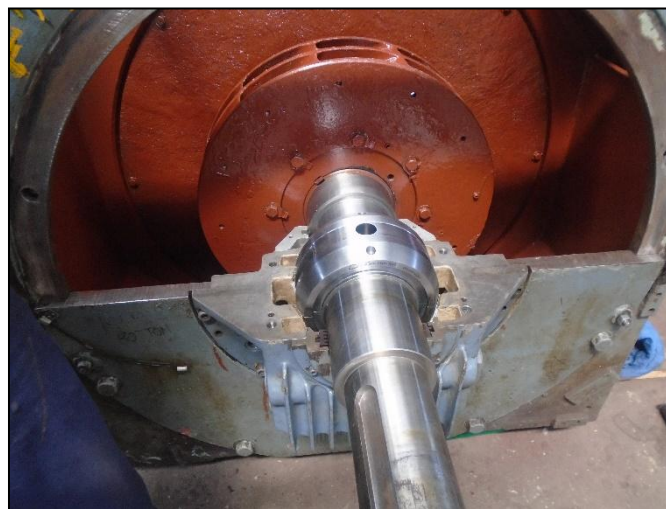
Fig. 6: Bearing Housing Assembly

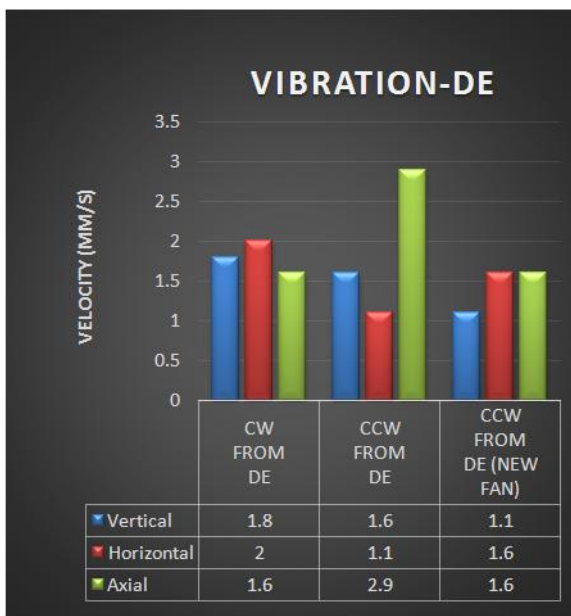
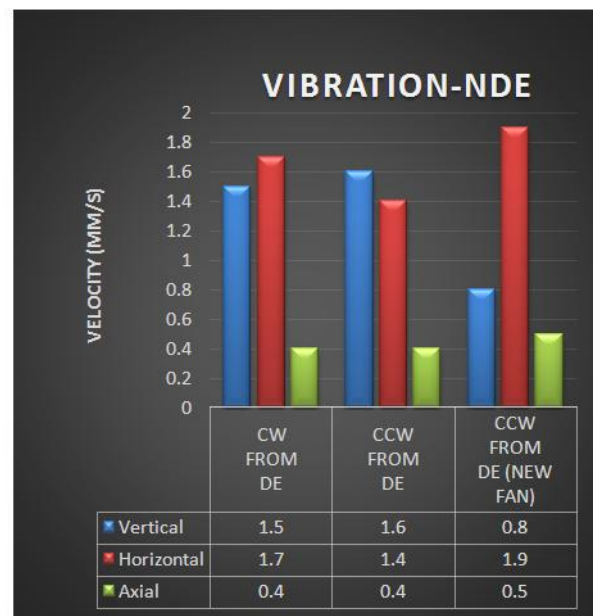
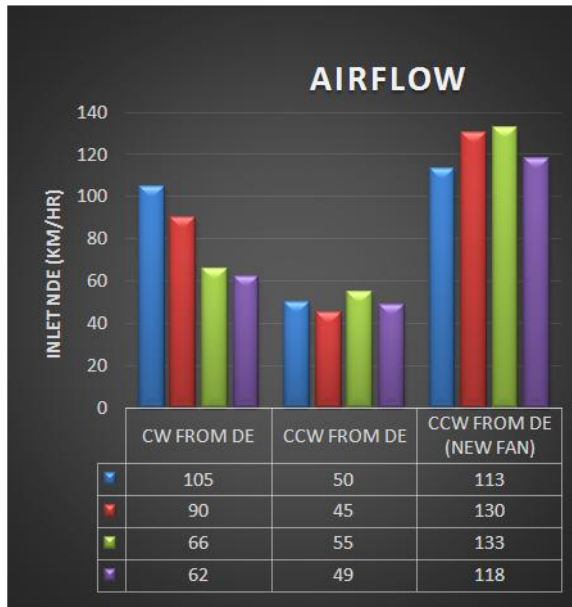
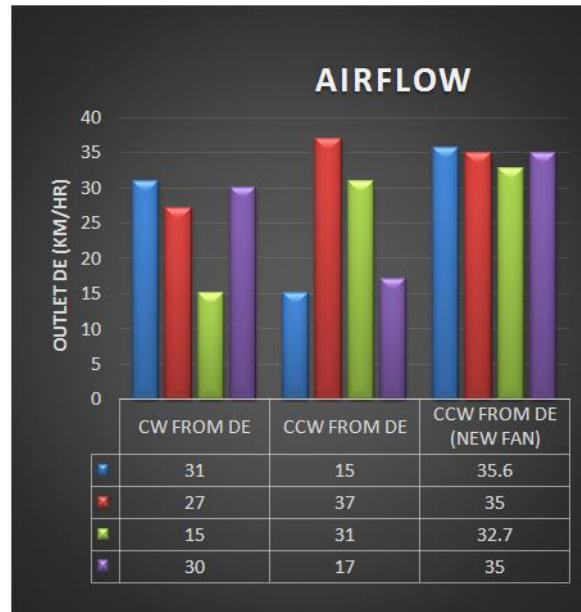
Comparative analysis of vibration & air flow of drive end (DE) and non-drive end (NDE) is been depicted in graphical form.

Modification did not affect the operating parameters of motor in no-load as well as load condition. It ultimately results in vibration obtained within limits, maintained the magnetic center & air flow increased so temperature rise was also within the limits. The motor is successfully in running condition and all parameters are within normal limits.
