Residential Architecture Of Botsa Rural Settlement In Konya-Turkey

A.Deniz Oktaç Beycan¹, Gamze Özmertyurt²

In this study, Botsa village houses, on which the examples of traditional housing typology can be found, were subjected to a general examination. Reliefs of the sample houses have been taken, the details which uniquely belong to that area houses have been examined and it has been concluded that the houses bear endemic characteristics and need to be put under protection.

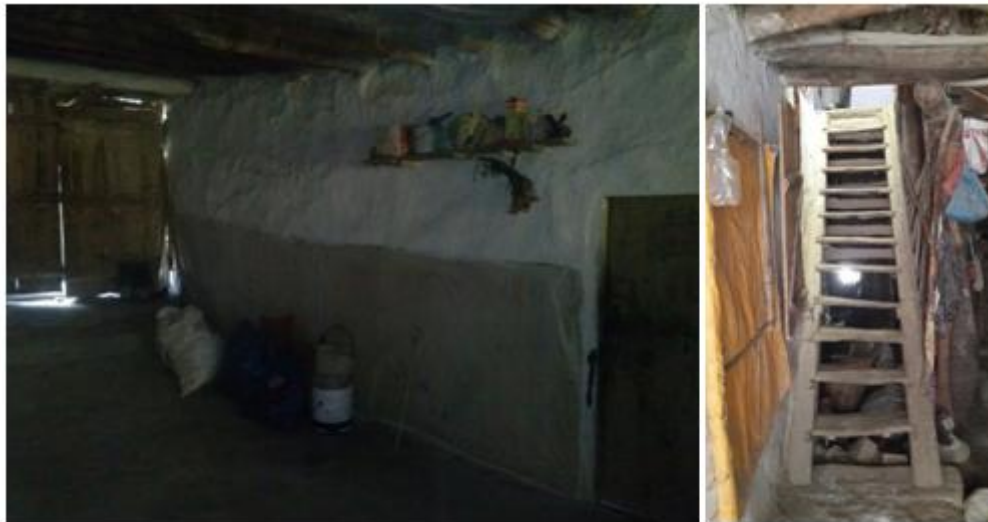
Figure 11. The entrance-Hayat space in the Elibols' house
 Figure 12. Wooden staircase connecting the ground floor to the first floor

Ground floor settlements are designed independently from the first floor. "Hayat" is the large and main space on the entrance from the street to the ground floor (Figure 11). Barn and haystack are reached through "Hayat" There is a staircase leading to the first floor hall from this section (Figure 12). The staircase with a few steps made of stone at the point it reaches the floor and the upper steps are made of wood, is located at such a position which can easily be seen when Hayat is entered. The staircase can be concealed with a cap in some of the houses where it leads to the arbor. In addition to storage spaces such as cellar and warehouse, "Hayat" includes farming and husbandry equipment. Therefore, the "Hayat" entrance doors are in the form of large double-wing wooden doors (Figure 13).

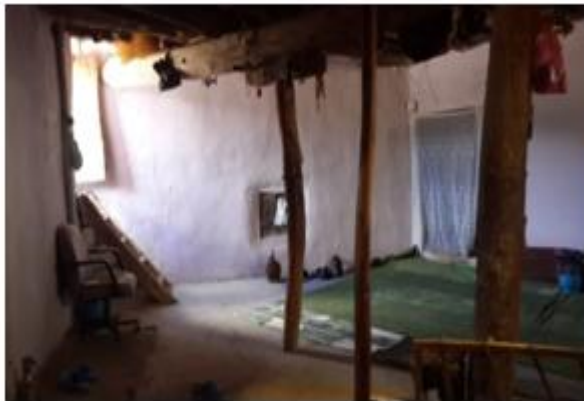
Figure 14. "Çardak" (hall) in the Uğurlus' House

We can identify the houses to be inner hall plan types (Table 1). The plan type can be seen on the first floors. The local name of the hall is "Çardak" (holl) and since it is shaped according to the land, it is seen in different sizes and geometrical forms in each house (Figure 14). Çardak is a circulation space with rooms, storage, kitchen on both sides, and a living space with the balcony section. The balcony space that is called "Tahtaboş" is elevated on columns from the ground. "Tahtaboş" which is the section of the Çardak that overhangs towards the street, is a living space with its side opening to the street is either open or closed with a window afterwards (Figure 46). In the house samples examined, the Çardak was seen to be in the shape of "L" or "I" surrounded by rooms from both sides. In some of the houses, in addition to the closed exedra, an open balcony is seen as well. In the Çardaks of some houses, hayloft hatches are seen on the ground nearby the entrance gate. The entrance gates of the Çardaks from the street are in the form of large wooden double wing doors (Figure 15).

In order to handle the wooden hoisting ceilings, pillars are used on the ground floor spaces and especially in the first floor halls (Figure 14). In order to gain large spaces in the ground floor, double main beams (pillow beams), thick pillars and rock planting bases were used on the ground floor under some of the thick stone walls of the first floor to handle them (Figure 50).

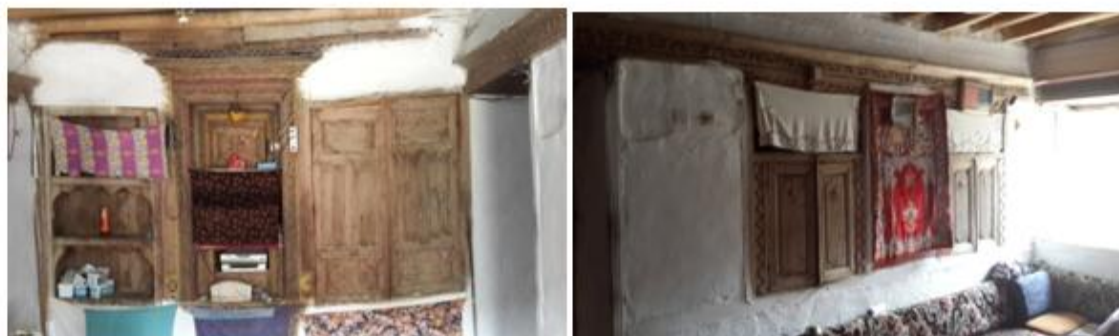
Figures 16-17. The main room wall organizations in the Ayyıldızs' house

Rooms are long and narrow with alcoves and bathing cubicles. On the wall where the door wing opens, there is an end to end complex of cupboards such as pitcher tub, flower tub, chest, alcove and bathing cubicle. In some houses, the alcove space is allocated, but blinded with a curtain without completing the carpentry work. The windows of the room are beveled windows enlarging from the outer wall to inside. The rooms are encompassed with a wooden belt underneath and over the windows. In some houses, the upper belt is in the form of a shelf named "sergen" (Figures 16-17).

Both interior and facade of houses have a plain architecture. There are very few examples of interior decorations on wooden chests and flower tubs (Figures 16-17). Ceilings are wooden joisting without any decoration.

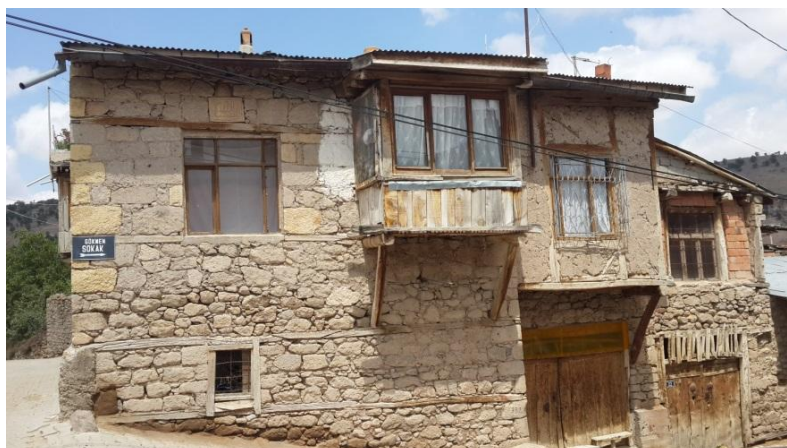
Figure 19. On the facade of a house, stone wall with fitches and the wooden exedra overflowing toward the street on beams and bolstered with buttresses is seen.

Tahtaboş (balcony) and exedras in some rooms are of wooden structure and placed on top of the main wooden girders that are extended out of the building. The housetop covering over the exedras is handled by beams that are placed on top of the main ceiling beams that overflow by either sides of the tahtaboş. While in the older houses, the tahtaboş exedras are open exedras and the housetop is handled by pillars at the corners, these have been closed by window walls one by one and turned into a form of window overlooking three directions in a way similar to Turkish house exedras. The exedras are bolstered with wooden buttresses between the underneath of the exedra and the verge of the ceiling fletcher (Figures 13, 19).

Wood: As wooden material, oak and juniper are used in the older houses, while walnut and poplar are used in the newer ones. Wood is used in fitches, ceiling beams, main beams, pillars and carpentry works in the buildings (Figures 18-19). While wooden window grids are seen on older houses, newer houses have iron window grids.

The main character of the facade of the houses is brought by stone architecture (Figures 13-19). On the facades, wooden fitches that appear among the unplastered stone facades of contiguous houses, soundproof or small windows, ground floors, room windows of the upper floor, room exedras, semi-open or closed balcony exedras, flat housetops and chimneys constitute a plain beauty.

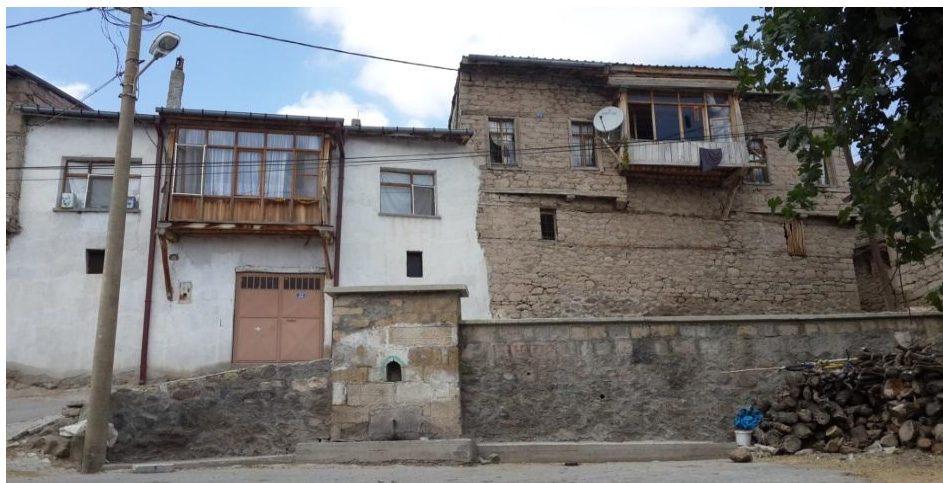
Figure 20. Facade Characteristics in Kör Çeşme Street

Houses are without garden except for a few ones. Entrances were made directly from the street (Figure 20). Ivies that climb on walls are seen in the entrances. Epitaph stones and ornamental plates on stones that are seen in very few examples are among the remarkable features of facades (Figure 21). Chimneys are constructed out of stone in the form of rectangular prism with single flues. Cubic chimneys are also seen in the area (Figure 22).
