STUDY AND SUGGESTIVE MEASURES OF LANDSLIDES ON PUNE MUMBAI ROUTE

Table 3 Geological and physical condition of the various places

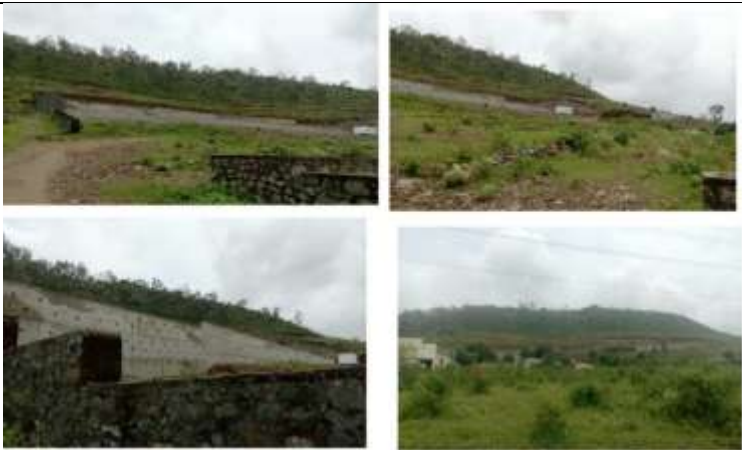
Sr. No.	Place	Spot	Photograph Photo
1	Between Vadgaon To Kanhe along NH4	N18.74184 E73.62944

Sr. No.	Place Name	Coordinate	Condition and Remark
1	Between Vadgaon To Kanhe	N18.74184 E73.62944	Retaining wall exist but due to existing of pebbles and cobbles present with soil and heavy rainfall it does not sustain by the single retaining wall. Vegetation on top
2	Near Kamshet Railway Station on the highway	N18 ⁰ 45.88' E73 ⁰ 32.55'	At this place there two spot, at spot A which content lateritic soil cover at top and with vegetation coverThe portion have 100 m length and 6m height. At the B spot which content soft weathered basalt rack
3	Near Kamshet Rly Station at the base of highway	N18 ⁰ 45.44' E73 ⁰ 32.96'	This place is important because of small movement make highway collapse At this place soil containing black cotton soil with pebbles and cobbles which is covered with vegetarian. Here rainfall is high and ground water table is low.Geologically the rock present here is weak as presence of spheroidal weathering in basalt, the slope around 60

Spot. No.	Place	Measure
1	Between Vadgaon To Kanhe along NH4	At this place retaining wall present but there is frequently landslide occur here some micro pilling to be inserted so as to compacting the ground.
2	Near Kamshet Railway Station on the highway	At this place there is no such structure of landslide avoiding, also here some part have soil so it treated with Gabion walls and at second place there is suitable of covering of slope with Coir netting or geo grid.
3	Near Kamshet Rly Station at the base of highway	Here as there is versed condition so at this place provision of Rock-fill buttresses type treatment is suitable.
4	Boraj Village	This place is similar case of Malin here proper drainage system with rerrace bedding is essential. And also regular inspection of the water content to be measure at rainy season.
5	At Khandala Raiway Station	At this place the cut surface is very high and it unsupported, as per the geological condition it necessity to provide bolting and netting with shot creating
