Rehabilitation the Irrigation Canals at End Reaches

Soha M. Mostafa¹, Gamal M. El-Shorpagy², Magdy H. Mowafy², Walaa Y. El-Nashar²

Abstract: The present study covers the area in the north of El-Sharkia governorate. This area is known to be suffered from irrigation problems and the farmers always complain about irrigation issues. Irrigation networks often are seen to perform below the expectation level, requiring their rehabilitation. Unfortunately, rehabilitation works are taken up on a piece-meal basis. The main object for rehabilitation is to improve conveyance efficiency, reliability and durability of the system so as to provide irrigation water to the beneficiaries in a more sustainable and equitable manner. The objectives of this study are to study the causes for water shortage in canals tails, perform rehabilitation for sections to improve the hydraulic performance. Questionnaires for both engineers and beneficiaries approved many reasons including need for rehabilitation behind the inefficiency of irrigation canals performance. A computer program is used to choose the best solution to achieve water balance. The CCHE-GUI 3.29 program is used to run upon a case study (El-Bat

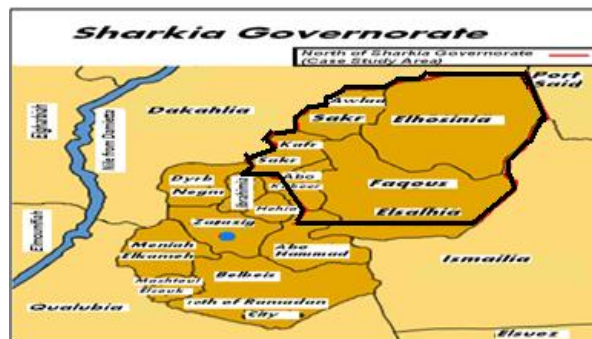
Fig 1. The East Delta Area

The study area is in the north of El-Sharkia governorate which includes areas of Kafr-Sakr, Awlad-Sakr, Elhosyniah, north of Abu Hammad and Faqous. This area lies between N 31° 6' and N 30° 42', E 31° 39' and E 32° 9'. The area with the bold border in the map shows the study area of this research as shown in Fig 1.

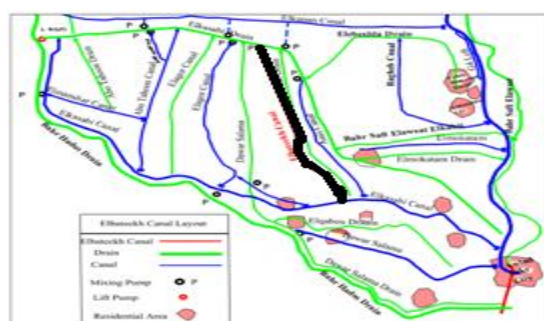
Fig 2. General Layout of El-Bateekh Canal

In this research El-Bateekh canal is studied. Its area served is 4000 feddan, and its length is 8.3 km. Actual discharge is $1.52\text{m}^3/\text{sec}$ while the designed discharge is $2.31\text{m}^3/\text{sec}$. Surface irrigation method is used in this canal. The map which identifies the general layout of the case study canal is shown in Fig 2.

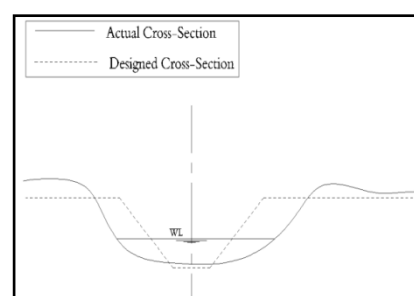
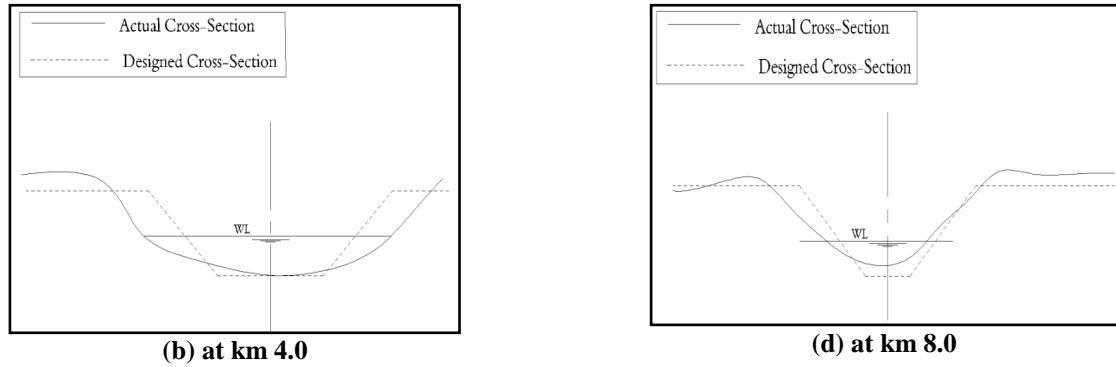
Fig 3. Cross Section of El-Bateekh Canal

The designed cross-sections and actual cross-sections of El-Bateekh canal at km 0.0, km 4.0, km 6.0 and km 8.0 are shown in Fig 3.

(a) at km 0.0

(c) at km 6.0

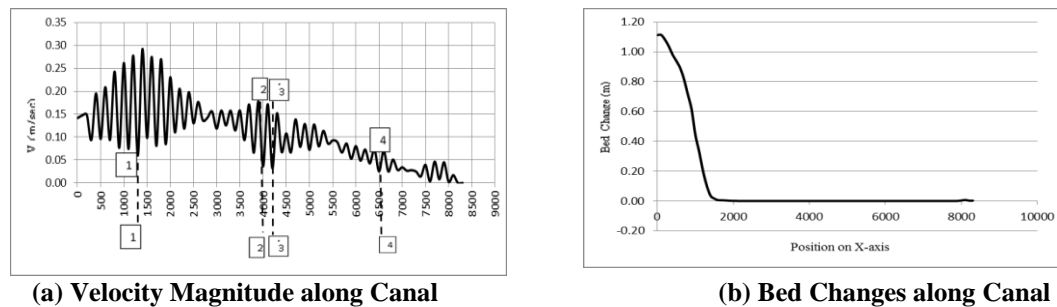
Fig 4. Results of Case1

In this run the actual discharge, water levels and cross-sections are entered and the resulted velocities magnitudes along the canal. The sediment initial conditions and sediment parameters are entered and the resulted of velocity magnitude and bed changes along the canal are shown in Fig 4.

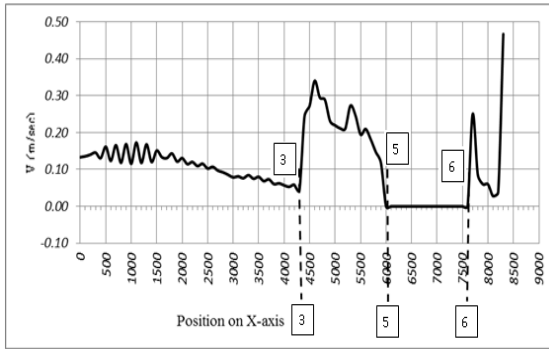
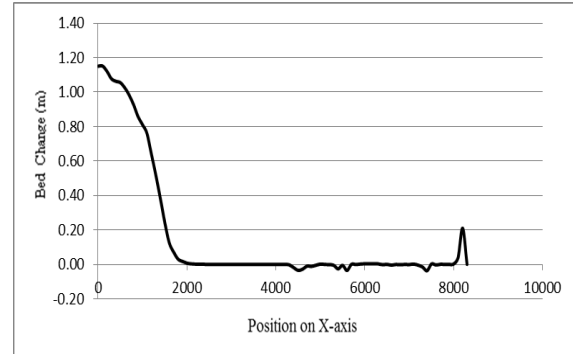
Fig 5. Results of Case2

The resulted of velocities magnitude along the canal and bed changes are shown in Fig 5.

(a) Velocity Magnitude along Canal

(b) Bed Changes along Canal

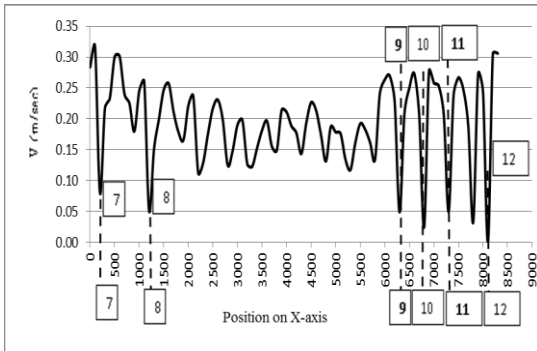
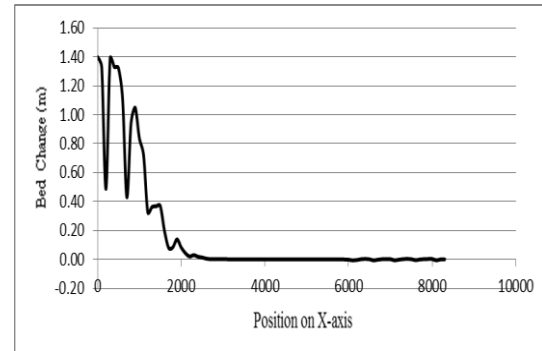
Fig 6. Results of Case3

The resulted of velocities magnitude and bed changes along the canal are shown in Fig 6.

(a) Velocity Magnitude along Canal

(b) Bed Changes along Canal

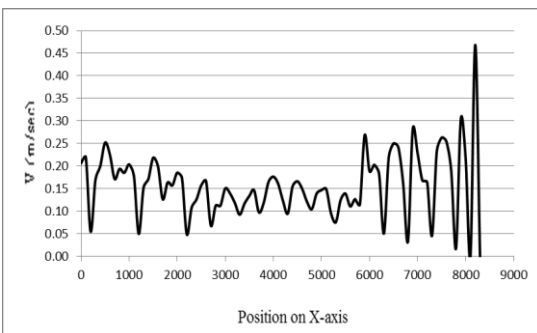
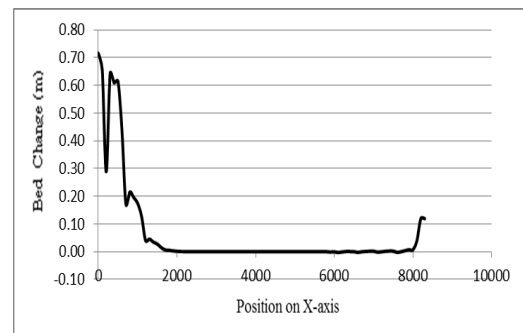
Fig 7. Results of Case4

The resulted of velocities magnitude and bed changes along the canal are shown in Fig 7.

(a) Velocity Magnitude along Canal

(b) Bed Changes along Canal

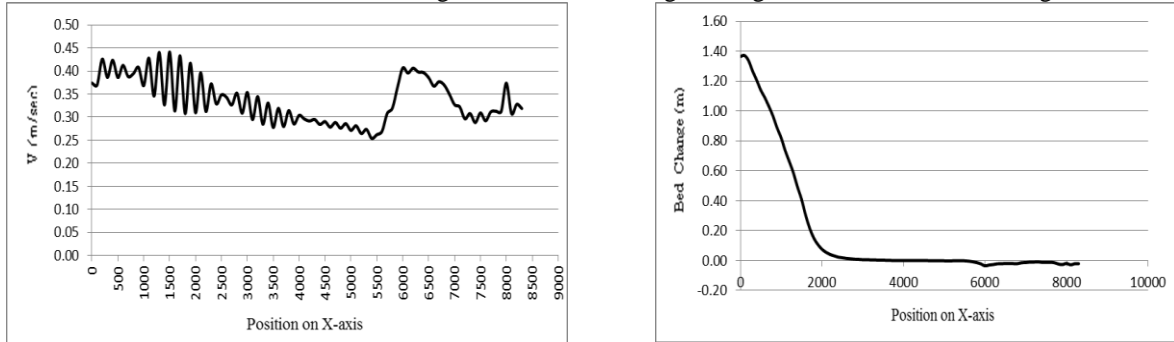
Fig 8. Results of Case5

The resulted of velocities magnitude and bed changes along the canal are shown in Fig 8.

(a) Velocity Magnitude along Canal

(b) Bed Changes along Canal

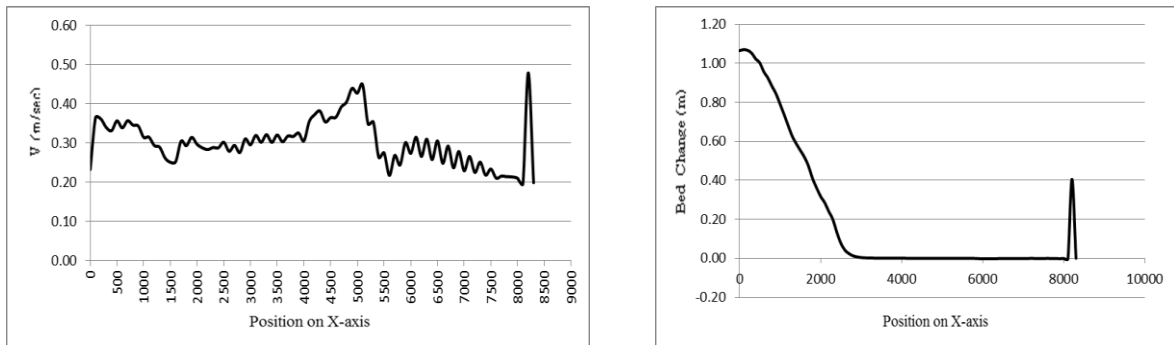
Fig 9. Results of Case 6

The resulted velocities of magnitude and bed changes along the canal are shown in Fig 9.

(a) Velocity Magnitude along Canal

(b) Bed Changes along Canal

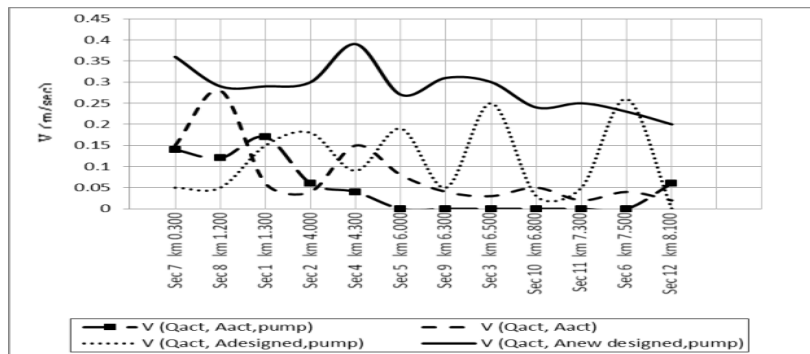
Fig 10. Velocity Magnitude of Critical Sections for Different Run Cases

The lowest velocities resulted from the actual discharge case and actual cross-section is shown in Fig 10, the velocities are high value in case of designed cross-section and case of suggested new designed cross section. This proved that using smaller cross-section area for case of decreasing discharges (as in the actual case) will resulted in higher velocities and better performance of canal.

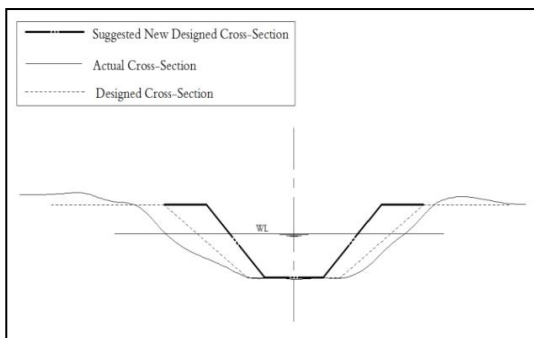
Fig 11. Cross-Sections of Section 1-1 at km 1.30

There is obvious change in the shape of the cross section of the canal as shown in Fig 11, the actual cross section area is 11.71 m² while as the designed cross section area is 9.46 m², and the area of the suggested new designed section is 6.17 m². The velocity of the designed cross section is 0.15 m/sec, the velocity of the actual cross section is 0.06 m/sec and the velocity of the actual cross section (case of +pump) is 0.17 m/sec, while as the velocity will be increased to 0.29 m/sec if we used the new suggested cross section (for the same actual discharge).

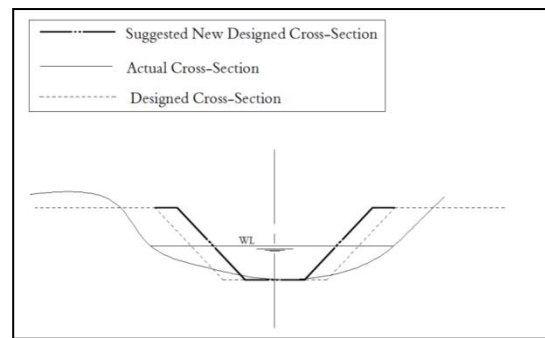
Fig 12. Cross-Section of Section 2-2 at km 4.0

There is obvious change in the shape of the cross section of the canal as shown in Fig 12, the actual cross section area is 5.97 m² while as the designed cross section area is 4.89 m², and the area of the suggested new designed section is 3.28 m². The velocity of the designed cross section is 0.18 m/sec, the velocity of the actual cross section is 0.04 m/sec and the velocity of the actual cross section (case of +pump) is 0.06 m/sec, while as the velocity will be increased to 0.3 m/sec if we used the new suggested cross section (for the same discharge).

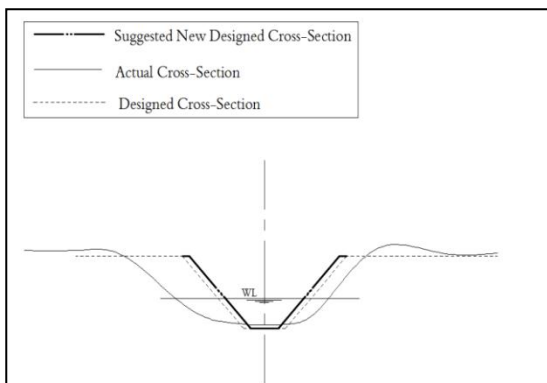
Fig 13. Cross-Section for Section 3-3 at km 6.50

There is obvious change in the shape of the cross section of the canal as shown in Fig 13, the actual cross section area is 3.32 m² while as the designed cross section area is 2.19 m², and the area of the suggested new designed section is 1.74 m². The velocity of the designed cross section is 0.25 m/sec, the velocity of the actual cross section is 0.03 m/sec and the velocity of the actual cross section (case of +pump) is 0.00 m/sec, while as the velocity will be increased to 0.3 m/sec if we used the new suggested cross section (for the same actual discharge).

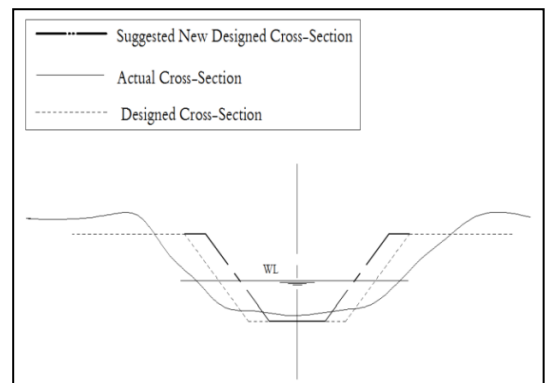
Fig 14. Cross-Section for Section 4-4 at km 4.30

There is obvious change in the shape of the cross section of the canal as shown in Fig 14, the actual cross section area is 5.08 m² while as the designed cross section area is 4.89 m², and the area of the suggested new designed section is 3.28 m². The velocity of the designed cross section is 0.09 m/sec, the velocity of the actual cross section is 0.15 m/sec and the velocity of the actual cross section (case of +pump) is 0.04 m/sec, while as the velocity will be increased to 0.39 m/sec if we used the new suggested cross section (for the same actual discharge).

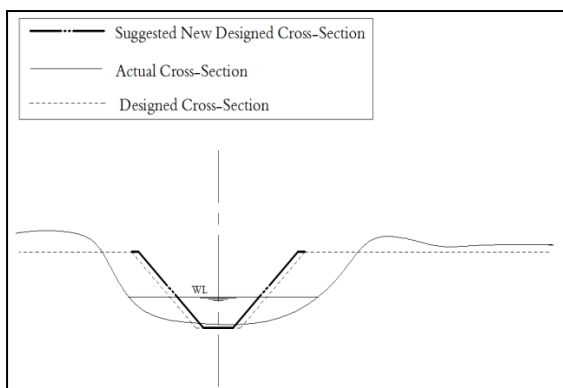
Fig 15. Cross-Section for Section 5-5 at km 6.0

There is obvious change in the shape of the cross section of the canal as shown in Fig 15, the actual cross section area is 3.88 m² while as the designed cross section area is 2.19 m², and the area of the suggested new designed section is 1.74 m². The velocity of the designed cross section is 0.19 m/sec, the velocity of the actual cross section is 0.08 m/sec and the velocity of the actual cross section (case of +pump) is 0.00 m/sec, while as the velocity will be increased to 0.27 m/sec if we used the new suggested cross section (for the same actual discharge).

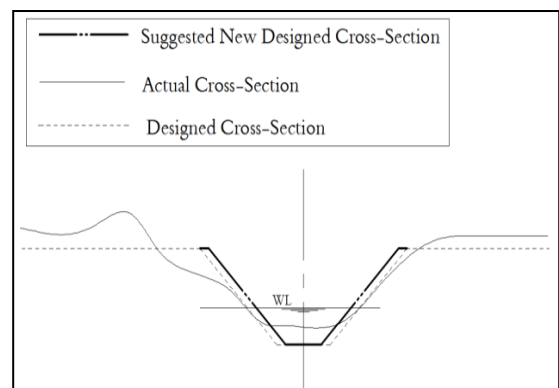
Fig 16. Cross-Section for Section 6-6 at km 7.50

There is a change in the shape of the cross section of the canal as shown in Fig 16, the actual cross section area is 1.14 m² while as the designed cross section area is 2.00 m², and the area of the suggested new designed section is 1.57 m². The velocity of the designed cross section is 0.26 m/sec, the velocity of the actual cross section is 0.04 m/sec and the velocity of the actual cross section (case of +pump) is 0.00 m/sec, while as the velocity will be increased to 0.23 m/sec if we used the new suggested cross section (for the same actual discharge).

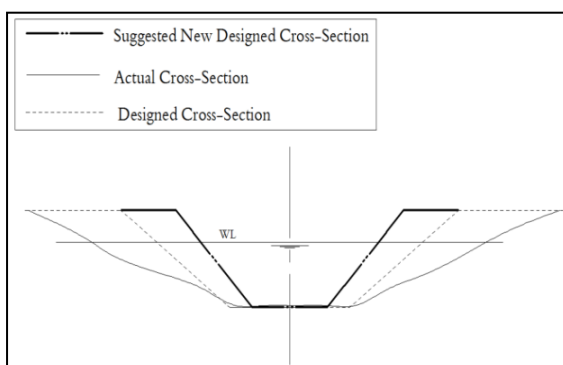
Fig 17. Cross-Section for Section 7-7 at km 0.20

There is obvious change in the shape of the cross section of the canal as shown in Fig 17, the actual cross section area is 14.43 m² while as the designed cross section area is 10.93 m², and the area of the suggested new designed section is 7.14 m². The velocity of the designed cross section is 0.05 m/sec, the velocity of the actual cross section is 0.15 m/sec and the velocity of the actual cross section (case of +pump) is 0.14 m/sec, while as the velocity will be increased to 0.36 m/sec if we used the new suggested cross section (for the same actual discharge).

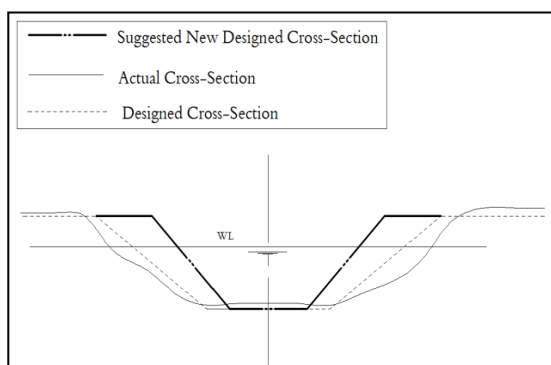
Fig 18. Cross-Section for Section 8-8 at km 1.20

There is obvious change in the shape of the cross section of the canal as shown in Fig 18, the actual cross section area is 12.41 m² while as the designed cross section area is 10.93 m², and the area of the suggested new designed section is 7.14 m². The velocity of the designed cross section is 0.05 m/sec, the velocity of the actual cross section is 0.28 m/sec and the velocity of the actual cross section (case of +pump) is 0.12 m/sec, while as the velocity will be increased to 0.29 m/sec if we used the new suggested cross section (for the same actual discharge).

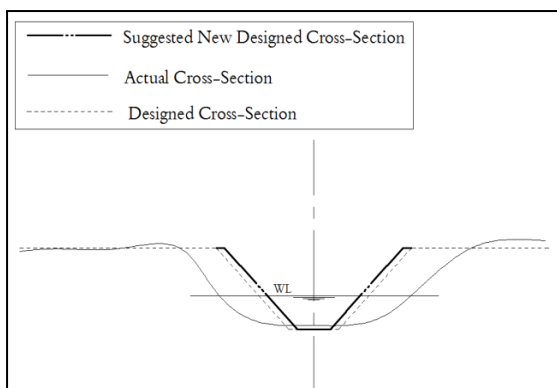
Fig 19. Cross-Section for Section 9-9 at km 6.30

There is obvious change in the shape of the cross section of the canal as shown in Fig 19, the actual cross section area is 3.67 m^2 while as the designed cross section area is 2.19 m^2 , and the area of the suggested new designed section is 1.74 m^2 . The velocity of the designed cross section is 0.05 m/sec , the velocity of the actual cross section is 0.04 m/sec and the velocity of the actual cross section (case of +pump) is 0.00 m/sec , while as the velocity will be increased to 0.31 m/sec if we used the new suggested cross section (for the same actual discharge).

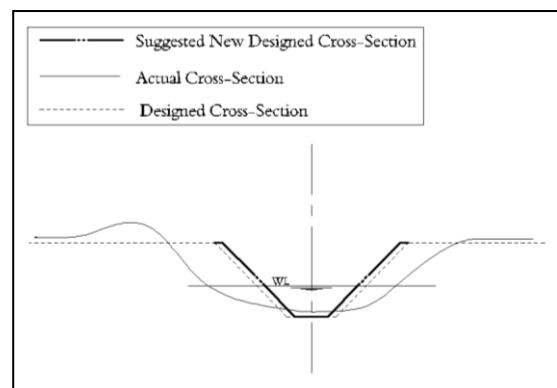
Fig 20. Cross-Section for Section 10-10 at km 6.80

There is obvious change in the shape of the cross section of the canal as shown in Fig 20, the actual cross section area is 3.14 m^2 while as the designed cross section area is 2.19 m^2 , and the area of the suggested new designed section is 1.74 m^2 . The velocity of the designed cross section is 0.03 m/sec , the velocity of the actual cross section is 0.05 m/sec and the velocity of the actual cross section (case of +pump) is 0.00 m/sec , while as the velocity will be increased to 0.24 m/sec if we used the new suggested cross section (for the same actual discharge).

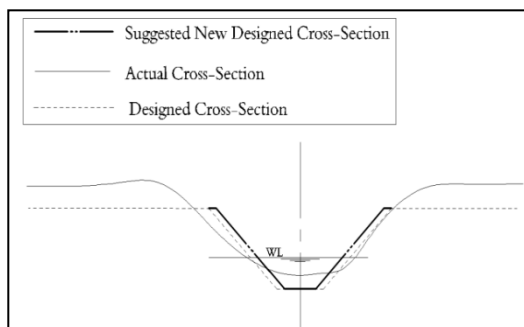
Fig 21. Cross-Section for Section 11-11 at km .30

There is a change in the shape of the cross section of the canal as shown in Fig 21, the actual cross section area is 1.19 m^2 while as the designed cross section area is 2.00 m^2 , and the area of the suggested new designed section is 1.57 m^2 . The velocity of the designed cross section is 0.05 m/sec , the velocity of the actual cross section is 0.02 m/sec and the velocity of the actual cross section (case of +pump) is 0.00 m/sec , while as the velocity will be increased to 0.25 m/sec if we used the new suggested cross section (for the same actual discharge).

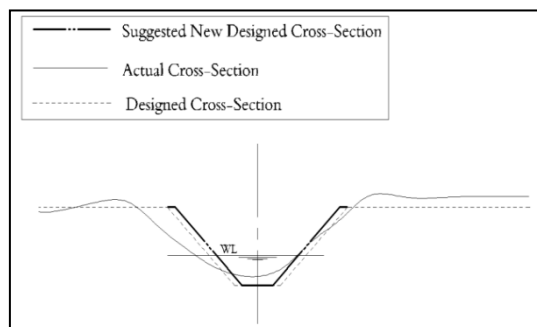
Fig 22. Cross-Section for Section 12-12 at km 8.10

There is a change in the shape of the cross section of the canal as shown in Fig 22, the actual cross section area is 1.36 m^2 while as the designed cross section area is 2.00 m^2 , and the area of the suggested new designed section is 1.57 m^2 . The velocity of the designed cross section is 0.00 m/sec , the velocity of the actual cross section is 0.02 m/sec and the velocity of the actual cross section (case of +pump) is 0.06 m/sec , while as the velocity will be increased to 0.20 m/sec if we used the new suggested cross section (for the same actual discharge).
