Development of a Systematic Diagnostic Strategy of the Repair of a Defective Universal Material Testing Machine (Model SM-100)

B. Kareem and R.K. Apalowo

Department of Mechanical Engineering, Federal University of Technology, Akure

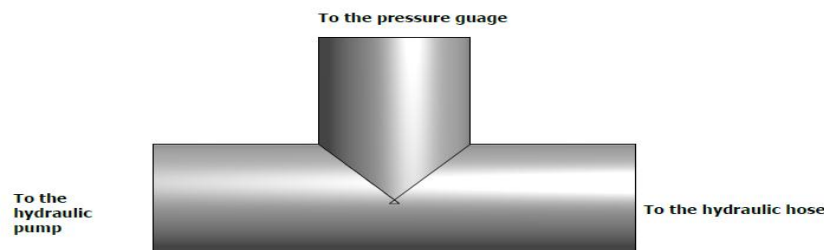
Fig. 1: The Tee-Nipple

- i. An analogue pressure gauge was acquired. The analogue pressure gauge was chosen to replace the digital pressure gauge so as to eliminate the necessity for the electrical connections required.
- ii. A tee-nipple was acquired. This is to aid a link among the hydraulic pump, the hydraulic hose and the pressure gauge by connecting them together through its three ports as shown in figure 1 below.
- iii. Two threaded connectors were acquired. This is to aid the connection of the tee-nipple with the hydraulic hose and the hydraulic pump.

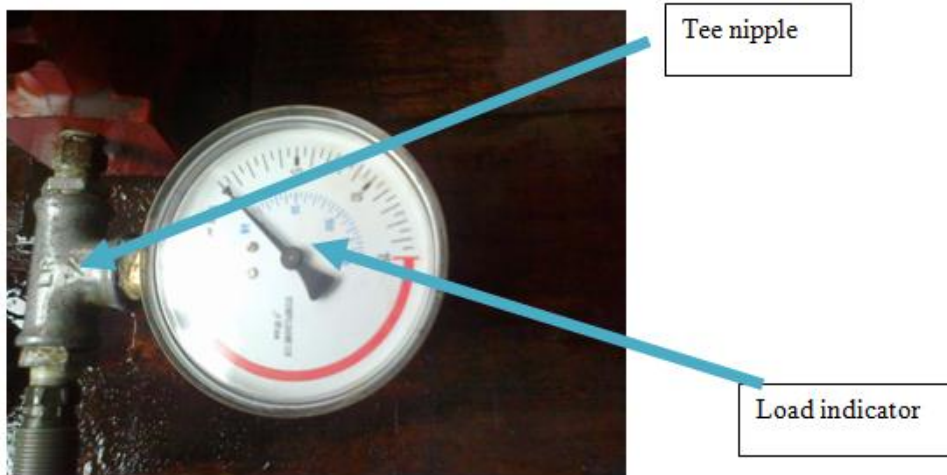
Fig. 2: the new load meter with the Tee Nipple

In an attempt to install the new load meter, tee-nipple was acquired and connected to the port of the hydraulic pump with a nut. The tee-nipple connects the load indicator, the hydraulic pump and its hose. The broken seals as well as the worn balls and broken seals were replaced. The old hydraulic oil was drained off and new one was poured into the cylinder. The machine parts were washed and necessary adjustments were made during the re-assembly process.

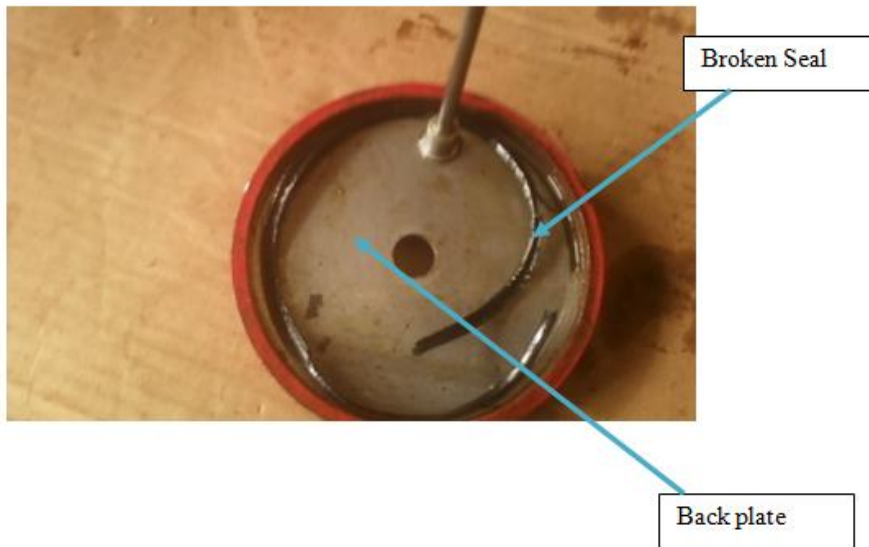
It was apparent that the leakage of oil detected at the hydraulic hose port of the hydraulic pump was due to the broken seals inside the hydraulic pump. The oil seals were replaced with new ones.

Fig. 3: The cover plate with the broken seal

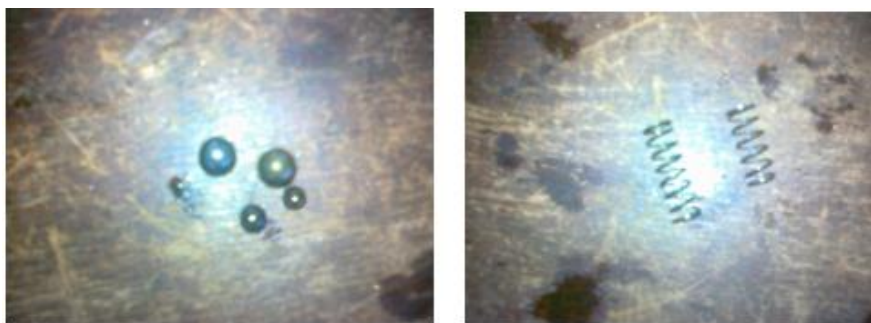
The balls on the valves are worn and this is responsible for the inadequate supply of oil to the machine reservoir. The balls are replaced.

The two springs inside the valve housing are broken. This will definitely affect the function of the valve mechanism negatively. Thus, the springs were replaced.

Fig. 4: The worn balls and broken springs

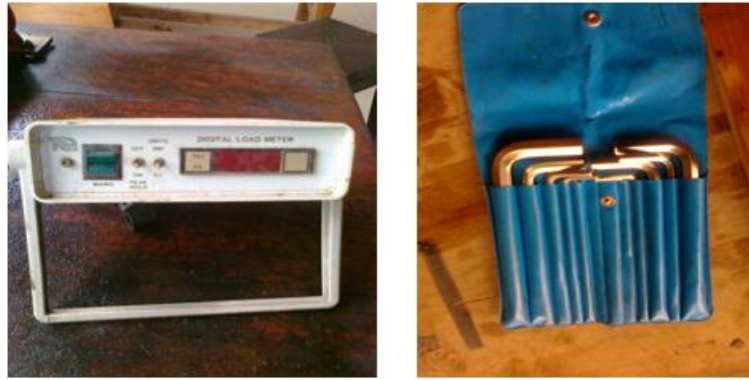
The load indicator system consists of the digital load meter and a sensor connected to it. Both the load meter and the sensor are completely damaged.

Fig. 5: The damaged load indicator and set of Allen key

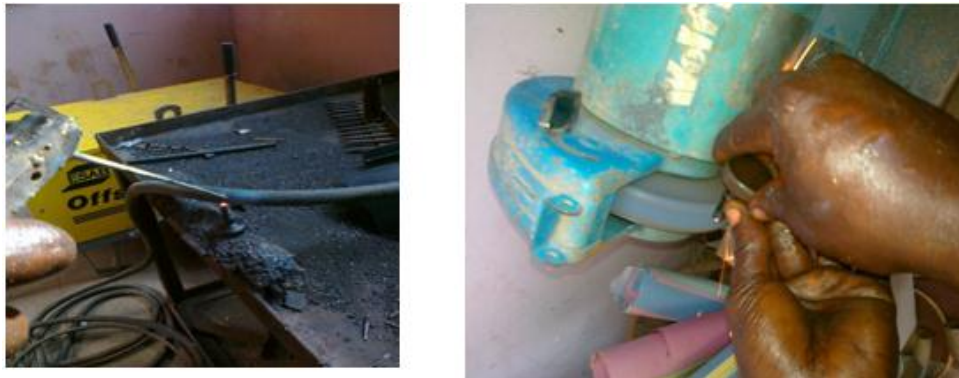
The lock nut aids the outflow of oil from the pump as the return of oil back into the hydraulic pump. The deformed lock nut was welded and then ground to achieve its proper shape.

Fig. 6: Welding and grinding of the deformed lock nut tip

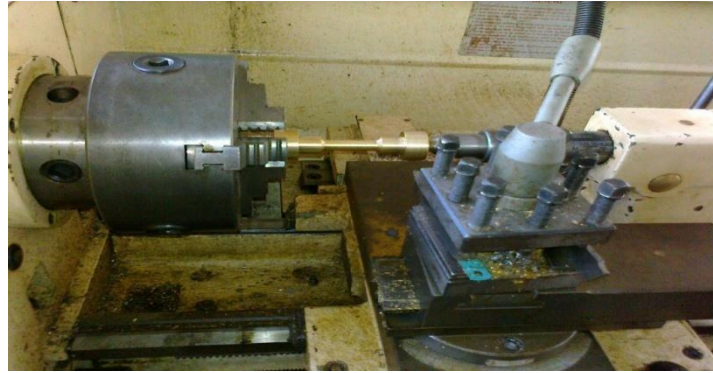
The repaired machine was evaluated by tensile tests carried out on it in order to determine working condition of the machine. Two test specimens were machined for each chosen material (Aluminum, mild steel and brass) on the lathe machine to the same size and geometry (i.e., length 100mm by step diameters of 30mm, 18mm and 10mm). The machine set up and detailed machining operations of the test specimen are shown in figures 7 and 8 respectively.

Fig. 9: Machine set-up for machining the Test Specimen

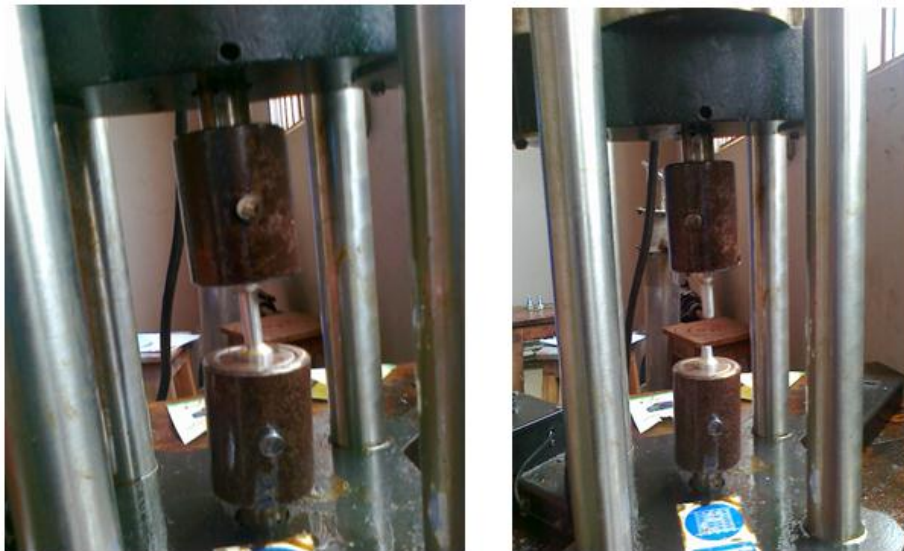
Tensile test was carried out on a specimen of each (one of the two) material using the repaired machine and the test was also done on the other specimens using a well functioning testing machine, as a mean of comparison. The machine set-up is shown in figure 10.

Fig. 10: Machine set-up before and after the experiment

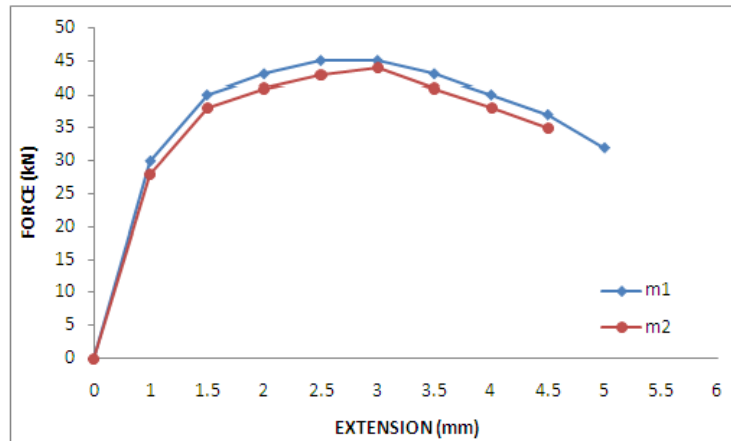
F₁ (kN)	0	30	40	43	45	45	43	40	37	32
F₂ (kN)	0	28	38	41	43	44	41	38	35	
e (mm)	0.0	1.0	1.5	2.0	2.5	3.0	3.5	4.0	4.5	5.0

Fig. 11: Graph of Force (kN) against Extension (mm) for Aluminum

From the analyses of the results given above, it can be seen that there is no significant difference between the tensile stress-strain curves obtained from using the repaired machine and that obtained using the functioning machine. This outcome is an indication that the repaired machine can perform adequately well as compared with the standard and functioning similar machine.

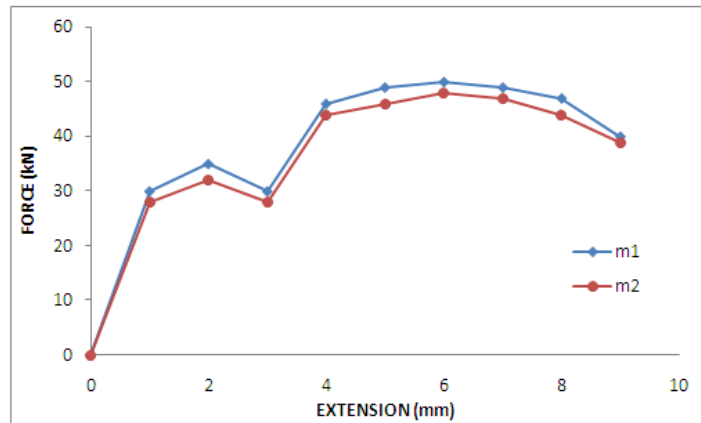
F_1 (kN)	0	30	35	30	46	49	50	49	47	40
F_2 (kN)	0	28	32	28	44	46	48	47	44	39
e (mm)	0.0	1.0	2.0	2.5	4.0	5.0	6.0	7.0	8.0	9.0

Fig. 12: Graph of Force (kN) against Extension (mm) for Mild steel

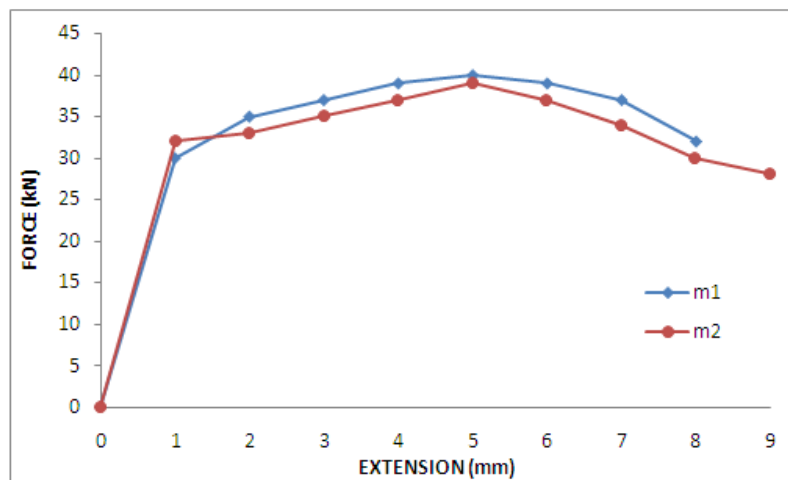
F_1 (kN)	0	30	35	30	46	49	50	49	47	40
F_2 (kN)	0	28	32	28	44	46	48	47	44	39
e (mm)	0.0	1.0	2.0	2.5	4.0	5.0	6.0	7.0	8.0	9.0

Fig. 13: Graph of Force (kN) against Extension (mm) for Brass
