## An Experimental Study of Flexural Strength of Reinforced Concrete Beam Due To Corrosion

**Abstract:** Reinforced concrete beams are normally designed as under reinforced to provide ductile behavior such as the tensile moment of resistance. In coastal environment reinforcement corrosion is an obvious cause of deterioration of concrete structure, which affects the durability and service of reinforced concrete structure. Structural stability is majorly influenced by strength of concrete. Flexural strength is a measure of the tensile strength of concrete, in other words it is a measure of a resistance against failure in bending. The main aim of this study is to analyze the strength, experimentally; of corroded beams using Ordinary Portland cement. Accelerated corrosion technique was adopted to corrode the beam experimentally. The corrosion was measured using Applied Corrosion monitoring instrument. Beam specimens are prepared using M20 grade concrete for OPC. Beam specimens casted are tested as vertical cantilever beam in specially prepared loading setup and load deflection behavior is studied.

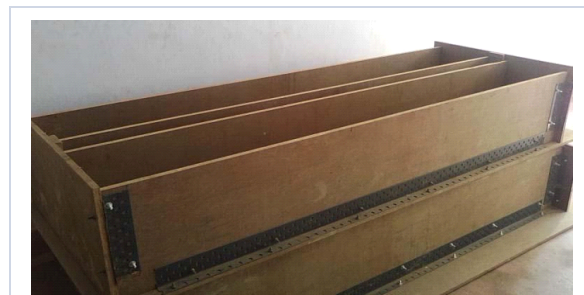
**Fig.4.2.1 (a) Wooden Formwork**

The formwork was fabricated locally using 76.2/101.6-mm plywood and cast iron steel flats. The internal dimensions of the mould are exactly equal to specimen dimension. The formwork consisted of two L-shaped plywood sheets and one straight plywood sheet, which were connected by nuts and bolts through end wooden blocks as shown Fig.3.1. The internal surface of the formwork will properly oil for easy removal of specimen from the formwork.

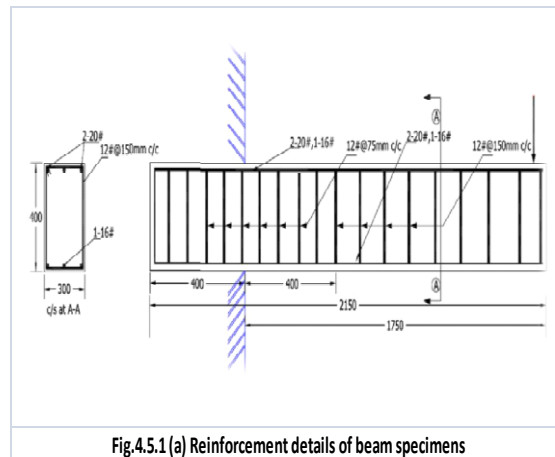
Two series of reinforced concrete cantilever beams of cross section 300mm x 400mm and 2150mm length have been cast. These cantilever beams have a shear span of 1750mm and 400mm bearing length. Beams with an effective cover of 30mm are designed as per IS 456:2000. Beams are provided with two 20mm diameter and one 16mm diameter TMT (Fe 415) bars at top and same reinforcement is provided at bottom. Shear reinforcement of 12 mm dia TMT bars with a spacing of 150mm c/c for a length of 1350mm from the free end and 12 mm diameter TMT bars with a spacing of 75mm c/c for a length of 800mm from remaining length of beam are adopted to ensure that flexural failure would dominate over shear failures shown in the Fig.4.5.1 (a), (b).

Fig.4.5.1 (a) Reinforcement details of beam specimens

Different colors electrical wires are soldered to both the end of the main tension reinforcement bars before placing the concrete in the beam moulds. These wires are held in place so that it exited from the top face of the beam. At the free end, one yellow color, 4 cm<sup>2</sup> multi-strand copper wires are connected to each reinforcement bar used to pass the electric current. Similarly at a distance of 300 mm from the fixed end, one red color, 2 cm<sup>2</sup> multi-strand copper wires were connected to each reinforcement bar which was used to continuous monitoring of the corrosion rate.

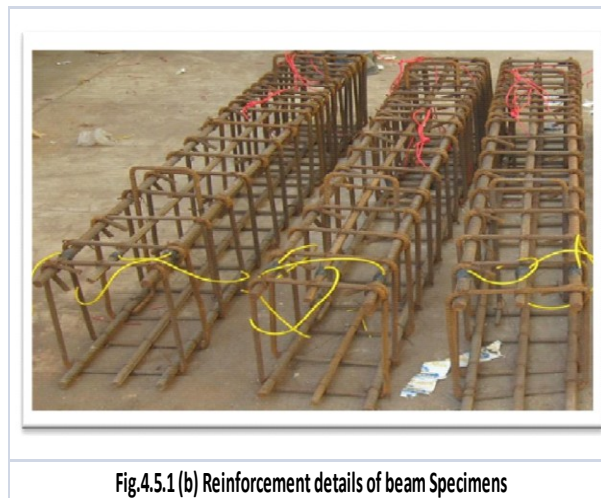
Fig.4.5.1 (b) Reinforcement details of beam Specimens

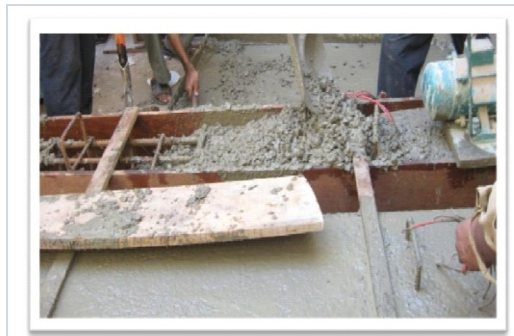
**Fig.4.6.1 Casting of Beam Specimen**

Casting of 30 beam specimens was carried out in 4 batches. Six concrete cube specimens were also cast from each batch of concrete mix to determine the corresponding compressive strength. OPC concrete specimens concrete ingredients were mixed in a revolving drum type mixer till it was uniform. The moulds were oiled and the steel reinforcement cages prepared beforehand were placed securely in their proper position in the moulds. 30 mm precast concrete cover blocks were used to maintain the 30 mm clear cover. The moulds were filled with concrete in three layers. After placement of each layer, the concrete was vibrated to ensure proper consolidation as shown in fig.4.6.1.

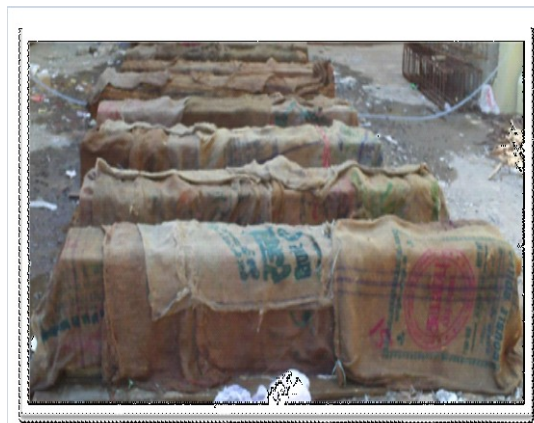
**Fig.4.6.2 Curing of Beam Specimen**

The specimens were demoulded after 24 hours of casting and then covered with wet gunny bags. For first two weeks after casting the beams were cured using wet gunny bags by applying water frequently as shown in Fig.4.6.2 after 14 days of gunny bags curing the beams were kept in a curing tank and cured for 14 days. After 28 days from casting the beams and the control specimens were stored to dry in atmosphere till test, after removing from the curing tank.

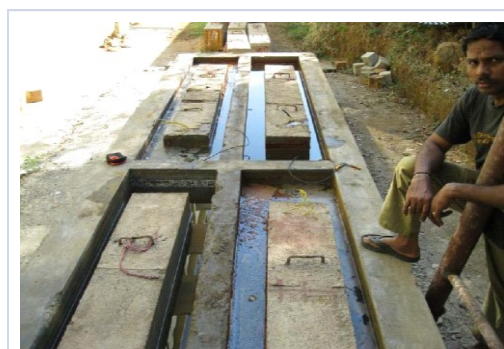
In this experiment the electrochemical corrosion technique is used to accelerate the corrosion of steel bars embedded in the specimens. To simulate the corrosion process, direct current is impressed on the bar embedded in the specimens using an integrated system incorporating a small direct current power supply with an in-built ammeter with an output of 64V and 10 amps to monitor the current. After specimens were immersed in a 5.0 % NaCl solution for a day to ensure full saturation condition, the direction of current was arranged so that the steel bars in the specimens served as the anode. The stainless steel plate used as a cathode was placed along the length of beam. This arrangement ensured a uniform distribution of the corrosion current along the whole length of the bar. A schematic representation of the test set-up is shown in Fig.4.7.1. To obtain the desired levels of reinforcement corrosion, the current intensity and the electrifying time had to be controlled.

**Fig.4.7.1 Photo of beam specimens under accelerated corrosion**

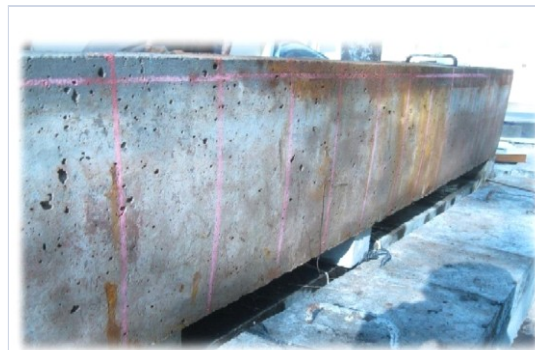
To study the existing corrosion level of the beam specimens, initial current density was measured using the corrosion measuring system “Gill AC”. The beam specimens were divided into number of grids to locate the guard ring probe to polarize the definite area on concrete rebar as shown in the fig 4.9.1. At each node, corrosion current density was measured by LPR technique. The current density for each control specimen is shown in the Table 4.9.1

**Fig.4.9.1** Beam specimen marked in to number of grid to measure corrosion current density

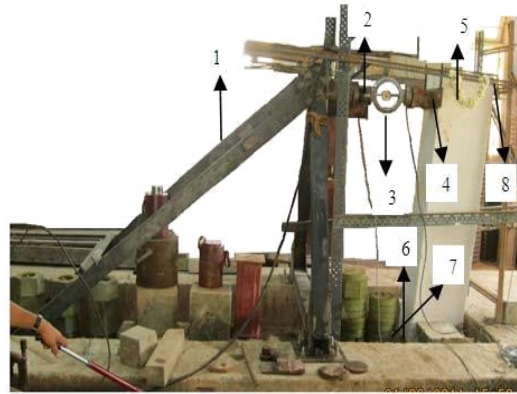
**Fig.5.1 Test set up for beam specimen**

Flexural testing of the cantilever beam was carried out under the specially prepared loading frame. Loading set up was constructed in the existing reaction bed at laboratory to test the beam as a vertical cantilever by applying point load at the free end of the beam in transverse direction. To achieve the fixity at the fixed end of the beam, heavy duty hydraulic jack was used against the steel column section at the other side of the beam. Full fixity was achieved at the bottom end of the beam by adjusting the movement of the hydraulic jack arm. The loading frame are designed as a steel space frame, Built up section made up of two ISMC-100 sections with face to face was used to construct the loading frame. 16 mm diameter hilty bolts of 40kN capacities were grouted on the reaction bed to fix the loading frame to the reaction bed. The loading frame was designed to carry a 100kN concentrated load, which is the expected reaction from the beam element.

All beams are tested as cantilever beams in a 15 tonne capacity steel testing frame made up of rolled steel joists, the beam having a span of 1850mm was fixed at one end for a bearing length of 400mm. The span

and load points are kept constant for all the beams. The concentrated load is applied on the free end of a beam. The load spreader arm, wherever used is a rolled steel joist which is supported on the rollers kept on the loading points. Over the load spreader arm the proving ring of 20 tonnes capacity which is used to measure the applied load, is placed over which the hydraulic jack of 20 tonnes was fixed to the rolled steel joist of the loading frame. The pump of a hydraulic jacks operated by a hand lever. Fig.5.1 shows the test set up with beam specimen.

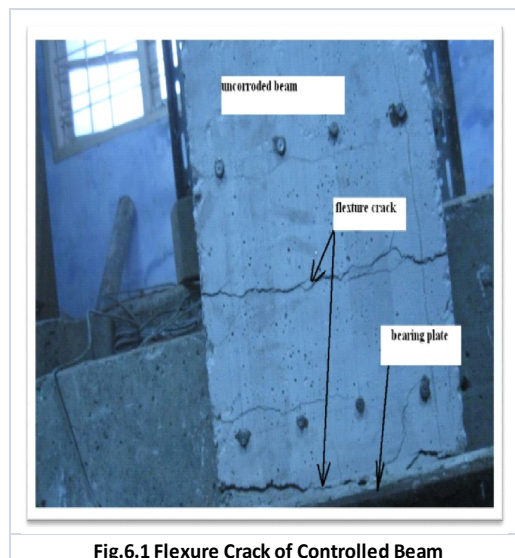
**Fig.6.1 Flexure Crack of Controlled Beam**

As the load was applied flexural cracks were initiated from the bottom of beam in the region of maximum moment. When the load beyond the yield strength of beam was applied, these cracks were widened and extended to the sides and new flexural cracks formed. As the applied load was further increased, cracks width increases and beam failed in flexure. The moment of resistance provided by the reinforcement was controlled by the anchorage (bond) of the bars and its magnitude was less than that provided by fully bonded reinforcement bars that yield at failure.

During the testing of control beam (CB1 to CB5), it was observed that the control beams failed in flexure at an ultimate load, 92.09 kN and for 2.5% corroded beams failed at a n ultimate load 87.83 k N remaining 5%, 7.5% corroded beams showing the failure at 86.17 k N, 72.14 kN respectively. As the load increases the cracks developed throughout the width of the beam. Fig 6.1 illustrates the failure modes of all beams. It was observed that controlled beam attained the highest flexural load capacity, followed by 2.5%, 5 %, 7.5%. Fig 6.2 shows the Deflection of beam after Flexure failure.

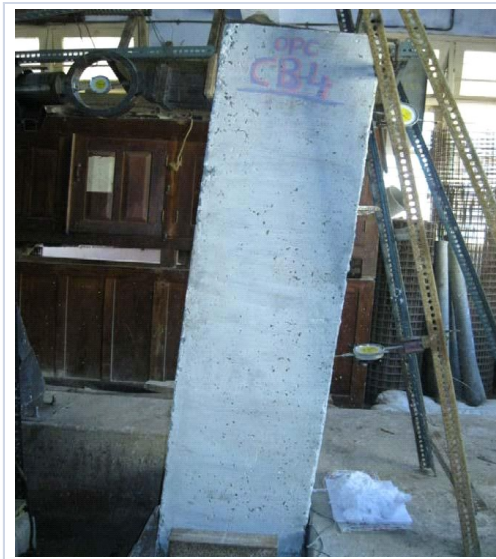
**Fig.6.2 Deflection of beam after Flexure failure**

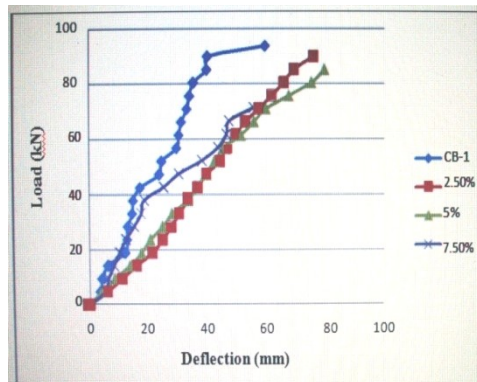
**Graph 6.1 Load vs. End Beam Deflection**

- It is observed that for Control Beams (i.e., Non-Corroded Beams), Peak load taken was maximum compared with 2.5%, 5%, 7.5%. Deflection observed for Control Beam was less than Corroded Beams.
- For Beams Corroded (i.e., 2.5%, 5%), the Peak load taken by Beams was less than Non-Corroded Beams, but the Deflection observed for Corroded Beams (2.5%, 5%) was more.
- It is observed that for 7.5% Corroded Beams, the Peak load taken by the Beam was less compared with (i.e., 2.5%, 5%), Control Beams and Deflection was also less.

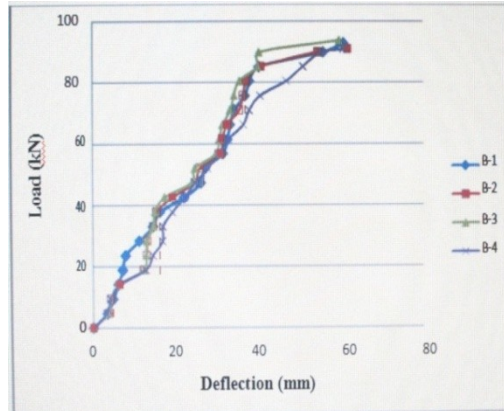
**Graph 6.2 Load vs. End Beam Deflection (Control Beam)**

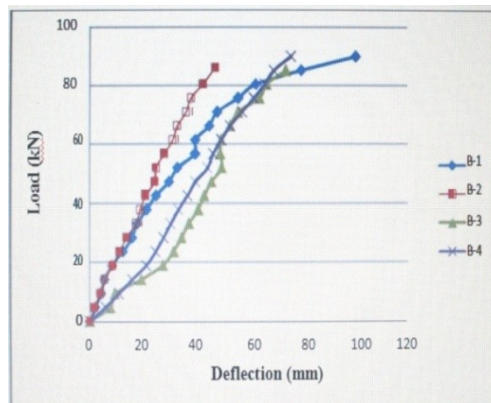
**Graph 6.3 Load vs. End Beam Deflection (2.5% Corroded Beam)**

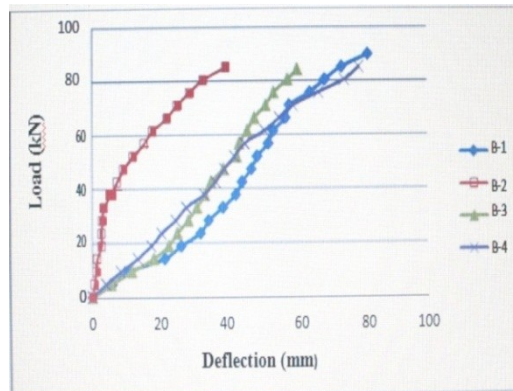
**Graph 6.4 Load vs. End Beam Deflection (5% Corroded Beam)**

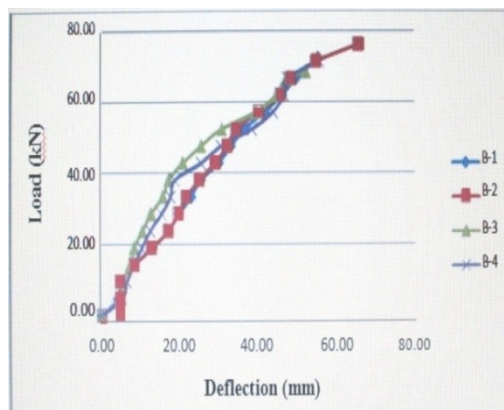
**Graph 6.5 Load vs. End Beam Deflection (7.5% Corroded Beam)**

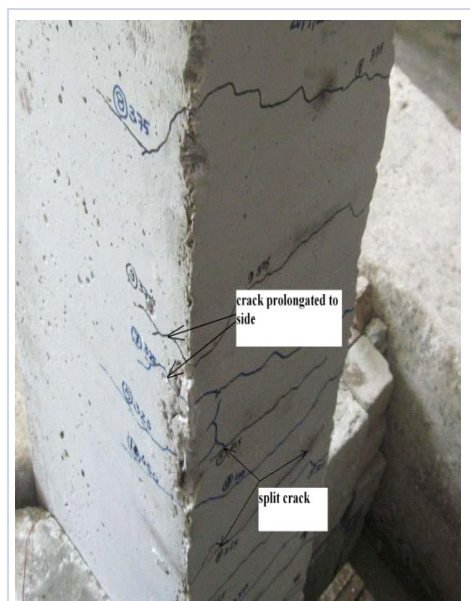
The effect of uniform corrosion, causing extensive cracking, staining and spalling of concrete cover. In this crack width measured using Crack Microscope with an accuracy of 0.02mm. The initiation of corrosion is likely to occur at the stirrup reinforcement surface which has the minimum concrete cover. In Corroded beams red and brownish-red colored rusts were observed in different amounts and at different locations. All corroded beams developed surface cracks. The crack pattern seen in Corroded specimen, the crack that propagated perpendicular to the corroded steel bars was observed on the extreme tensile face of the beam to where corrosion agents drawn into the concrete. These cracks were observed at intervals ranging from 72mm to 86mm intervals, from fixed end to a length of 450mm to 630mm towards the top. It is observed that some of the cracks as they propagate split into two and few such cracks cross the side face and propagate further. In this cracks split into two and the split cracks then crossed to the side faces and propagated and also perpendicular to the corroded bars. The majority of beams in this research (uncontrolled) exhibited this crack pattern. As the load increases crack width also increases. In case of controlled beam, at the extreme tensile face only some cracks are split in to two and the cracks were observed from fixed end to a length 220mm to 400mm towards the top. In control beam (0%) the first cracks observed at the load 37.87kN, the maximum crack width is between 0.40 mm and 0.5 mm and in 2.5% corroded beam specimen, first crack developed was similar to controlled specimen and the maximum crack varies 0.45mm to 0.50mm. 5% beam specimen develop the first crack at load 37.87kN, here crack width increased 11% than the controlled specimen. In 7.5% corroded specimen shows the first crack width at the load 33.14kN, in this out of four specimen one specimen crushed at the bottom, maximum crack width varies 0.55mm to 0.58mm it was observed that this crack 17% more than the controlled specimen. Corrosion crack pattern of corroded specimen as shown in Fig 7.1

Fig.7.1 Tension cracks pattern in the Corroded Beam
