New Technique for Partial Continuity of Simple Support Beam-Column Connection

Abstract: *This paper presents new technique to develop the precast concrete beam column connection to be capable of mobilizing the beam's negative moment and relieve percent of the direct reaction from column corbel to be direct transfer to the column core.*

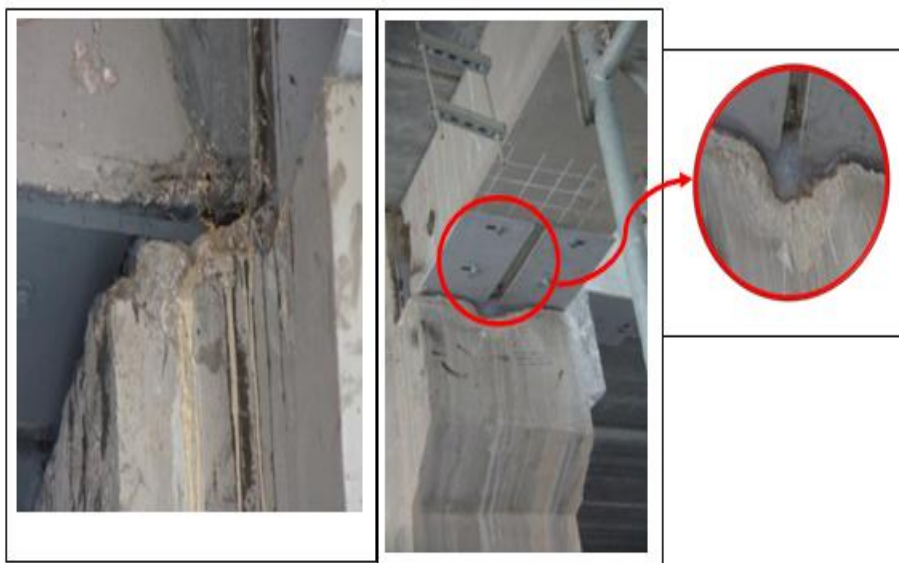
Fig.1 Corbel shortfall reinforcement detailing.

- 1- To introduce partial continuity along beam-lines within the completed structures- by enhancing the structural topping reinforcement details, and by infilling the gaps between beam ends and column faces with grout.
- 2- To effectively extend the beams closer to their supporting columns by introducing extension steel plates to the bottom of the beams by creating a shear key within each beam end, as shown in Fig. 1.

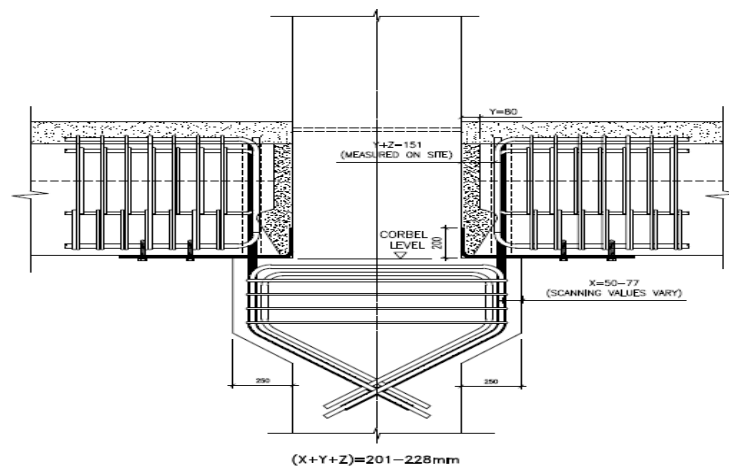
Fig. 2 Corbel deviations' parameters

- 1- Cover between corbel-face and down-turned primary corbel bars greater than shown on drawings
- 2- Gap between end of beam and face of column larger than intended.
- 3- Cover between beam-end and up-turned beam bars greater than shown on drawings.
- 4- Cover between top of corbel and primary reinforcement greater than intended.
- 5- Cover between sides of corbel and primary corbel reinforcement greater than intended.

These factors, or combinations of them, could reduce the actual capacities of some of the corbels further. They could also result in premature local spalling of concrete of the outer edges of some corbels. Critical to the overall load-carrying performance of the corbels are the above points (1, 2, 3); as shown in Figure.2.

- X= Cover between corbel-face and down-turned primary corbel bars. [measurable by Ferro scan]
- Y= Gap between end of beam and face of column. [measurable by tape measure]
- Z= Cover between beam-end and upturned primary beam bars. [measurable by Ferro scan]

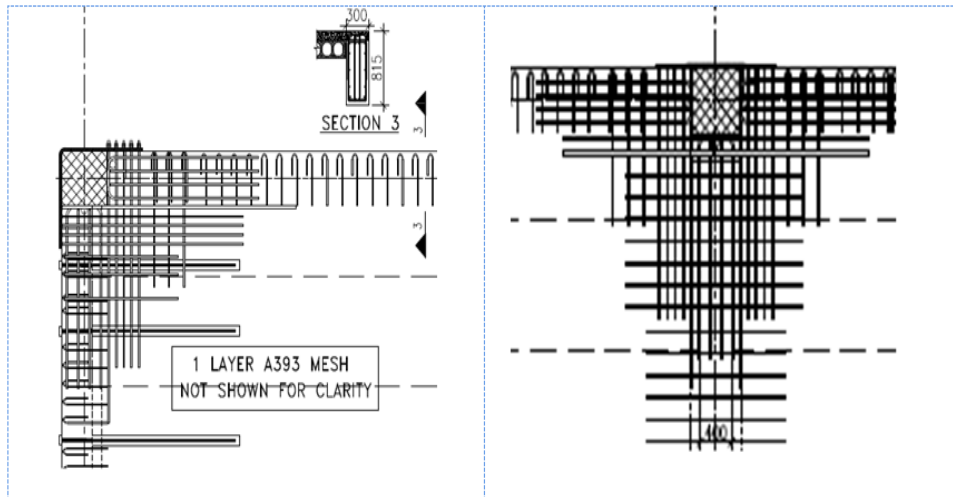
Fig. 3 the new proposed steel reinforcement details in structural topping for corner and internal column for partial continuity, respectively.

- The magnitude of the value of the horizontal compression towards the bottom of the section- acting between the beam end and the column face.
- The length of compression zone established by determining the distance from column face at which the overall bending moment is zero.
- The new reinforcement details are presented clear as shown in Fig.3 to show the new proposed steel reinforcement details in the structural topping for corner and edge column, respectively.

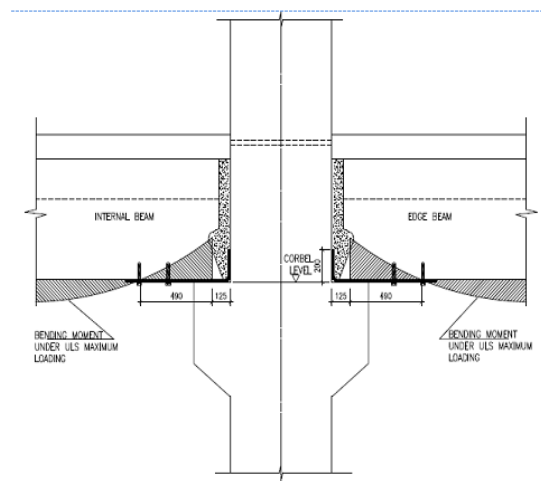
Fig. 4 Section elevation of new corbel beam connection to create partial continuity.

As shown in the Figure 4, with shear key and imbed steel plate, It can be consider that a beam is able to deliver its vertical shear to appoint that is slightly short of the intended support. The aim of the additional measure is therefore to transfer this shear from the point of action of shear to the intended point of support. The distances by which this shear needs to be extended is only of the order of 100mm to 150mm. it is proposed that the additional force transfer be achieved by creating a mini strut and tie system. The main components of this mini strut and tie system are as follows:

- Thrust key formed in the end of the installed beam to allow the strut to direct the compression into the body of the beam at an angle to the vertical.
- Tie constructed from bent steel plate.
- Bolts or bonding connecting bent late to underside of beam.

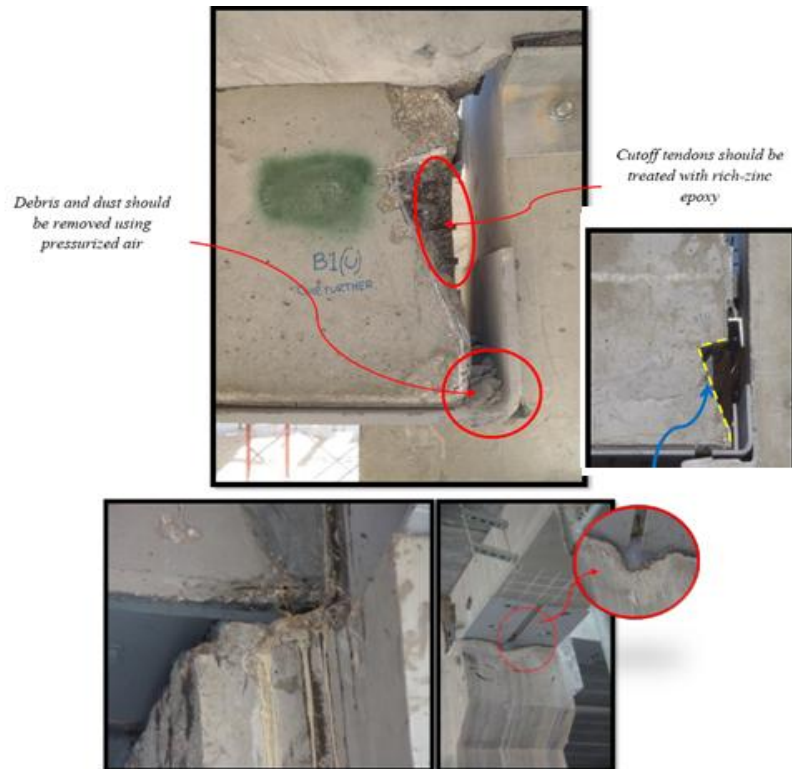
Fig. 5 Installation of steel plate with shear key shape at end of beam.

Figure 5 viewed real photos for the additional measure can be considered as a simple extension of the bottom-reinforcement towards the intended support-point of the beam, and an extension of the shear strength of the beam by means of a strut, working in conjunction with the plate-extension.

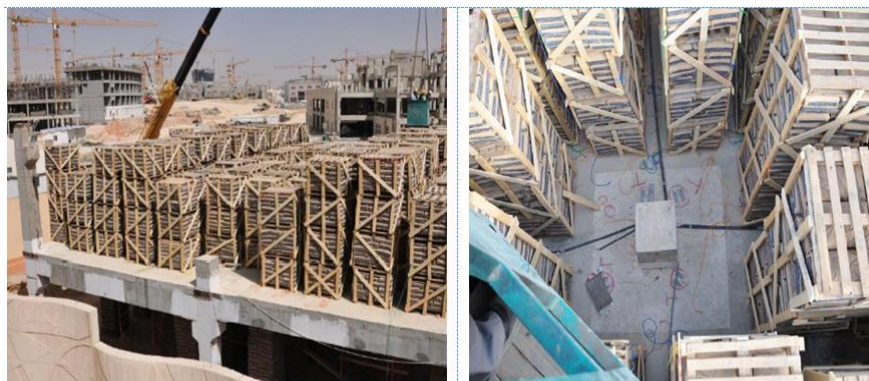
Fig. 6 Loading of the Mockup Structure

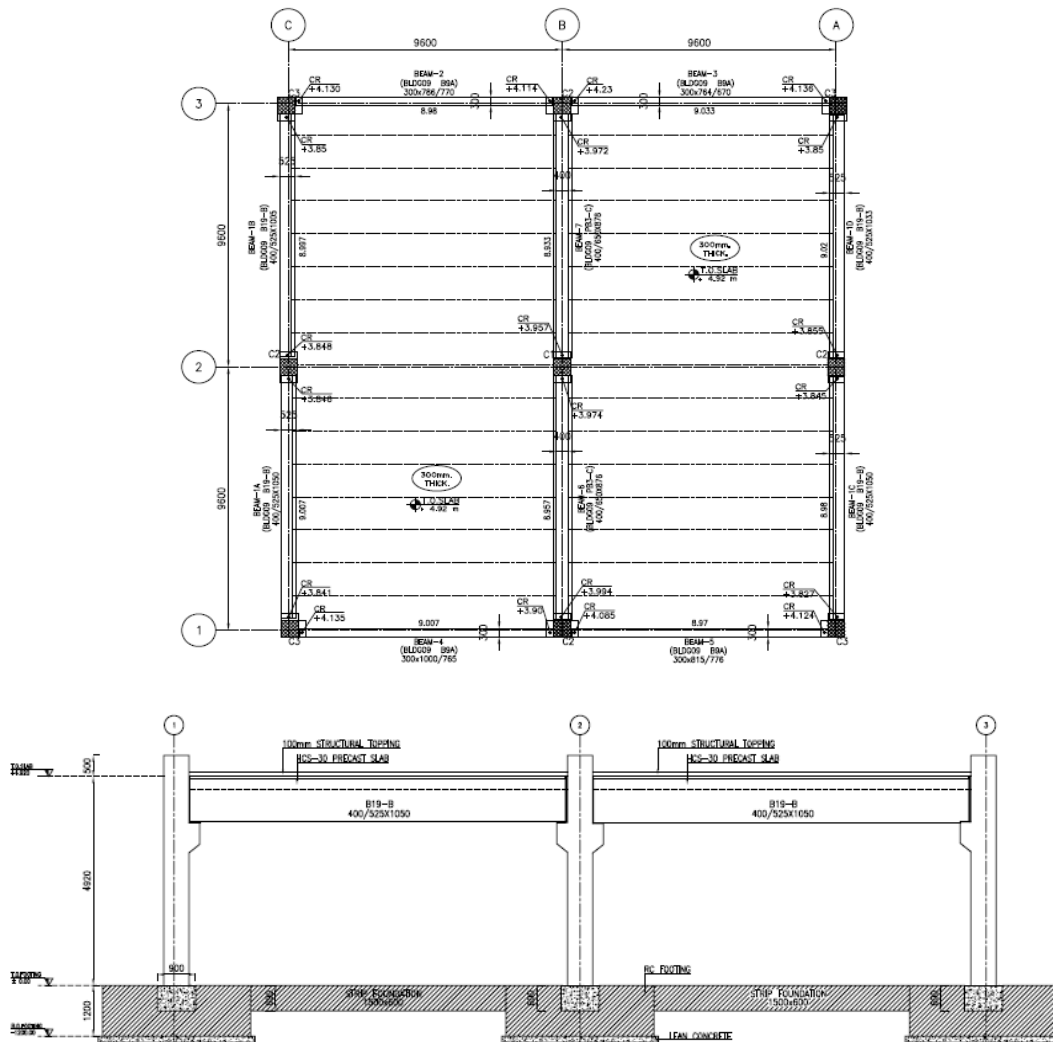
Fig. 7 Plan and elevation cross section of tested Mockup sample, respectively.

Figure 7 presents plan and section elevation of tested mockup sample, all precast elements columns and beams that was used in the construction of this mockup sample was selected from the rejected elements that has defects on corbel reinforcement details and beams. Hollow core slabs, selected from the same supplier but its not erected before to be sure it has the efficiency to resist applied load with the design pre camber value as per the original design.

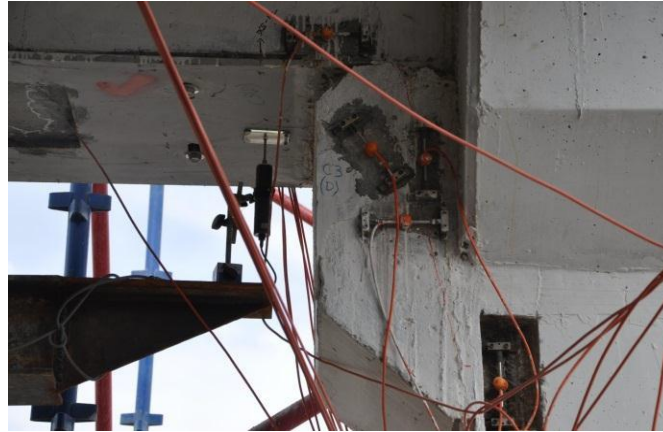
Fig. 9 photo of fixation displacement and inclinometers for interior and external beams.

Figures 8 and 9 present locations and real photos for the fixation of displacement and inclinometers for interior beams and non edge beams, respectively. The inclinometers was used at beam column connection to measured any rotation angle where it is very important to inspect the negative moment by mathematical integration to

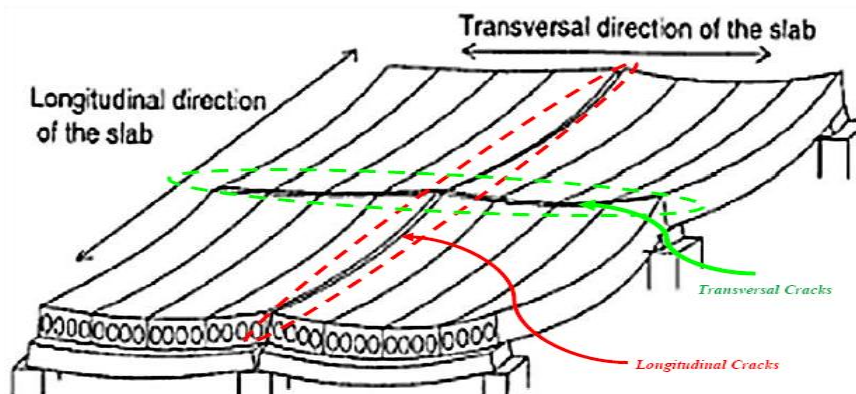
Fig. 10 Longitudinal and Transversal Cracks Formation at the HCS and Beam Interface.

After unloading of the majority of loading stage, three types of cracks were visually observed; namely (i) transversal (parallel to the beams axes as shown in Figure 10), (ii) longitudinal (parallel to the HCS axes – Figure 10) and (iii) diagonal cracks around the column perimeters (refer to Fig.11). The transversal cracks were developed along the junctions between the hollow cores and the main girders. When the floor is loaded, both the HC slabs and the beams deflect. The mid-span deflection of the slabs depends on stiffness of both the supporting beams and slabs (see Figure 10). It is anticipated that the formation of the transversal cracks may result in a decrease in composite action. These transversal cracks usually developed due a combined effect of shrinkage of the topping materials (at these junction locations) and end rotations of the hollow cores under loading.

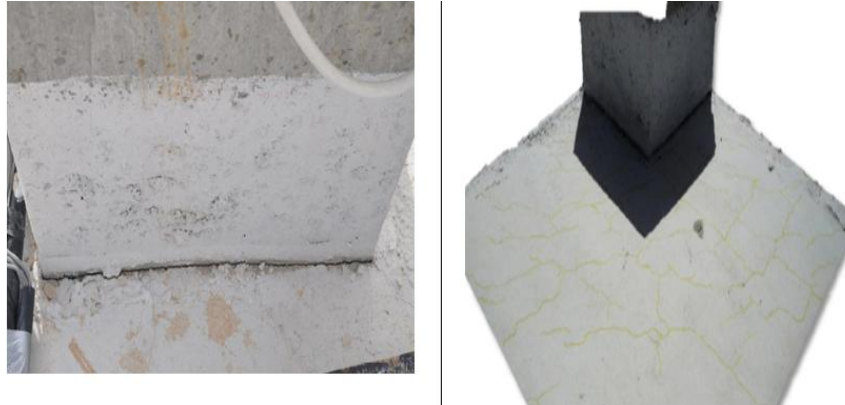
Fig. 11 Example of Crack Pattern of the Mockup Top Floor around the Column

As shown in Figure 11, two crack lines at the girder boundaries initiated at the column edges were observed with sizes ranged from 0.1 to 0.4 mm in different locations.

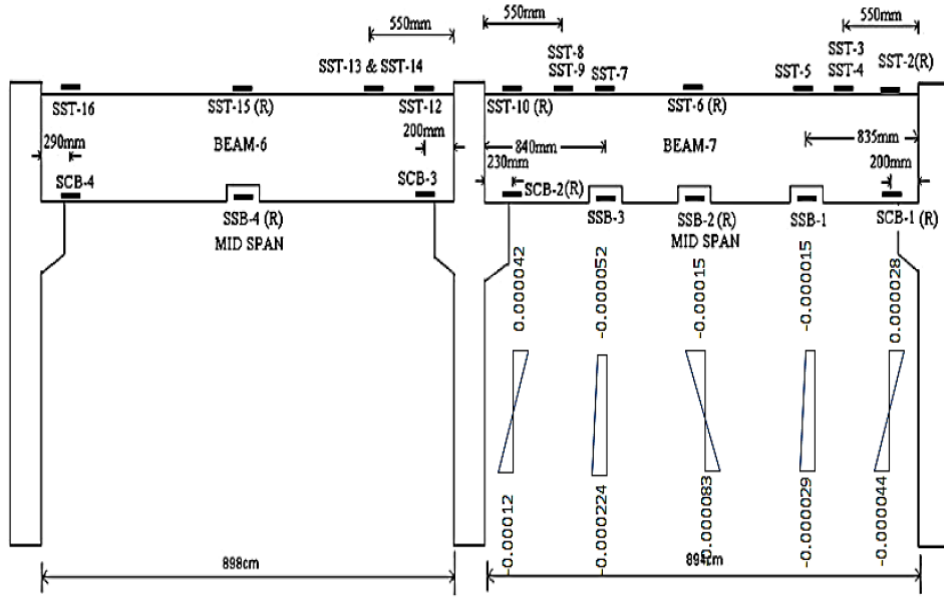
Fig.12 Strain distribution for external beam at different locations along beam length.

Figures 12 and 13 show the strain distribution for both the interior beams and edge beams. Unlike deflection and rotation recorded measurements, strain values gathered from the mockup tests were fluctuating and in some instants inconsistent. In order to evaluate the strain sensors used in the mockup test, tests were performed on standard steel rebar that were instrumented by both vibrating wire strain sensors as well as electrical strain sensors to check if the vibrating wire sensors were malfunctioning. Laboratory test results indicated that both sensors readings were similar that verified that the vibrating wire sensors used in the mockup structure tests had no technical problems. So, the variation can be attributed to several issues including the relatively very low strain level of both the beams and corbels with high stiffness design sections, temperature effects, and the influence of ambient vibration from cranes, equipment generated at the site on the performance of the vibrating wires sensors.

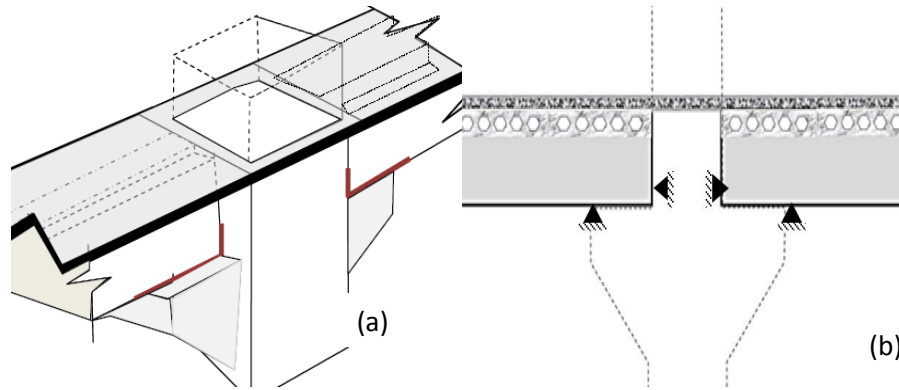
Fig.14 (a, b) An Isometric Showing the Edge Tie Plates (Surrounding the Column to create Partial Continuity Load Path), that Connect the two adjacent Beams

This applies to both interior and exterior cases as shown in Figure 14b, extrapolation was used to predict the hogging moment based on the aforementioned assumptions. The partial physical continuity is provided by a two-dimensional (2D) edge tie plates. This edge tie plates are these portion of the specially reinforced concrete topping. The assumed statistical system of this complex system is illustrated in Fig.14b.

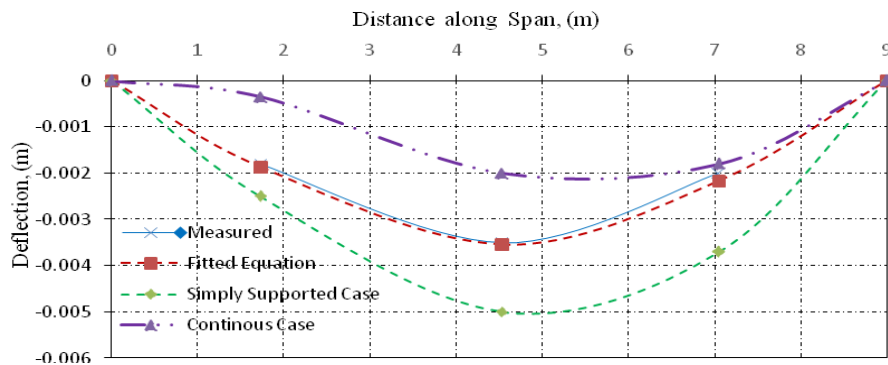
Fig. 15 Deflection beam value of continuous, simply, numerical, and measured beam value of mockup sample.

Deflection, Rotation and Curvature: Figure 15 shows the elastic curve (deflection profile) of internal Beam at the Loading case1 Condition. Using regression analysis, a best fit equation was derived for the deflection elastic curve as shown in the Figure 15. By differentiating this equation once, one can obtain the equation for the slope angle, i.e.:

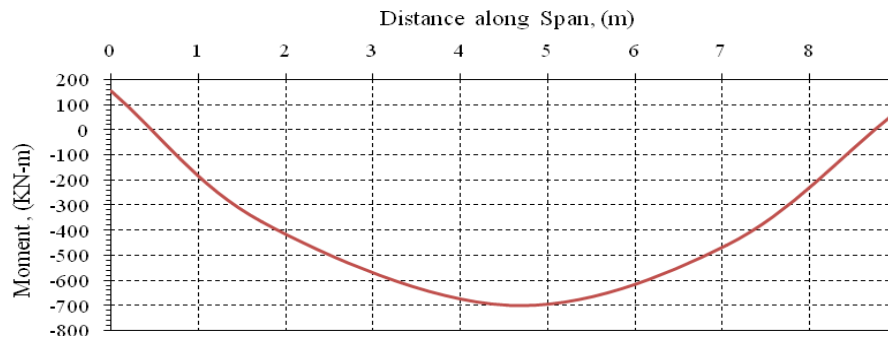
Fig. 16 Predicted moment of internal beam under loading case 1.

Table (3) presents the different values of y' , y'' , y''' , and moment value for internal beam, while the predicted moment values are illustrated graphically in Fig.16. Now, differentiating the elastic curve (deflection) equation four times, y'''' is determined (refer to Equation 3). Knowing the value of actual applied load on the mockup structure at this loading case, a realistic (as-built) value of the beam flexural stiffness (EI) can be estimated.

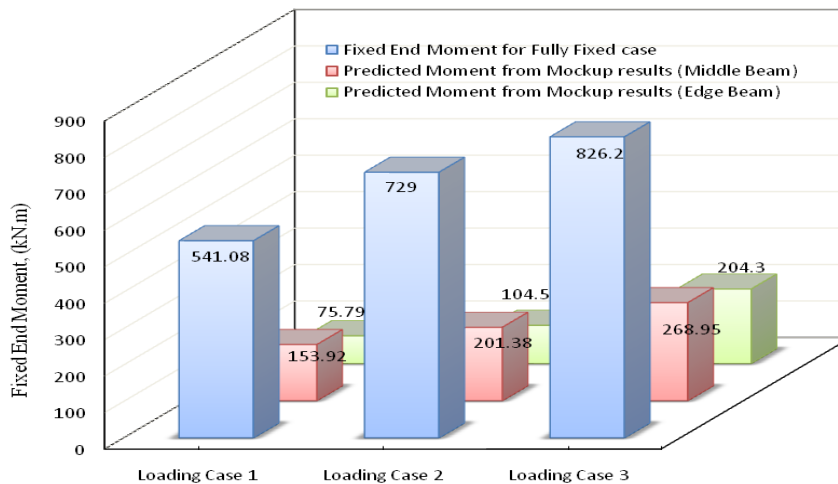
Fig. 17 Comparison between fully fixed end moment beam to middle, and edge beam, respectively; under different loading cases.

Figure17 is bar columns presents the fixed end moment for full continuous beam compared to the predicted end moment measured from mockup sample (partial continuous beam), of mid and external beams

respectively. The moment value for mid beam is higher than the edge beam where the partial continuity for the mid beam is more improved than the edge one; which is expected. As shown in Figure 17 Fixity ratio was about 28% up to 37% depend on the load cases for mid beam where the fixity ratio of edge beam for the same load cases about 14% to 25%.
