Study on Structural Failures and Remedial Measures

Dr.G.Baskar "Study on Structural Failures and Remedial Measures "IOSR Journal of Mechanical and Civil Engineering (IOSR-JMCE) , vol. 15, no. 3, 2018, pp. 15-20

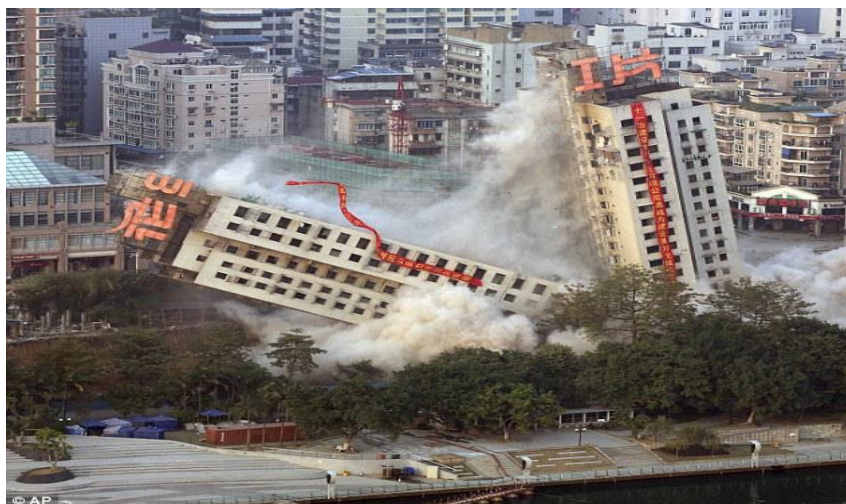
Figure 1.1 Splitting of a tall structure into two portions in a vertical manner at Oogue at Siberia

The history of failure of structures started from very olden time from 300A.D. and continues till date. Figure 1.1 shows the splitting of a tall structure into two portions in a vertical manner at Oogue at Siberia. One more example is the failure of World Trade Centre at New York by air crash.

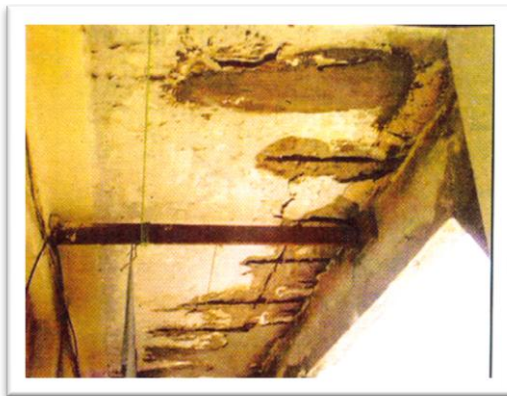
Figure 1.2 Corrosion of steel and Spalling of concrete in a RCC canopy.

The failures in building like Cracks, Dampness, Leakage and Spalling shows the weakness of building. That is the way of talking of a building to a Civil Engineer as a patient talks to a Doctor about his/her illness. So we have to take care of the buildings. Some of the examples of failures are shown the Figures 1.2, Figure 1.3 and Figure 1.4.

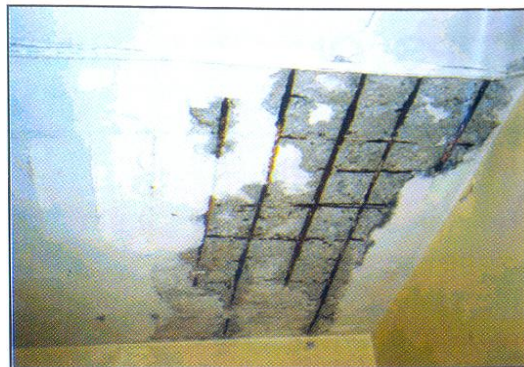
Figure 1.3 Corrosion of steel and Spalling of roof concrete on a slab

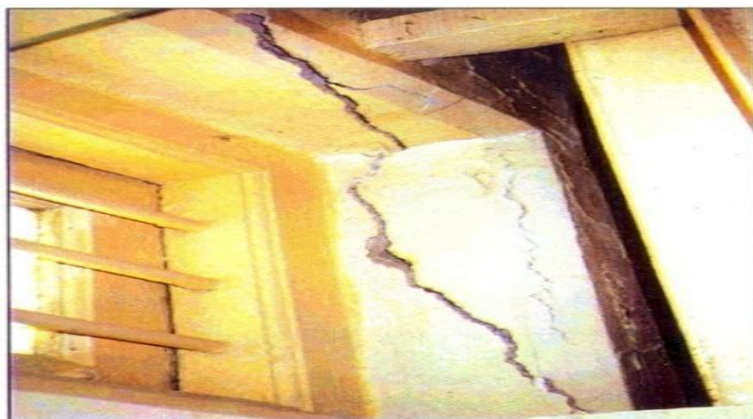
Figure 1.4 Crack in concrete due to corrosion of steel

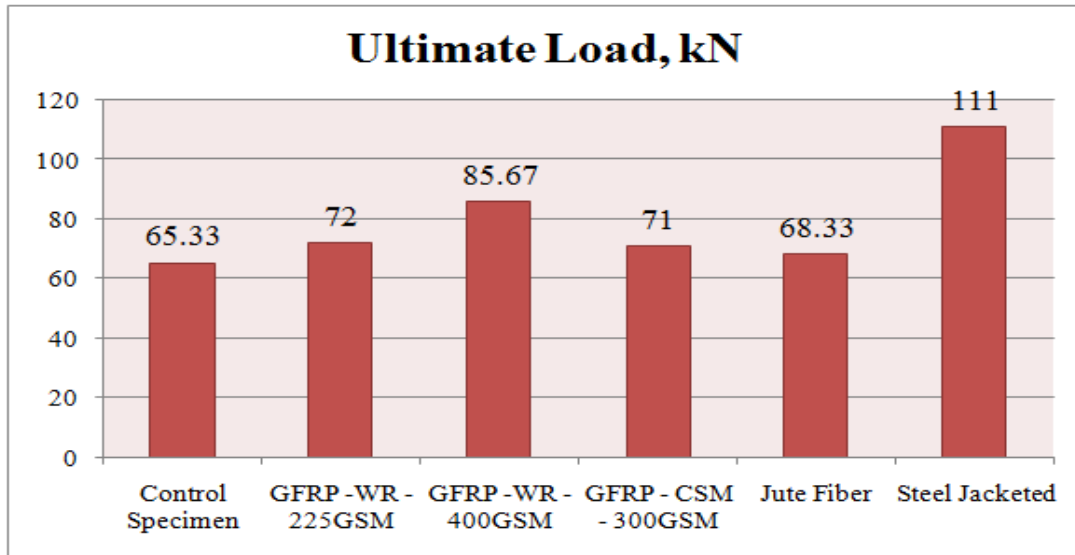
Load comparison for Rehabilitation method is as shown in Figure 3.1.

Figure 3.1 Load Comparison for Rehabilitation Method.

- Control Specimen – 65.33kN
- Method – 72 kN
- Method – 85.67kN
- Method – 71kN
- Method – 68.33kN
- Method – 111kN

As for as Strength is concerned Steel Jacket method is found to the best.

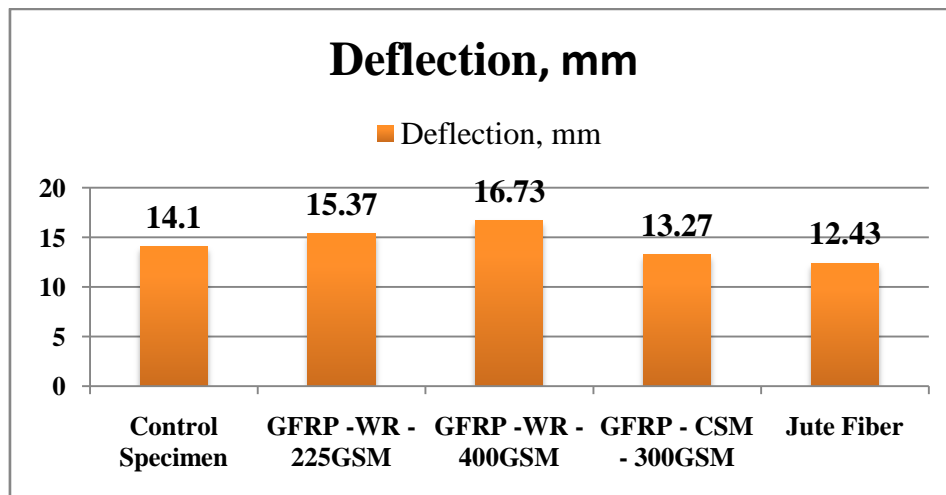
The deflection of the rehabilitated beams is compared with the control Specimen. The comparison is made and it is charted in Figure 3.2.

Figure 3.2 Deflection Comparison of Rehabilitated Beam

As per deflection concept Jute Fiber gives the lowest Deflection.
