Effects of the Quality of Facilities on Residential Building and Environmental Sustainability in the LSDPC Low-Cost Housing Estate Iba, Lagos State.

Ajetomobi, Oludare Olayinka¹ and Fagbhoun, Philip Oluwole²

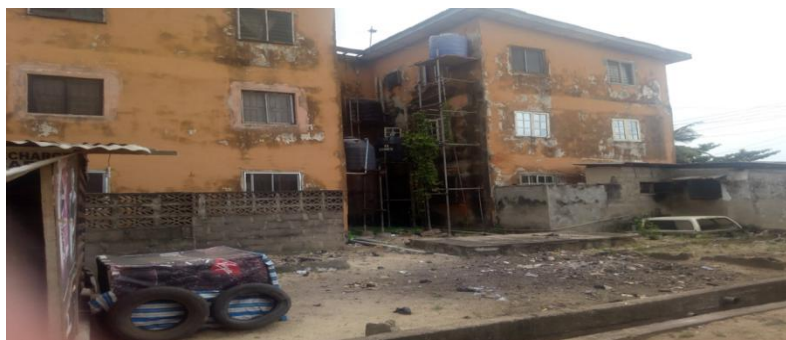
Plate 1: A Typical Building Provided with Water Facilities Using Different Methods

The reason why the case of households' water facilities was like that is because there was no public water, particularly, pipe born water. The only public water, a borehole provided by the Federal Government, under the Ogun-Osun River Basin water scheme was not functioning. Hence, 63.37% (64) of the sampled buildings have access to borehole, while 36.63% (37) have access to well. It was observed that each apartment has their different water facilities, provided by individual households. This made the provision of these facilities uncoordinated, and was not constructed in accordance with the building plan, as shown by the picture in Plate 1. However, Plate 2 shows illegal installation of such facilities as air conditioners, television decoder signaling system, and other illegal developments.

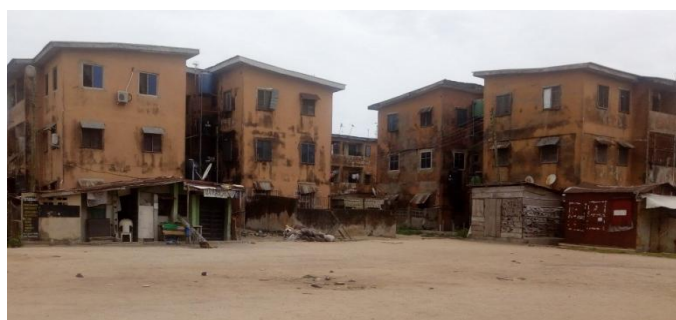
Plate 2: Illegal Installation of Air Conditioners, Television Decoder Signaling System, Water Tank

The study discovered that 42.57% of the buildings inspected have their pipes for liquid waste disposal in good condition, while 57.43% have their own broken and in bad condition. In case of households' water, 37.62% of the sampled buildings have their water pipes in working and in good condition, while 62.38% have their own broken and in bad condition. Because of this situation, 62.38% of the sampled buildings have their structures, including foundations under threat, due water and wastewater leakages, overflowing on the sampled building walls. This has resulted in weakening of building walls and foundation.

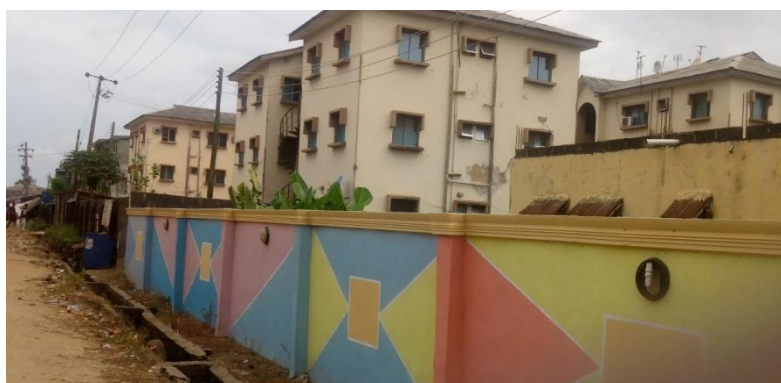
Plate 3: New Blocks of Flats in Iba Housing Estate

The reason for the present condition of these facilities was because of the quality of installation. As shown in Table 7, it was only .32.67% of the sampled buildings that have their water connection pipes properly installed, while 67.33% were not properly installed. In the case of liquid waste or sewage pipes, 45.55% were properly installed, while 54.46% were not properly installed. Majority of buildings that have these 2 facilities under investigation properly installed could be found in the new buildings, as shown by Plate 3.
