## **Effect of Recycle Waste Fine Aggregate Replacement on Strength and Corrosion of Steel Bars Exposed to Various Environmental Conditions of Polypropylene Fiber Concrete**

### **Abstract:**

## II. Research Significance

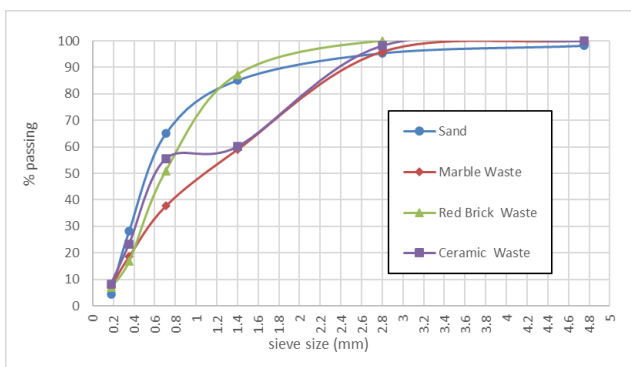
**Fig. 1:** Sieve Analysis of Sand and Recycle Wastes.

1. Sieve analysis of sand and coarse aggregate as shown in **Fig. 1** and **Fig. 2**.
2. Sieve analysis of recycle material (marble waste, red brick waste and ceramic waste) is shown in **Table 1** and **Fig.1**.
3. Maximum aggregate size of coarse aggregate and fineness modulus of sand as shown in **Table 2**.
4. Specific gravity of coarse and fine aggregate as shown in **Table 2**.
5. Unit weight of coarse and fine aggregate as shown in **Table 2**.
6. Properties of recycle material (Marble waste, Red brick waste and Ceramic waste) as shown in **Table 3**.
7. Properties of Polypropylene fibers (PF) from Sika company in **Table 4**.
8. The reinforcing steel bars were used  $\Phi 12$  as longitudinal steel reinforcements. The yield strength of main reinforcement was 360 MPa.

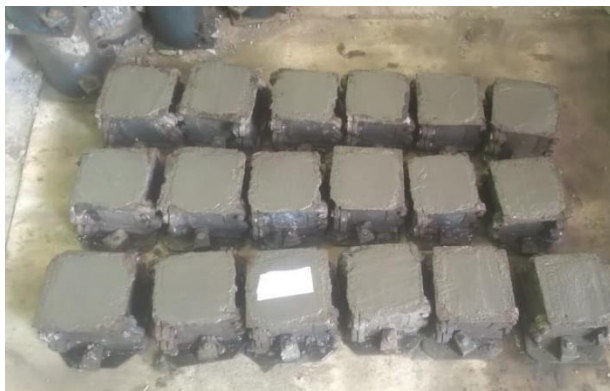
**Fig. 3:** Cubes (100 ×100 ×100 mm) During Casting

The experimental program of this study involved testing of 150 cubes (100 ×100 ×100 mm) as shown in **Fig. 3**, 150 cylinders (70 ×100 mm) as shown in **Fig. 4**.

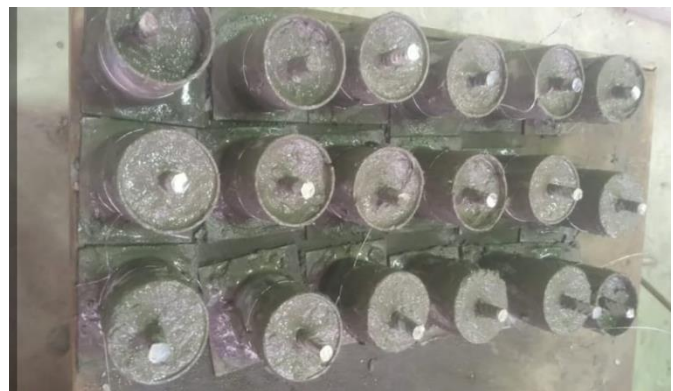
**Fig. 4:** Cylinders (70 ×100 mm) During Casting

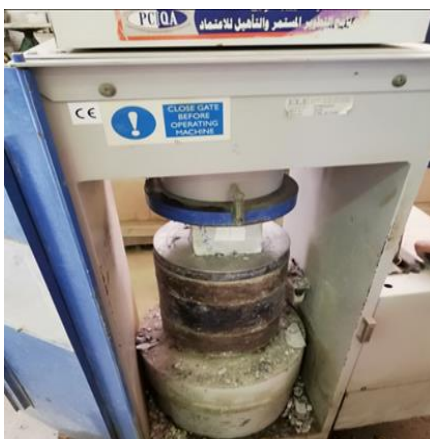
**Fig. 4:** Cube (10 × 10 ×10 cm) during Compressive Strength test

For compressive strength test, prepared 30 cubes specimens for each mix, of dimensions 100 × 100 × 100 mm were cast. After 24 hours specimens were demolded and were transferred to curing tank in pure water (15 cubes for each mix) and sea water (15 cubes for each mix) where they were allowed to cure for 28, 60, 90 days, 180, and 270 days. These specimens were tested in compression testing machine (shown in Fig. 4). In each category, for each mix 3 cubes, their average value is reported by using following form:

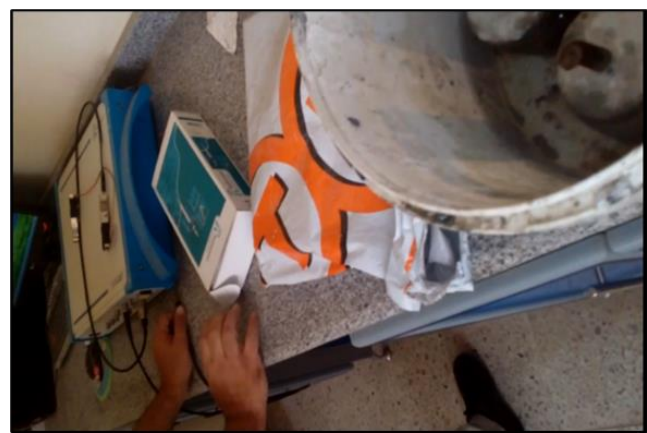
**Fig. 5:** Cylinder (7 × 10 cm) During Measuring Corrosion

Cylindrical specimens (70 mm in diameter and 100 mm in length) with rebar in its middle (12 mm in diameter and 100 mm in length) were to assess the corrosion rate. Cylinders were cast with the mix, and the rebar was placed vertically, in the middle, and parallel to the long side of the mold. The mix was filled in layers by ensuring it was distributed evenly, and the mold was compacted in the vibrating table. Samples were de-mold after 24 h and cured in the specified water (either in fresh water or sea-water) for 28, 60, 90 days, 180, and 270 days.

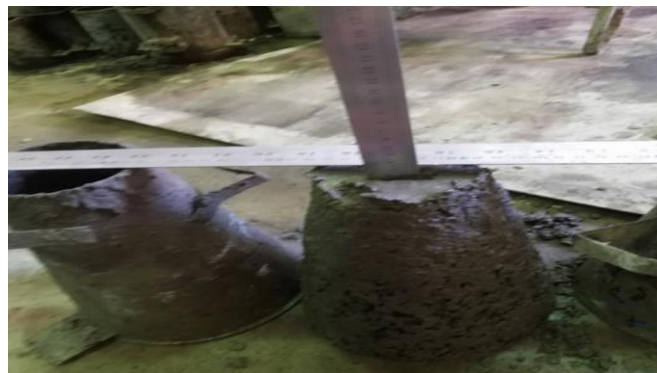
For measure the consistency of each fresh mix and compare between conventional mixes and others include recycle waste, slump test has performed. Tools for slump test essentially consist of a metallic mold on the form of a cone having internal dimensions of 20 cm diameter bottom, 10 cm diameter top and 30 cm in height. The mold is placed on a smooth, horizontal and non-absorbent surface. The fresh test sample of concrete is taken from the pan mixer immediately after mixing and is placed into the cone mold at three layers. Each layer is compacted 25 times by a standard tamping rod. Slump is measured immediately by determining the vertical distance between the height of the mold and that of highest point of the specimen being tested as shown in **Fig. 6**.

**Fig. 6:** Slump Test.

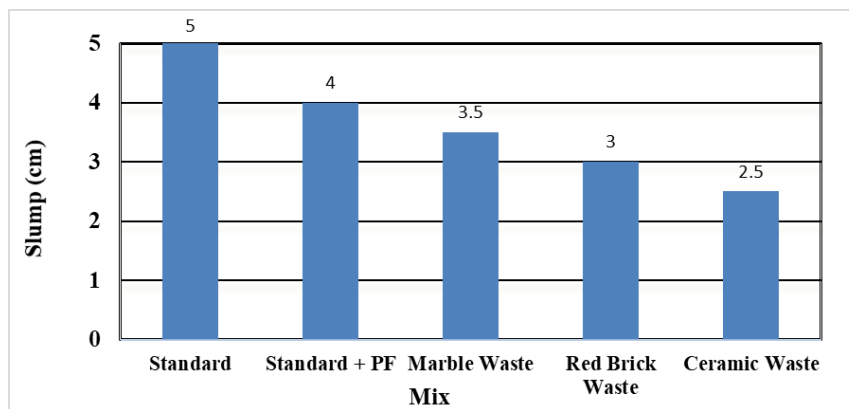
Results of slump test for sand replacement with marble waste, red brick waste and ceramic waste mixes is shown in Fig. 8. The results indicated that, slump value is reduced with sand replacement with different wastes.

Fig. 8: Slump Test for Recycle Sand Replacement.

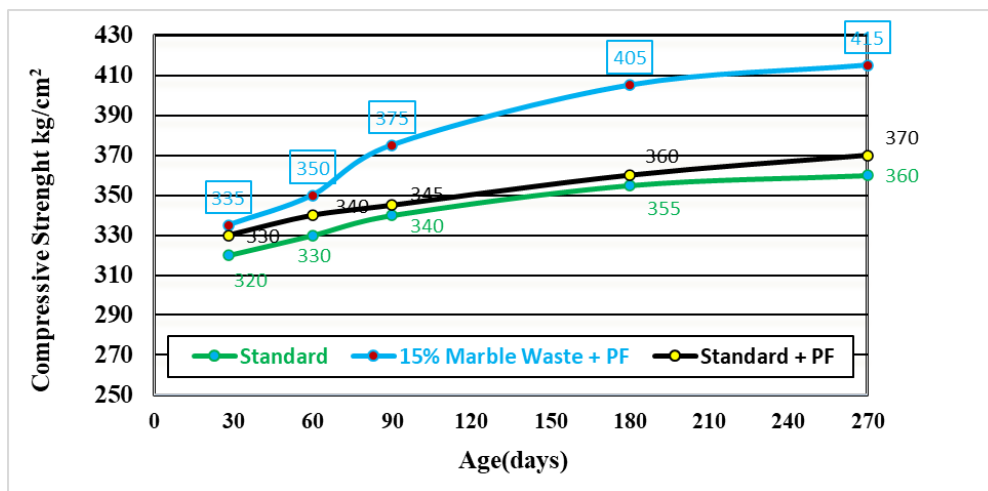
Table 6 and Fig. 10 show compressive Strength Variation at 28, 60, 90, 180 and 270 days for standard mixture, standard with PF, and marble waste sand replacement of samples immersed in pure water. The results demonstrated that: -

- Compressive strength is increased with increase of concrete ages.
- Compressive strength for Polypropylene fibers (PF) samples without sand replacement (100 % sand) are larger than that of standard samples (without PF).
- Largest increase in compressive strength occurs for mixes with PF and 15% marble waste replacement.

Fig. 10: Compressive Strength Variation for Marble Waste Sand Replacement, Standard and Standard with PF for Samples Immersed in Pure Water at Different Ages.

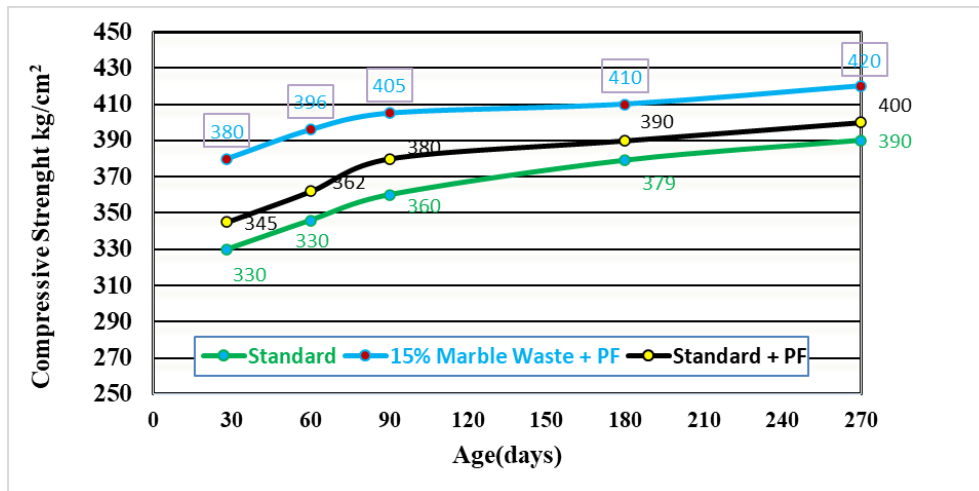
Table 7 and Fig. 11 show compressive Strength Variation at 28, 60, 90, 180 and 270 days for standard mixture, standard with PF, and marble waste sand replacement of samples immersed in sea water. The results demonstrated that: -

- Compressive strength is increased with increase of concrete ages.
- Compressive strength for Polypropylene fibers (PF) samples without sand replacement are larger than that of standard samples (without PF).
- Largest increase in compressive strength occurs for mixes with PF and 15% marble waste replacement.

**Fig. 11:** Compressive Strength Variation for Marble Waste Sand Replacement, Standard and Standard with PF for Samples **Immersed in sea Water** at Different Ages.

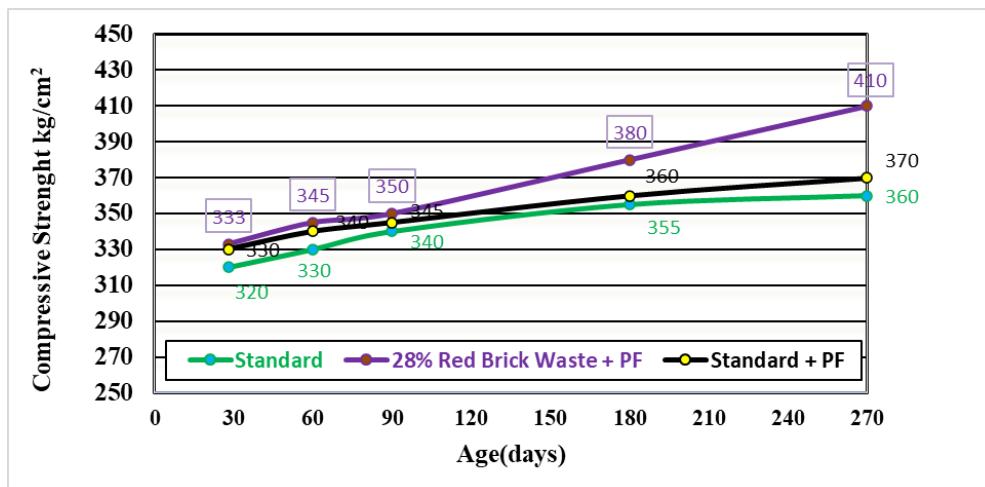
**Fig. 12** shows compressive Strength Variation at 28, 60, 90, 180 and 270 days for standard mixture, standard with PF, red brick waste sand replacement of samples **immersed in pure water**. The results indicate same trends and observations of marble waste sand replacement.

**Fig. 12:** Compressive Strength Variation for Red Brick Waste Sand Replacement, Standard and Standard with PF for Samples **Immersed in Pure Water** at Different Ages.

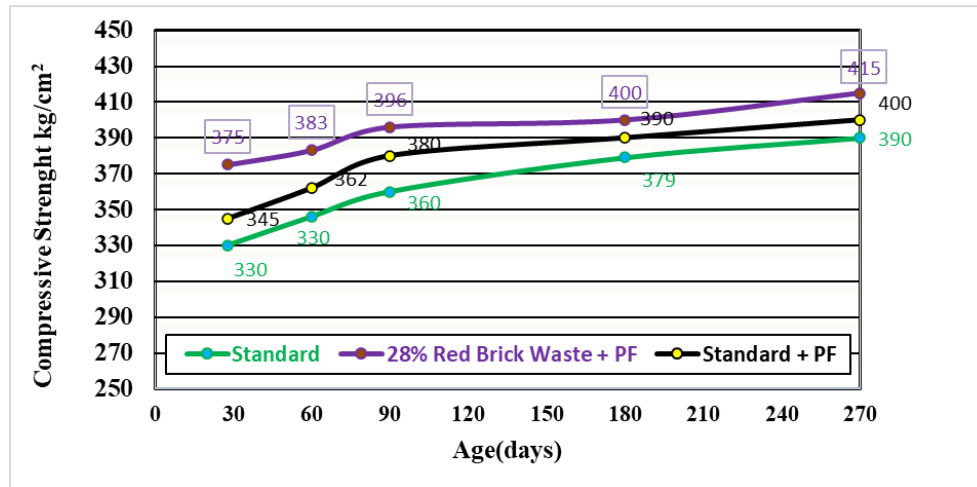
Fig. 13 shows compressive Strength Variation at 28, 60, 90, 180 and 270 days for standard mixture, standard with PF, red brick waste sand replacement of samples immersed in sea water. The results indicate same trends and observations of marble waste sand replacement.

Fig. 13: Compressive Strength Variation for Red Brick Waste Sand Replacement, Standard and Standard with PF for Samples Immersed in Sea Water at Different Ages.

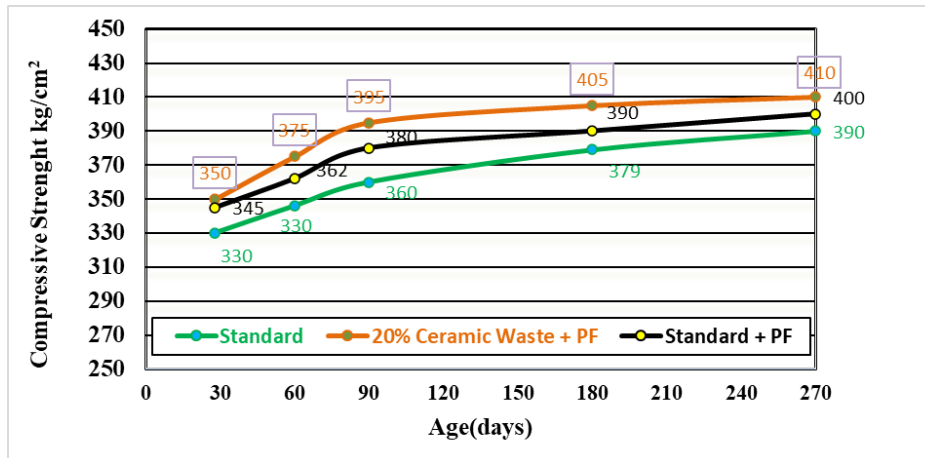
Fig. 15 shows compressive Strength Variation at 28, 60, 90, 180 and 270 days for standard mixture, standard with PF, ceramic waste sand replacement of samples immersed in sea water. The results indicate same trends and observations of marble waste and red brick waste sand replacement.

Fig. 15: Compressive Strength Variation for Ceramic Waste Replacement, Standard and Standard with PF for Samples Immersed in Sea Water at Different Ages.

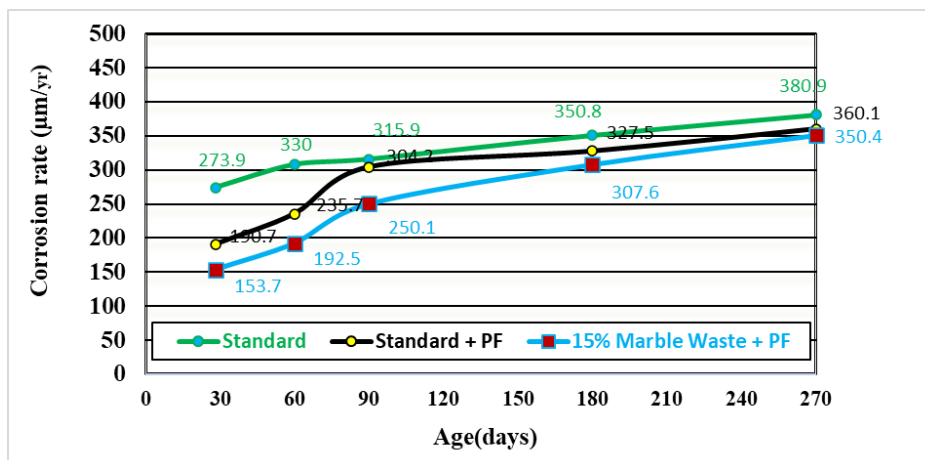
From Table 8 and Fig. 16 show corrosion rate values at 28, 60, 90, 180 and 270 days for standard mixture, standard with PF, marble waste sand replacement of samples immersed in pure water. It is clear that from the given results, the corrosion rate values increased with the increase of concrete age. Also, the corrosion rate at all ages is decreased with PF samples than that of standard mixes (without PF) and the smallest corrosion rate values occurs for polypropylene fibers concrete samples with marble waste sand replacement.

Fig. 16: Corrosion Rate Variation for Marble Waste Sand Replacement, Standard and Standard with PF all Samples Immersed in Pure Water at Different Ages.

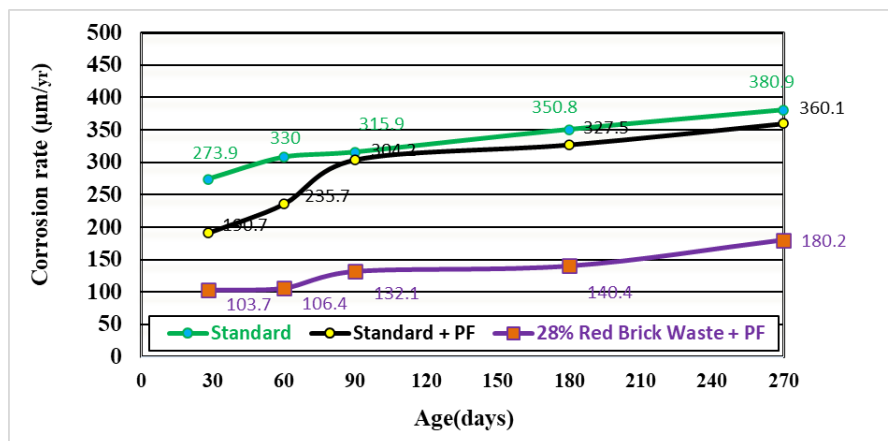
Fig. 18 shows corrosion rate values at 28, 60, 90 and 270 days for standard mixture, standard with PF, red brick waste sand replacement of samples **immersed in pure water**. The results indicate that, same trends and observations of marble waste sand replacement samples.

**Fig. 18:** Corrosion Rate Variation for Red Brick Waste Sand Replacement, Standard and Standard with PF for Samples **Immersed in Pure Water** at Different Ages.

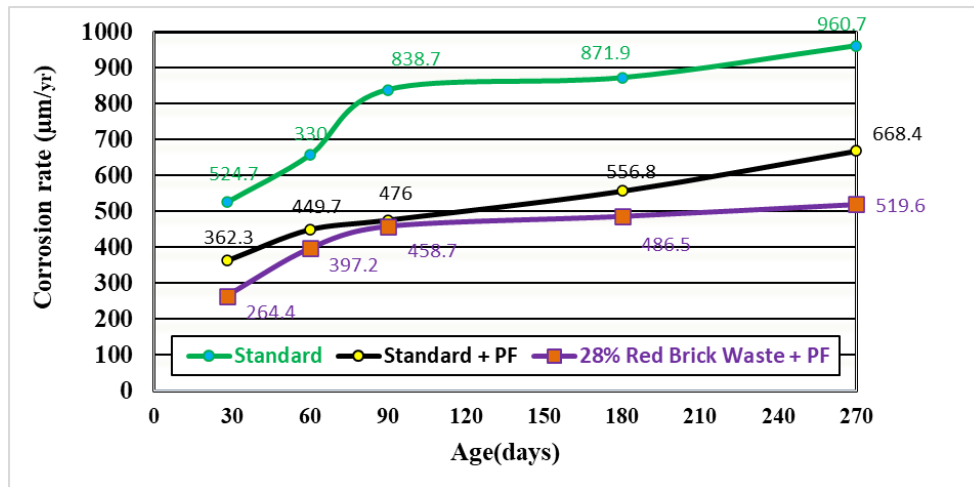
Fig. 19 shows corrosion rate values at 28, 60, 90, 180 and 270 days for standard mixture, standard with PF, red brick waste sand replacement of samples immersed in sea water. The results indicate that, same trends and observations of marble waste sand replacement samples.

Fig. 19: Corrosion Rate Variation for Red Brick Waste Sand Replacement, Standard and Standard with PF for Samples Immersed in Sea Water at Different Ages.

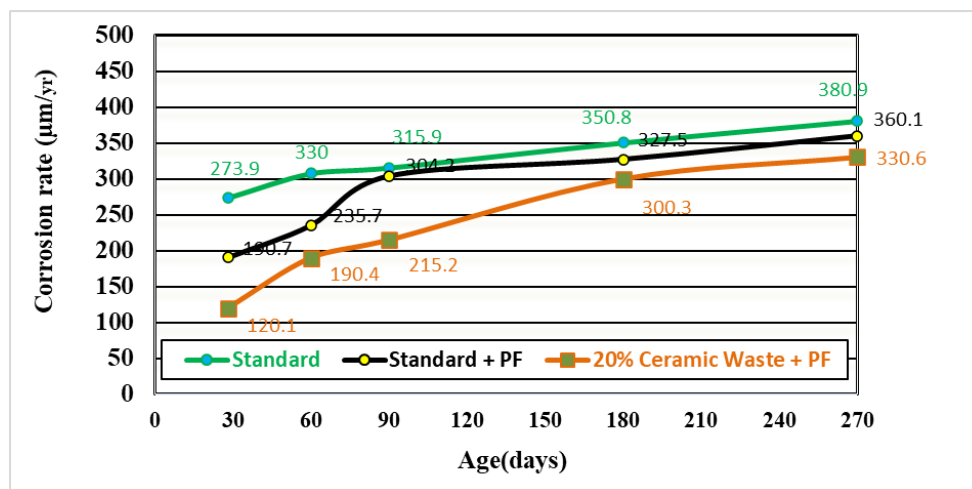
Fig. 20 shows corrosion rate values at 28, 60, 90, 180 and 270 days for standard mixture, standard with PF, ceramic waste sand replacement of samples immersed in pure water. The results indicate that, same trends and observations of marble waste and red brick waste sand replacement samples.

Fig. 20: Corrosion Rate Variation for Ceramic Waste Sand Replacement, Standard and Standard with PF for Samples Immersed in Pure Water at Different Ages.

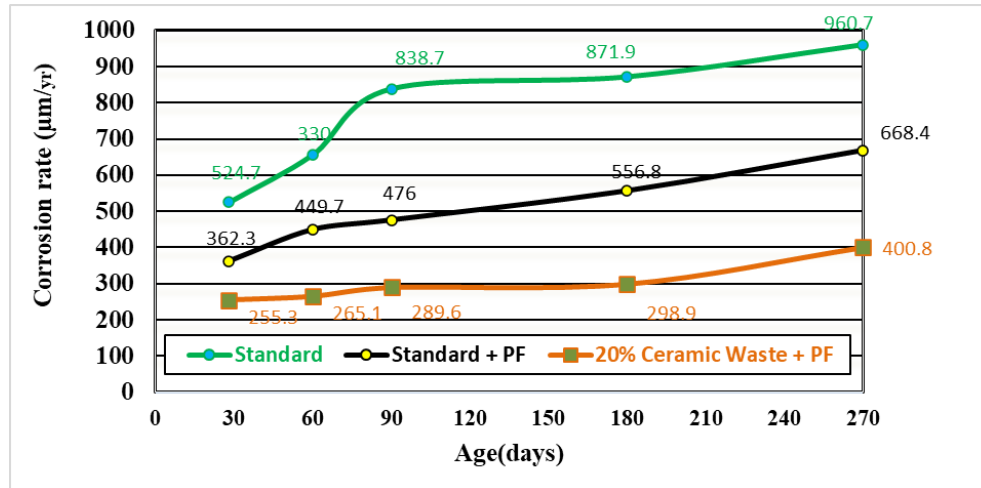
Fig. 21 shows corrosion rate values at 28, 60, 90, 180 and 270 days for standard mixture, standard with PF, ceramic waste sand replacement of samples immersed in sea water. The results indicate that, same trends and observations of marble waste and red brick waste sand replacement samples.

Fig. 21: Corrosion Rate Variation for Ceramic Waste Sand Replacement, Standard and Standard with PF all Samples Immersed in Sea Water at Different Ages.
