Evaluation of Asphalt Concrete Road - A case study of Voi - Maungu

¹Gunda Athman Chembea, ²Professor Abiero Gariy and
³Professor Kiptanui Too

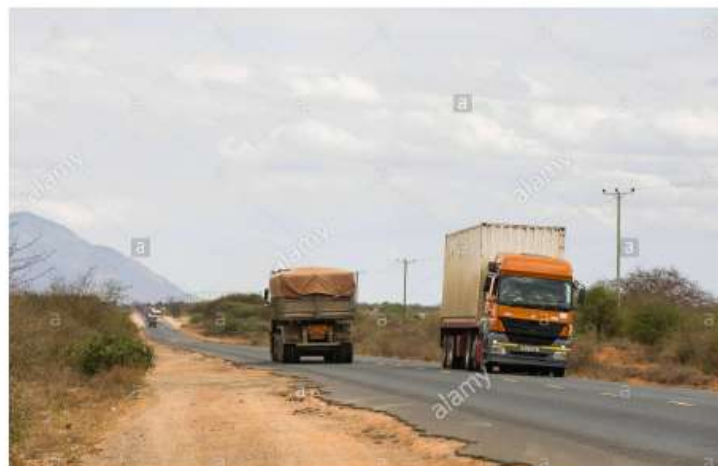
Fig. 2: Section of Voi - Maungu Road

Voi – Maungu road is a stretch along Nairobi – Mombasa highway forming a component of northern corridor. The stretch lies in Taita Taveta County and it's about 29km length. The width of the road without shoulders is 618 cm. Voi – Maungu road is a service road, serving industrial and commercial areas, educational institutions and large residential communities and as a component of the Northern Transport Corridor which is an economic lifeline within East and Central Africa, linking the landlocked countries of Uganda, Rwanda and Burundi with Kenya's maritime port of Mombasa. It also serves eastern part of the Democratic Republic of Congo, Southern Sudan and northern Tanzania. The road moves more than 50 percent of all goods traded in the East African Community. Due to the volume of traffic, and the concentration of heavy-duty transport vehicles, the route is distress development-prone. Below is Figure 2. Showing section of Voi – Maungu Road.

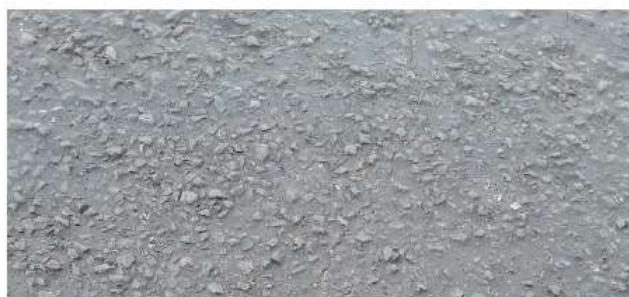
Figure 4. Raveling

Raveling is loss of material that covered asphalt surface or is the progressive disintegration of HMA layer as a result of the dislodgement of aggregate particles. These defects indicate that asphalt materials may be hardness or the asphalt mixture that was used is poor as shown in Figure 4 below.

For small raveled areas, which centered areas of raveling (section F), Remove the raveled pavement and patch. For large raveled areas (section A, B, C, D and E) indicative of general HMA failure, Remove the damaged pavement and overlay.

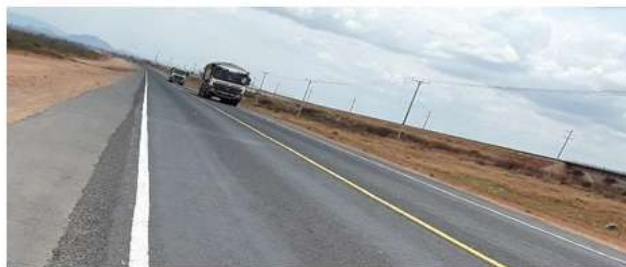
Figure5.Bleeding

Excess bituminous binder occurring on the pavement surface, usually found in the wheel paths. May range from a surface discolored relative to the remainder of the pavement, to a surface that is losing surface texture because of excess asphalt, to a condition where the aggregate may be obscured by excess asphalt possibly with a shiny, glass- like, reflective surface that may be tacky to the touch.

Bleeding occurs when Asphalt binder fills the aggregate voids during hot weather and then expands onto the pavement surface. Since bleeding is not reversible during cold weather, asphalt binder will accumulate on the pavement surface over time. One or a combination of the following can cause this:

- Minor bleeding can often be corrected by applying coarse sand to blot up the excess asphalt binder.
- Major bleeding can be corrected by cutting off excess asphalt with a motor grader or removing it with a heater planer. If the resulting surface is excessively rough, resurfacing may be necessary (APAI, no date given).
