Casting Defects Analysis in Foundry and Their Remedial Measures with Industrial Case Studies

Avinash Juriani¹

¹(M.tech Scholar, Department of Mechanical Engineering, Indian School of Mines, Dhanbad, Jharkhand, India)

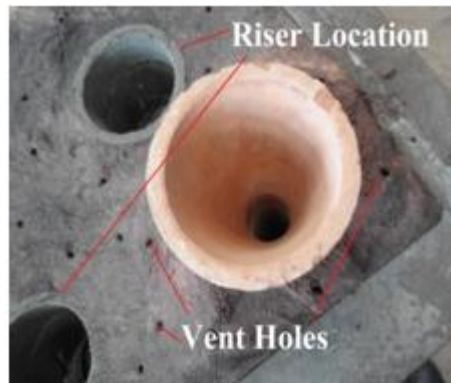
Fig.3. Vent Holes and Riser Placing

Sheave of Grade 270-540 IS1030 undertaken for study showed blowholes on groove edges.

- Avoid over ramming of sand.
- Use dry chills only.
- Optimum pouring temperature at 1585 degree centigrade for mild steel.
- Avoid using fine sand grains.
- Provision of adequate venting.
- Use dried and properly dressed cores.
- Reduce binder and additives.
- Control of Aluminum level.
- Increase runner height for increased static pressure.
- Adjust carbon equivalent value.
- Use water based zircon coatings.

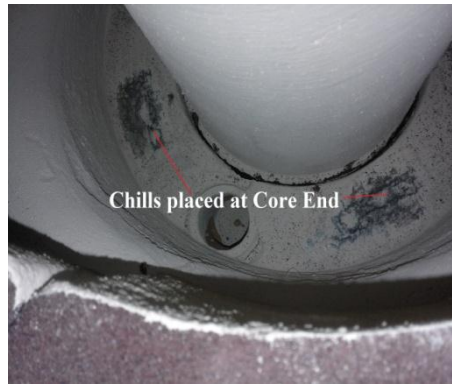
Fig.5. Chills Placing at Ends

Bottom bearing housing of Grade EN-9 alloy undertaken for study showed internal shrinkage defect towards the centerline.

- Dry mould using CO₂ gas for at least 60 seconds for high rigidity.
- Use of chills at correct position to for directional solidification.
- Feeding of sharp corners to avoid hot spots.
- Riser to be properly located.
- Use of inoculants.

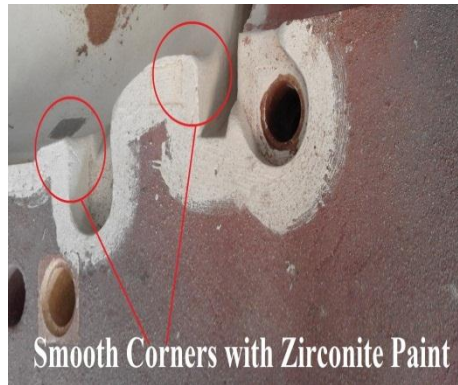
Fig.7. Smooth Corners with Zirconite Paint

Bottom Chock of Grade EN-9 alloy undertaken for study showed hot tear near thick sections.

- Sufficient cooling of mould to be done.
- Avoid sharp turns/corners.
- Provision of draft during removal.
- Deoxidize to kill sulphur/phosphorus present.
- Use inoculants mixture of Mn/Si/Mg to reduce sulphur/phosphorus content.
- Use of fine sand grains.
- Add coal dust to increase eutectic cells during solidification.

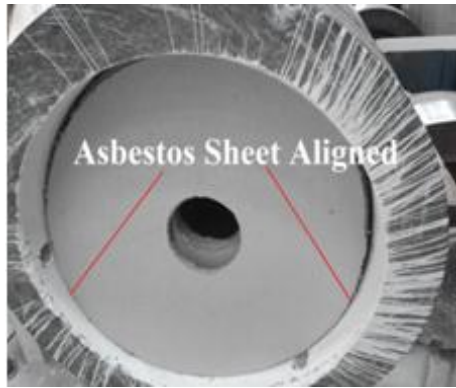
Fig.9. Asbestos Alignment

Centrifugally Casted Pipe of Grade SS HK40 undertaken for study showed lamination defect protruding from pipe periphery.

- Pipe to be rotated at optimum speed of 500rpm.
- Use of best quality materials for charging.
- Locking of pipe die by correct flange size.
- Asbestos sheet for packing should be of good quality and properly aligned in pipe die.

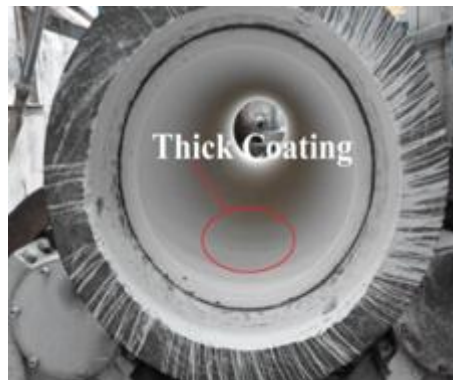
Fig.11. MOLD Coat

Centrifugally Casted Pipe of Grade SS HK40 undertaken for study showed lumps defect on pipe surface

- Increase rotation speedup to 475 to 500 rpm.
- Proper preheat of pipe die.
- Pouring ladle and die to be free from any foreign particles.
- Increase number of mould coatings inside pipe die.

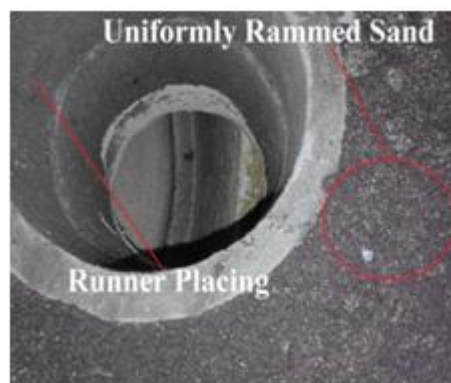
Fig.13. Sand Ramming and Runner Placing

- Tilting of metal stream directly to cores causing erosion.
- Use of unevenly compacted moulds.
- Mould breakage during assembly.
- Uneven sand mixing.
- Improper pouring practices leading to mould disturbances.

- Use of high bentonite content.
- Proper ramming of sand for uniform compaction.
- Frequent cleaning of mould boxes.
- Use of properly dressed cores.
- Proper mixing ratio of reclaimed sand and binder.
- Proper pouring time.
- Optimum pouring height.

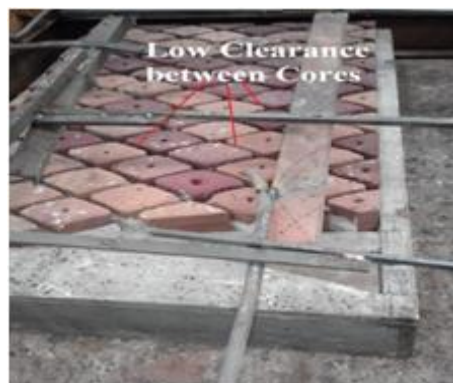
Fig.15. Core Clearance Setting

Grid plate of Grade SG500/7IS1865 undertaken for study showed flashes defect.

- Excessive Clearance between top and bottom parts of mould box.
- High pouring pressure.
- Use of mould with poor pattern designs.
- Patterns having cavities at the end.
- Improper clamping of top and bottom parts.

- Sealing of mould box near parting line.
- Ensure end cavities to be filled to avoid metal leakage.
- Dimensions to be controlled.
- Carefully setting mould assembly.
- Proper core setting.

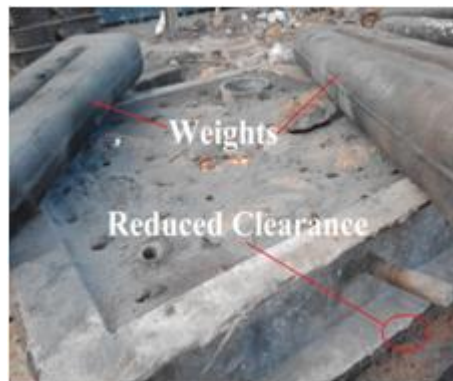
Fig.17. Heavy Weights on Cope

- Clamping cope and drag using worn out dowels.

- Faulty pattern designs of top and bottom parts.
- Inadequate amount of weight kept on cope part.

- Use of proper gating system.
- Heavy weight to be kept on top of casting, ensuring no dislocation of cope part.
- Ensure top and bottom parts are aligned properly.
- Replace worn out dowel pins with new ones.
- Use locators to match top & bottom parts.
- Use C-Clamps to clamp the mould box.

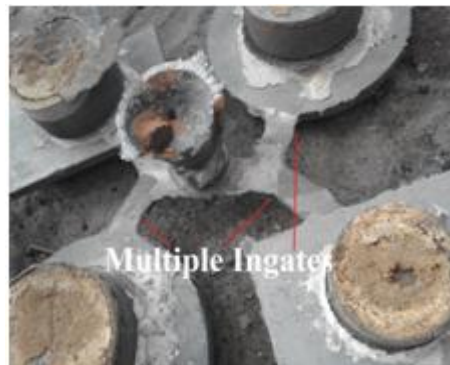
Fig.19. Multi Gates System

Wind Box of Grade SG500/7IS1865 undertaken for study showed misrun defect at thin section.

- Lower pouring temperature.
- Intermittent Pouring.
- Pouring Delayed.
- Back Pressure during Pouring.
- Inadequate venting.

- Sufficient pouring temperature to ensure fluidity.
- Design proper gating system.
- Cleaning of mould box before pouring.

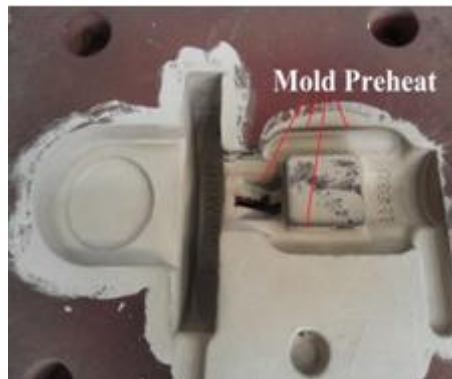
Fig.21.Mould Preheat at 45°C

Valve of Grade ASTM A216WCB undertaken for study showed defective surface at flange face.

- Preheat the mould before pouring
- Check for slag formation during charge
- Pouring temperature to be lowered
