Concrete Face Rockfill Dam Failure Process

Bharat Raj Pandey¹, Dr. Ram Krishna Regmi², Dr. Ram Chandra Tiwari³

1 Author: Tribhuvan University (TU), Institute of Engineering (IoE), Pulchowk Campus

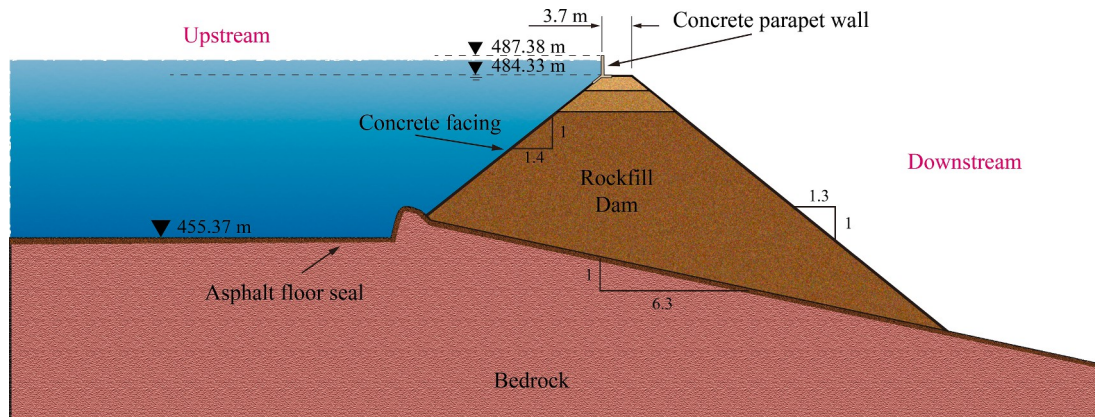
Figure 1 Schematic diagram of the typical longitudinal section of the Upper Taum Sauk dam.

On December 14, 2005, the stage sensors of the upper reservoir failed to turn off the pumps employed to convey water from the lower reservoir during the overnight filling, resulting in the water overflowing the wall top of Upper Taum Sauk dam. When the dam breached, 5.30 million m³ of water was released within 25 min and flowed into the Black River. According to the site investigation, FERC (Federal Energy Regulatory Commission), 2006, the circle parapet wall was not horizontal due to differential settlement of dam materials. Some parapet wall does not fulfill the requirements compared to the designed value of 487.38 m, and the slab labeled 92 had the most differential settlement. According to the surveyed data, the slab 92 crest elevation was 486.76 m below the design elevation of 0.62 m, A. J. Hendron, 2005.

According to the accident investigation report, FERC (Federal Energy Regulatory Commission), 2006, due to the lack of timely monitoring information on the settlement of the dam crest, the stage sensors installed in the upper reservoir set a higher water level than the dam crest in some parts of the parapet wall, resulted in the overtopping failure of the Upper Taum Sauk dam. Data recovered from the control system of the upper reservoir and back calculations indicated that the water initially overtopped the crest of the parapet wall at about 4:55 a.m., December 14. Then, around 20 min later, the water overflowed, and the Upper Taum Sauk dam began to breach, J. L. Ehasz, P.H. Rydlund, 2006. One of the turbine pump units had stopped before the overtopping (this unit was programmed to automatically shut down when the water level of the upper reservoir reached 1.50 m below the crest of the parapet wall), but the second unit continued to run until the overflow height attained 0.11 m. This pump unit was intended to shut down automatically when the reservoir water level reached 0.61 m below the specified parapet
