# Analysis of Utilization of Pandan Fiber Biocomposite Materials as a Motorcycle Body Kit Using Impact Testing With Charpy Method

This study aims to analyze the impact test strength of a mixture of pandan mat fiber with epoxy resin as a test medium for motorcycle body kit materials with fiber orientation directions  $0^\circ$ ,  $45^\circ$ ,  $*R^\circ$  (Random), with a comparison of the composition of the epoxy resin matrix (A) + hardener (B) (A: B/2:1), 95%, 85%, 75%, with pandan mat fiber as 5%, 15%, and 25%, with the Charpy Impact testing method. This test is carried out regarding the JIS Z 2202 impact test standard. In the experiments that have been carried out, it was found that the test object with the code MF-04 with fiber orientation direction  $0^\circ$  with a ratio of the resin composition (A) + hardener (B) (A: B/2:1) as much as 85% and 15% pandan fiber mat. It has the highest fracture strength value of 783 KJ (Kilo Joule) and has the highest ductility value of 9.78 KJ/m<sup>2</sup>. Based on the visual observation of the macrostructure, the test object with code MF-04 has a rough fracture surface, and this is similar to the characteristics of ductile fracture. This

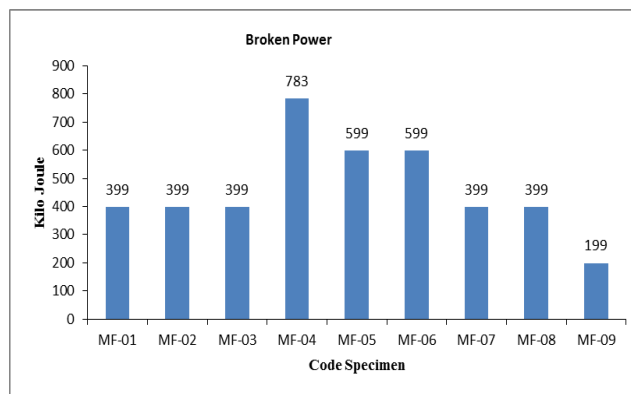
**Figure 5** Explaining Fracture

From the graph above, it can be explained that the specimen with the code MF-04 with a composition of 85% resin + hardener with a mixture ratio (Mix A: B) 2:1 and 15% pandan mat fiber, the highest value of fracture strength was obtained from the impact test of 783 KJ (kilojoules). With specimen code MF-05 with a composition of 85% resin + hardener with a mixture ratio (Mix A: B) of 2:1 and 15% pandan mat fiber and MF-06 with a composition of 85% resin + hardener with a mixed ratio (Mix A: B ) 2:1 and 15% pandan mat fiber obtained a moderate value of fracture strength from the impact test results of 599 KJ. With specimen code MF-01, MF-02, MF-03 with a composition of 95% resin + hardener with a mixture ratio (Mix A: B) of 2:1 and 5% pandan mat fiber and MF-07, MF-08 with a composition of 75 % resin + hardener with a mixture ratio (Mix A: B) 2:1 and 25% pandan mat fiber obtained a value below moderate fracture strength from the impact test results of 399 KJ. With the code specimen MF-09 with a composition of 85% resin + hardener with a mixture ratio (Mix A: B) 2:1 and 15% pandan mat fiber, the lowest fracture strength value was obtained from the impact test results of 199 KJ.

From the table, the results of the calculation of the data above can be explained in the form of a graph below:

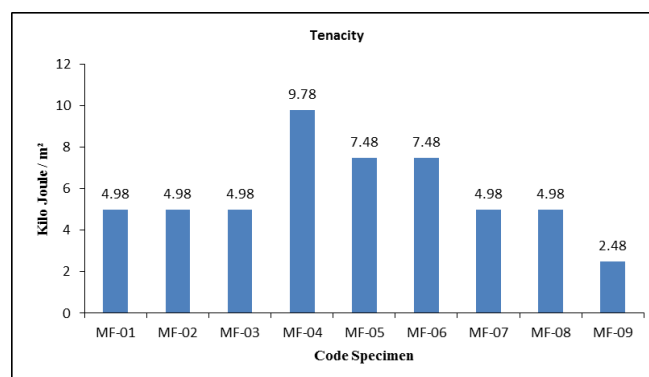
**Figure 6** Explaining Tenacity

From the graph above, it can be explained that the specimen with the code MF-04 with a composition of 85% resin + hardener with a mixture ratio (Mix A:B) of 2:1 and 15% pandan fiber mat, the highest value of ductility from the impact test was 9.78 KJ. /m<sup>2</sup> (Kilo Joule/meter<sup>2</sup>). With specimen code MF-05 with a composition of 85% resin + hardener with a mixture ratio (Mix A:B) of 2:1 and 15% pandan mat fiber and MF-06 with a composition of 85% resin + hardener with a mixed ratio (Mix A:B ) 2:1 and 15% pandan mat fiber obtained a moderate value of tenacity from the impact test results of 7.48 KJ/m<sup>2</sup>. With specimen code MF-01, MF-02, MF-03 with a composition of 95% resin + hardener with a mixture ratio (Mix A:B) of 2:1 and 5% pandan fiber mat and MF-07, MF-08 with a composition of 75 % resin + hardener with a mixture ratio (Mix A:B) 2:1 and 25% pandan mat fiber obtained a value below moderate ductility from the impact test results of 4.98 KJ/m<sup>2</sup>. With code specimen MF-09 with a composition of 85% resin + hardener with a mixture ratio (Mix A:B) of 2:1 and 15% pandan fiber, the lowest ductility value from the impact test results is 2.48 KJ/m<sup>2</sup>.

From the table the results of the calculation of the data above can be explained in the form of a graph below:
