Aesthetic Rehabilitation of a Severely Discolored Anterior Tooth: A Clinical Report

Abstract: Discoloration of anterior teeth is a major concern in today's society. This can result in the cosmetic impairment of such patients which affects their social interaction with the peers. Discoloration of anterior teeth is often due to traumatic injury and its aesthetic rehabilitation poses a great challenge for the dentist. The aesthetic rehabilitation of an endodontically treated tooth usually done by translucent metal free ceramic restoration is contraindicated for a heavy discoloured tooth, as this affects the shade matching of the affected tooth with that of the natural dentition. So internal bleaching technique can be utilized here to reduce the shade of the discoloured tooth crown before ceramic restoration. This article presents a case report of aesthetic rehabilitation of an endodontically treated discoloured tooth with translucent lithium disilicate crown after intracoronal bleaching.

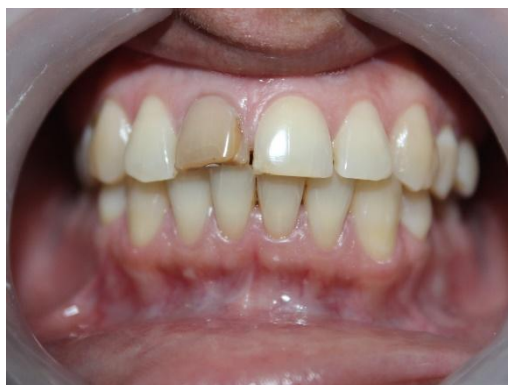
A 37-year-old female patient presented with the complaint of severely discolored and endodontically upper front tooth and expressed the wish to restore it with an aesthetic restoration. It was confirmed that she had not experienced any problems since the root canal treatment done 5 years previously; however, she was dissatisfied with the impaired esthetic appearance due to discoloration caused by the affected tooth as seen in figure 1

Figure 1: Preoperative view of the severely discolored teeth

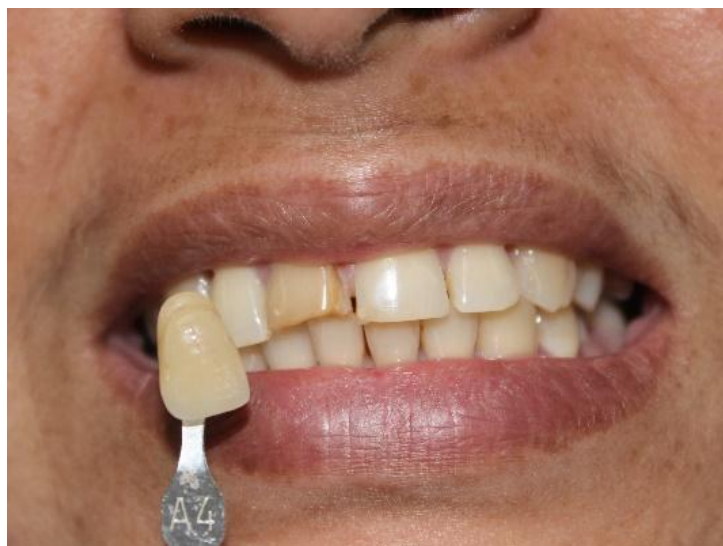
Initially, the shade of the affected right central incisor was noted as A4 with vita classical porcelain shade guide (Vita Zahafabrik,Germany)which was differing from the adjacent right central incisor tooth of A2 shade. The pre-bleaching photograph was taken and, this allows the matching of the shade and brightness of the affected tooth with that of the adjacent natural tooth as in the figures 2a and 2b.

Figure 2a: Shade selection of the affected tooth

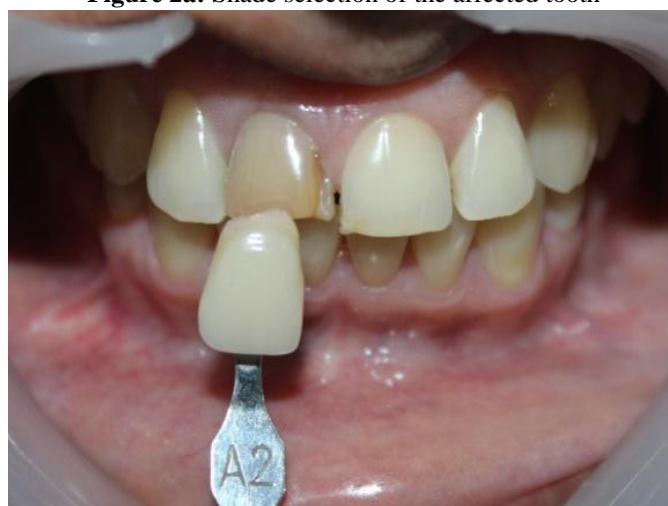
Figure 2b: Shade selection of the natural dentition

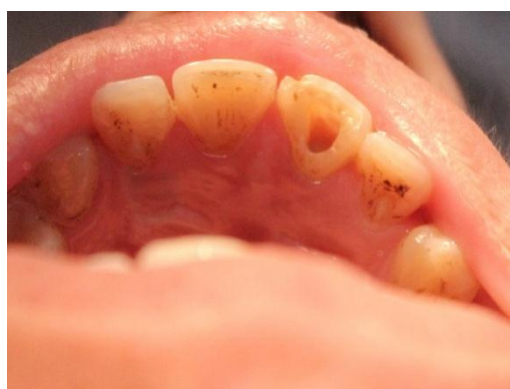
Figure 3: Cleaned coronal chamber devoid of restoration

The coronal pulp chamber of the incisor was cleaned after the removal of the restoration, and obturated gutta percha and root canal sealer were removed to a level of 2-3 mm below the cement-enamel junction as seen in the figure 3.

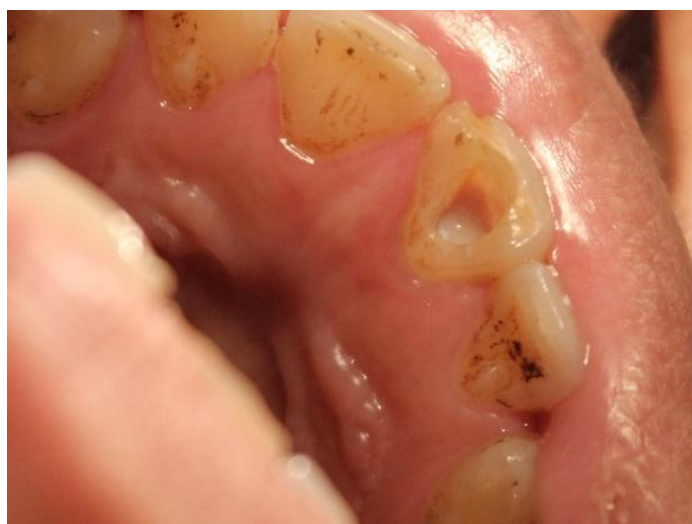
Figure 4: Glass ionomer as the mechanical barrier

A base of 1–2 mm glass ionomer cement was placed over the root filling material to assure a mechanical barrier between the sealed root canal and the bleaching agent as seen in the figure 4. This measure ensured that the bleaching agent which would be applied later will not diffuse into these sensitive areas.

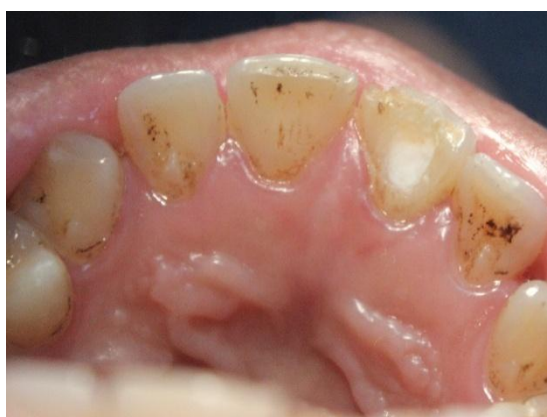
Figure 5: Coronal chamber plugged with bleaching agent

Sodium perborate (trihydrate) and 30% hydrogen peroxide were mixed in relation 2 g to 1 mL and the creamy paste was placed into the prepared cavity for bleaching as in the figure 5. The excess liquid of the material was removed by tamping with a cotton pellet which also pushed the paste into the pulp chamber. The cavity was then filled with cotton pellet and glass ionomer cement. The patient was recalled after 7 days for the assessment of the shade. For a better shade, intracoronal bleaching was performed for two more weeks. After 2 weeks, the shade of the affected tooth was confirmed to be A2 in accordance with the adjacent natural dentition as seen in the figures 6a and 6b. A calcium hydroxide preparation was inserted into the pulp chamber and left in place for a week in order to neutralize the bleaching agent. After the neutralization phase, composite restoration was done after the thorough cleaning of the coronal chamber.

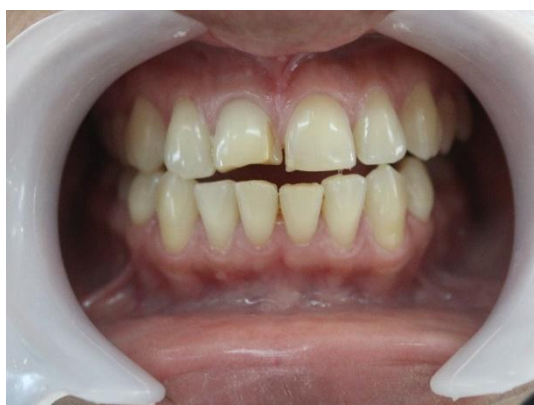
Figure 6a: Shade of the affected tooth similar to natural dentition

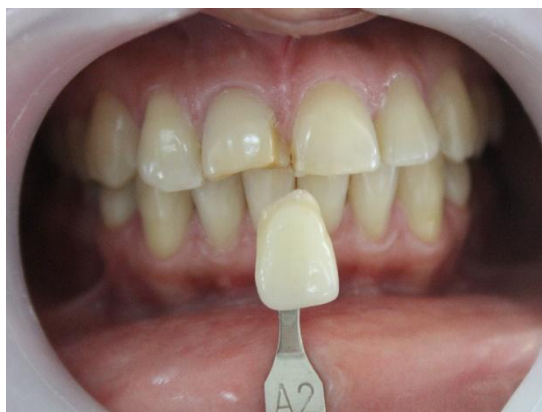
Figure 6b: Shade if the affected tooth changed to A2

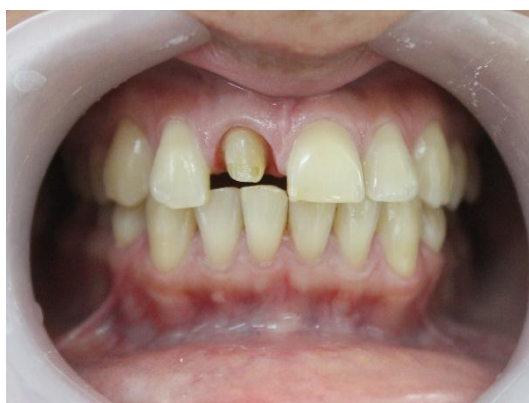
Figure 7: Tooth preparation

Tooth preparation for metal free ceramic restoration was performed with shoulder finish line equigingivally as seen in figure 7. A highly precise final impression of the preparation was made using elastomeric impression material, additional silicone with light body and putty consistency along with antagonistic jaw impression made using irreversible hydrocolloid impression material, alginate. Bite was registered followed by provisionalization using eugenol free cement. Metal free ceramic (Emax,IvoclarVivadent, Liechtenstein) crown was fabricated using the layering technique. Bisque try in was done to evaluate the fit,occlusion,shape and contour of the restoration as seen in the figure 8. Glazed crown was tried again and confirmed for fit, shade, shape and contour and occlusion of the tooth and its cementation was done using the resin cement(RelyXU200, 3M ESPE,Germany) after the thorough removal of eugenol free temporary cements as shown in the figures 9a and 9b

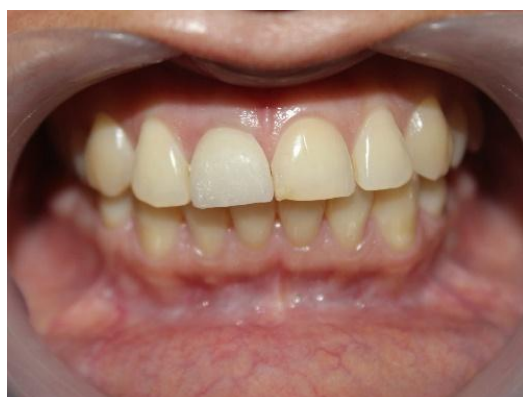
Figure 8: Bisque try in

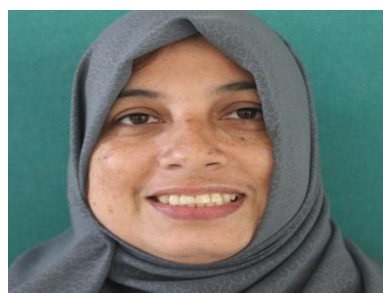
The tooth shade was in perfect harmony with the natural dentition. We were able to correct the tooth position and adjust the tooth proportions in addition to removing the severe discoloration of the affected tooth as in the figure 10. The patient did not experience any phonetic problems resulting from the correction of the tooth position and was extremely happy and fully satisfied with the esthetically pleasing outcome. At the final evaluation and during the follow up, the outcome was found to be very satisfactory with regard to the functional and esthetic parameters

Figure 10: Post-operative view
