Is Speed Bumps Installation Panacea For Road Traffic Crash Prevention? An Evaluation of Selected Major Routes in Ondo, Southwestern Nigeria

Richard Paul Chukwugozi,
Federal Road Safety Corps, Akure, Nigeria

This study is to evaluate the effect of speed bump installations along the selected major routes in Ondo, Southwestern Nigeria

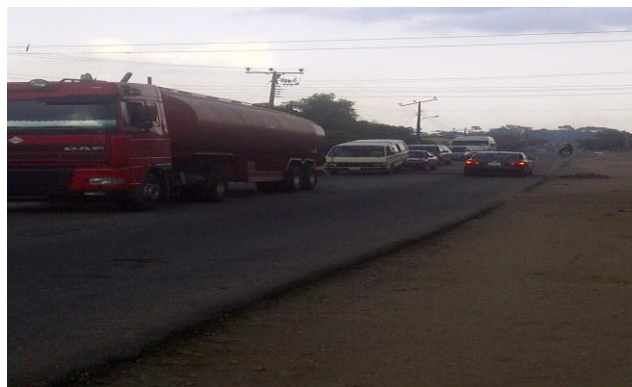
Fig.1: Categories of vehicle negotiating the speed bumps along Ikare-Owo Route

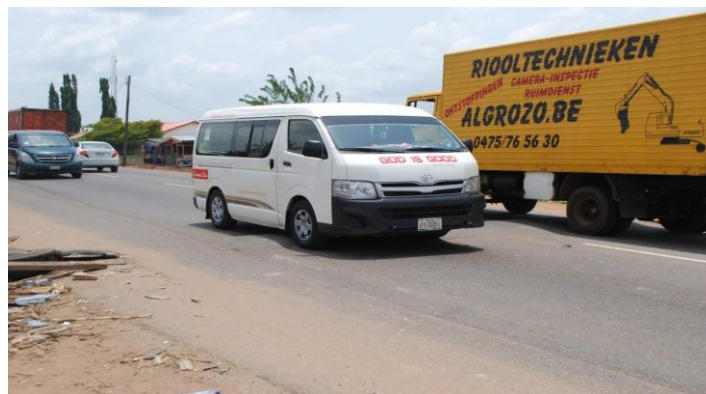
Fig.2: Categories of vehicle negotiating the speed bumps along Akure-Owo Route
