## Performance, Problems and Remedial Measures for Roads Constructed on Expansive Soil in Trinidad and Tobago

### Abstract:

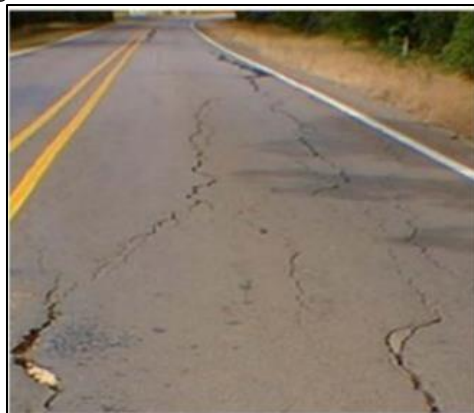
**Figure 6** Longitudinal cracking due to subgrade shrinkage adapted from Sebesta [19].

**Longitudinal Cracking:** Generated by tensile stresses induced during subgrade shrinkage, as shown in Figure 6. Crucially, this type of failure must be correctly differentiated from longitudinal cracks caused by traffic-induced pavement fatigue, as shown in Figure 7.

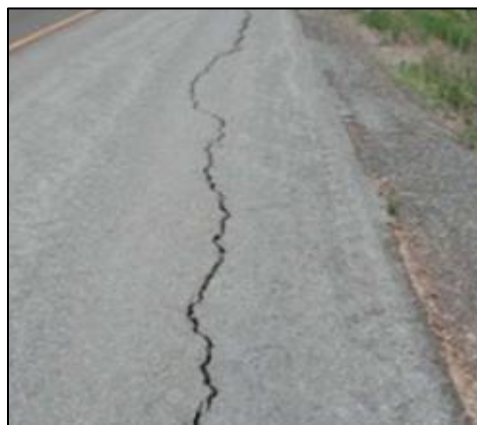
**Figure 7:** Longitudinal cracking due to pavement fatigue adapted from Scullion et al. [20].

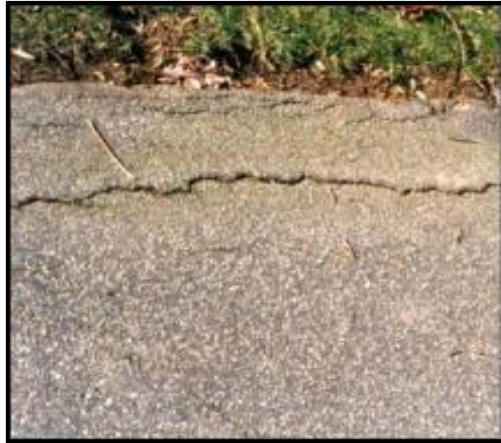
**Figure 8:** Edge Cracks due to Shrinking of Soil, adapted from Sebesta [19].

**Edge Cracking:** A localised phenomenon near the pavement edge, resulting from the shrinking of surrounding plastic clays, often accelerated by water extraction from nearby vegetation, as shown in Figure 8.

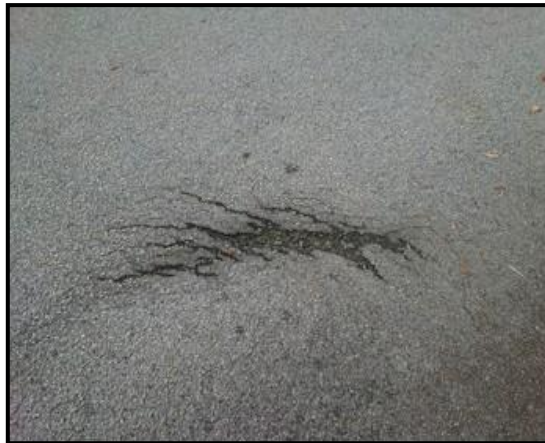
**Figure 9:** Rutting of pavement due to cyclic moisture changes, adapted from Daniel [21].

**Pavement Rutting:** A consequence of cyclic shrinking and swelling, leading to differential settlement and potential water pooling on the surface, increasing the risk of hydroplaning, as shown in Figure 9.

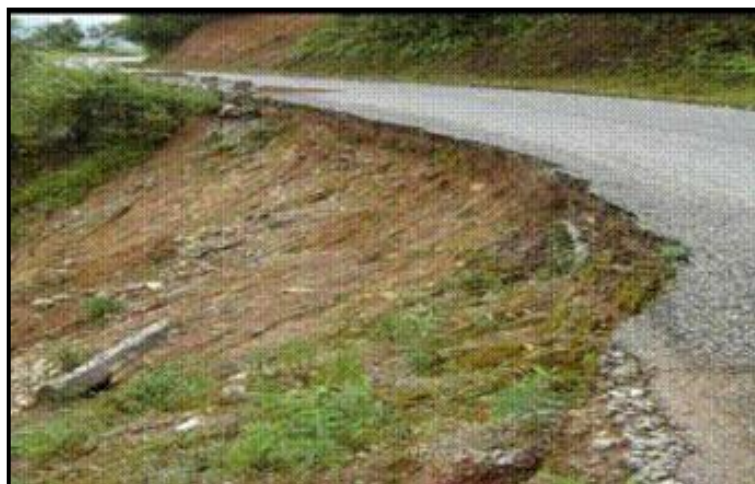
**Figure 10:** Pavement Failure due to Slope Instability, adapted from Hearn et al. [22].

**Shallow Landslides:** Infiltration of rainwater can reduce soil shear strength, causing slope instability and consequential pavement edge failure, as shown in Figure 10.

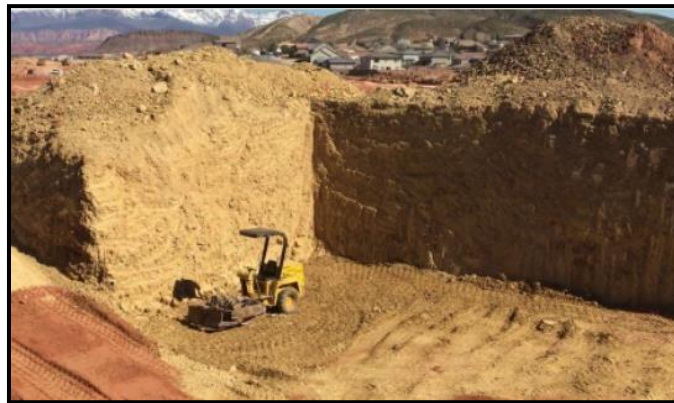
**Figure 13:** Excavation and Replacement of Expansive soils adapted from Obinna [27]

**Mechanical, Chemical, or Physical Alteration:** Replacement and Compaction: Excavating the expansive soil (recommended depths of 1-3.5 m) and replacing it with a properly compacted non-expansive fill, as shown in Figure 13. This method is fast but highly dependent on the cost and availability of suitable fill [27].

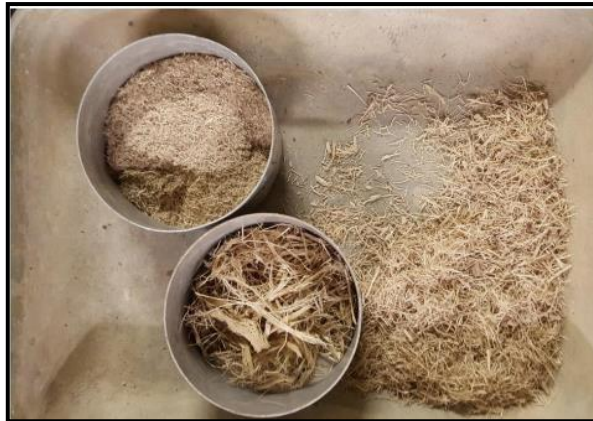
**Figure 16** Bagasse Fibre adapted from Nai [30].

**Bagasse Fibre and Lime/Ash:** Utilising local industrial waste products (Bagasse Fibre/Ash, Lime Sludge) as natural polymers and pozzolanic materials to control both shrinking and swelling and enhance compressive strength, as shown in Figure 16.
